Alliance Home Inspections LLC
Home Inspection Report
12910 E 40 Hwy. Independence, MO. 64055

9-6-2016

THE HOUSE IN PERSPECTIVE

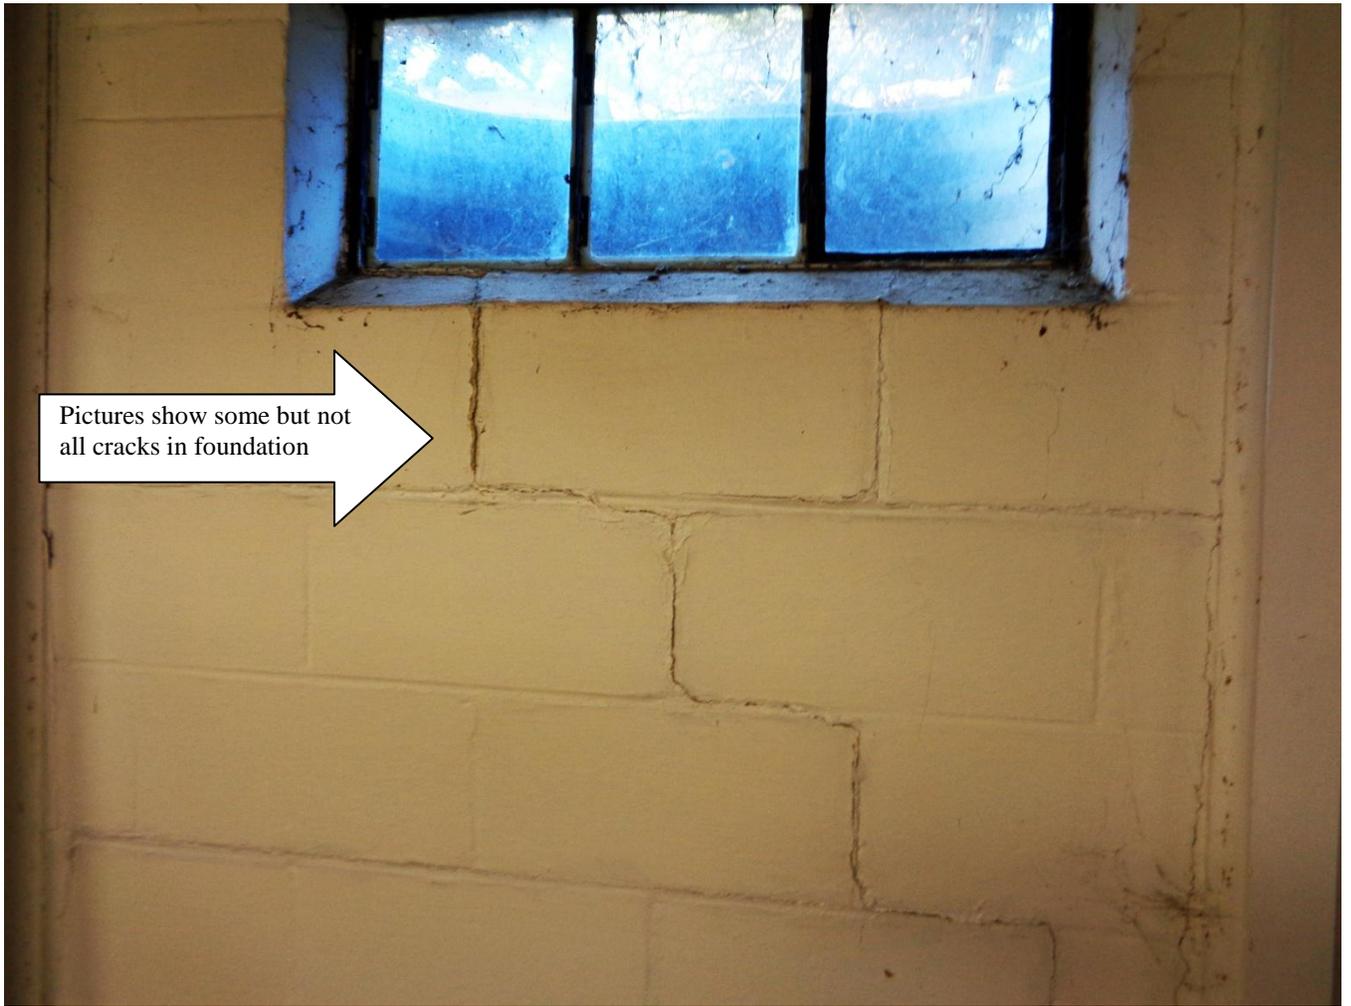
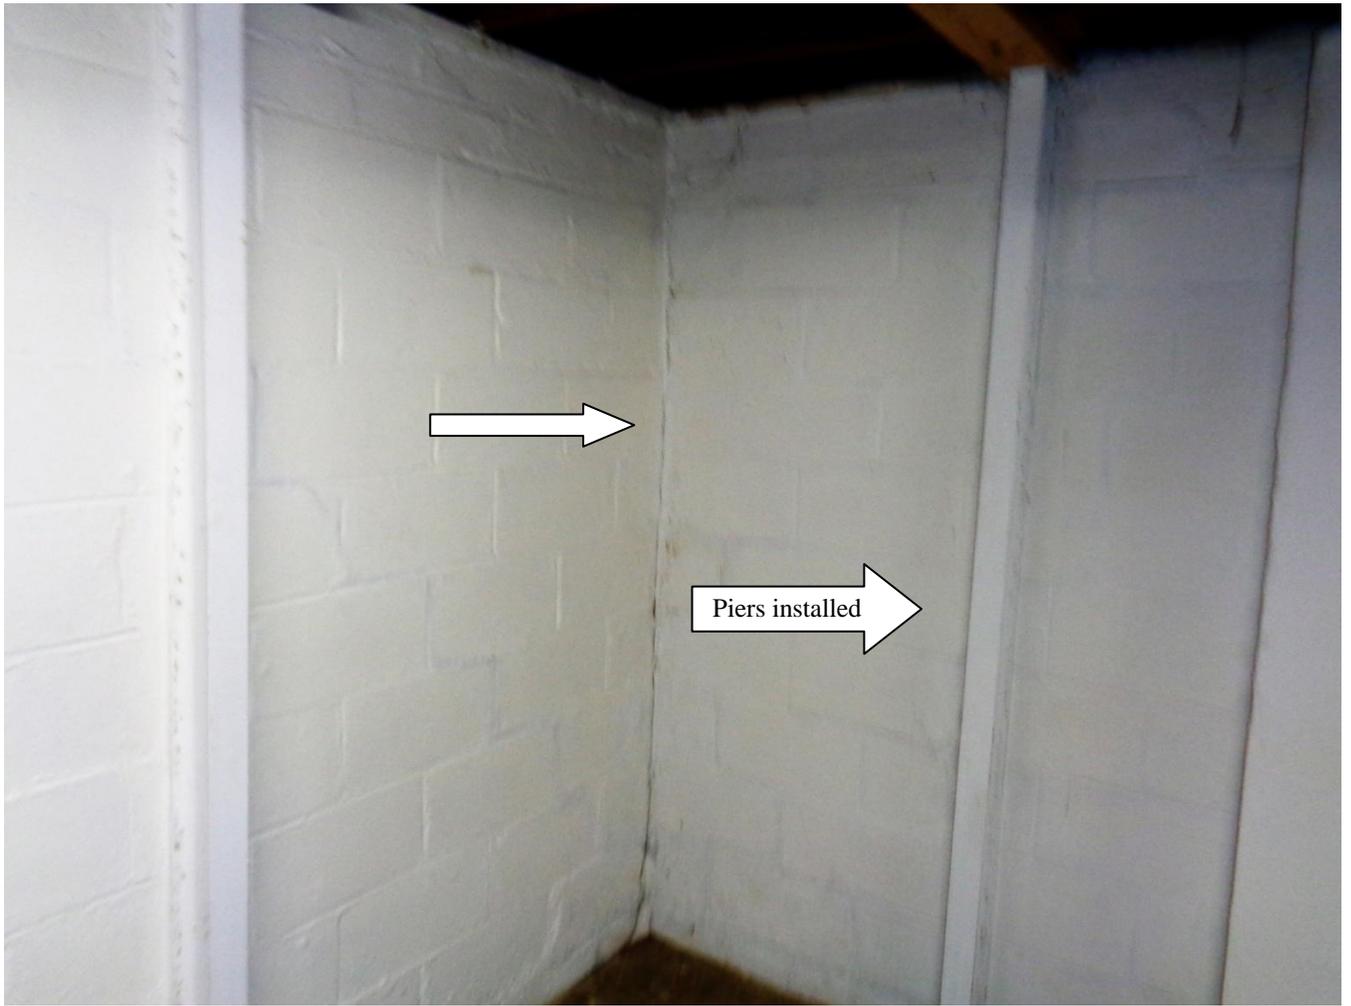
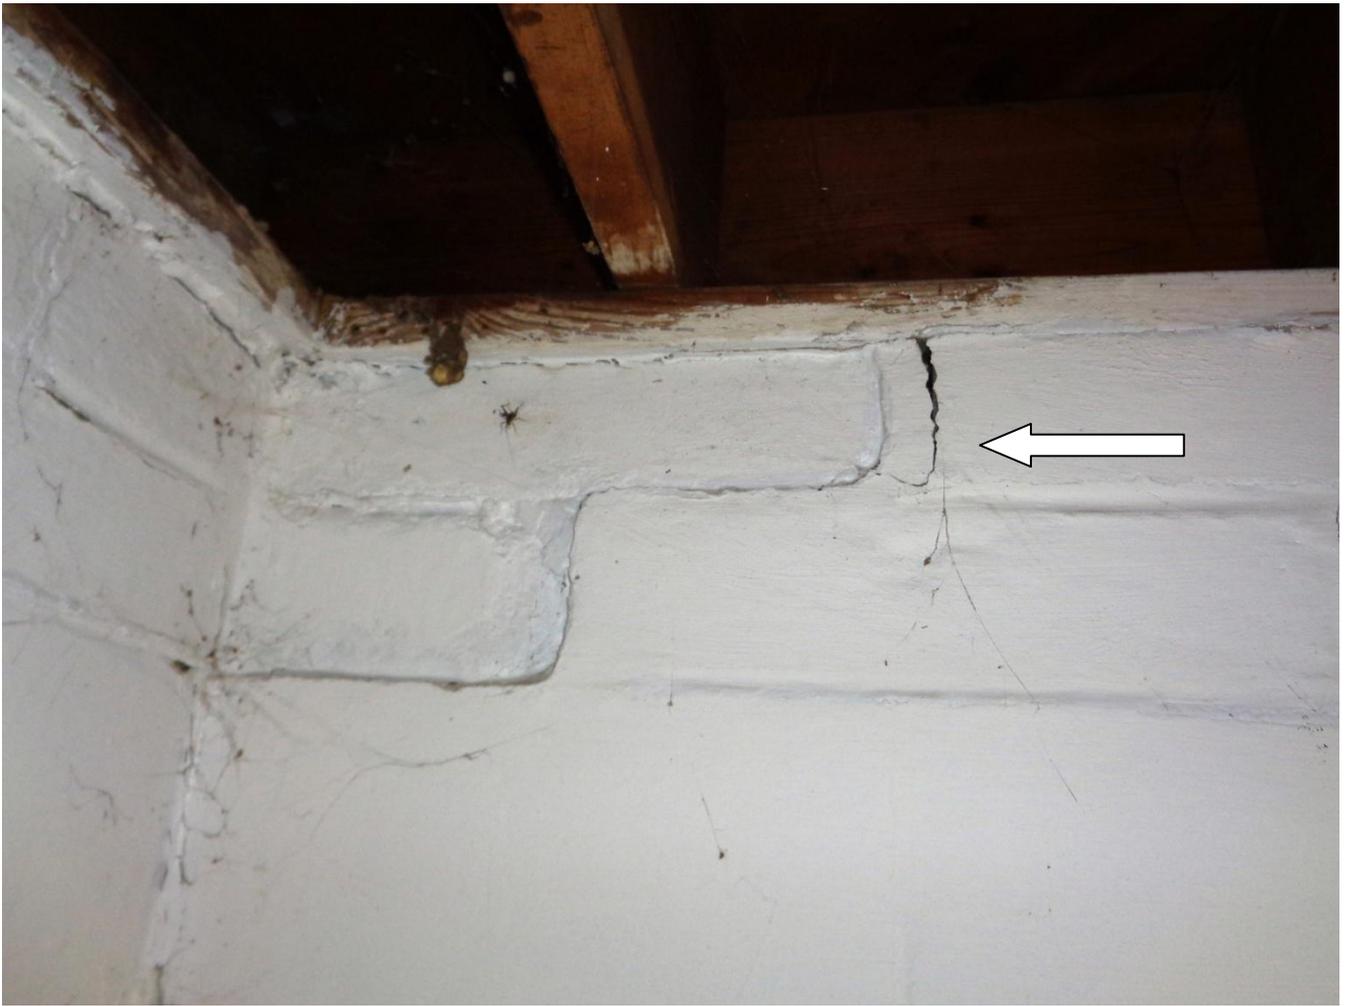
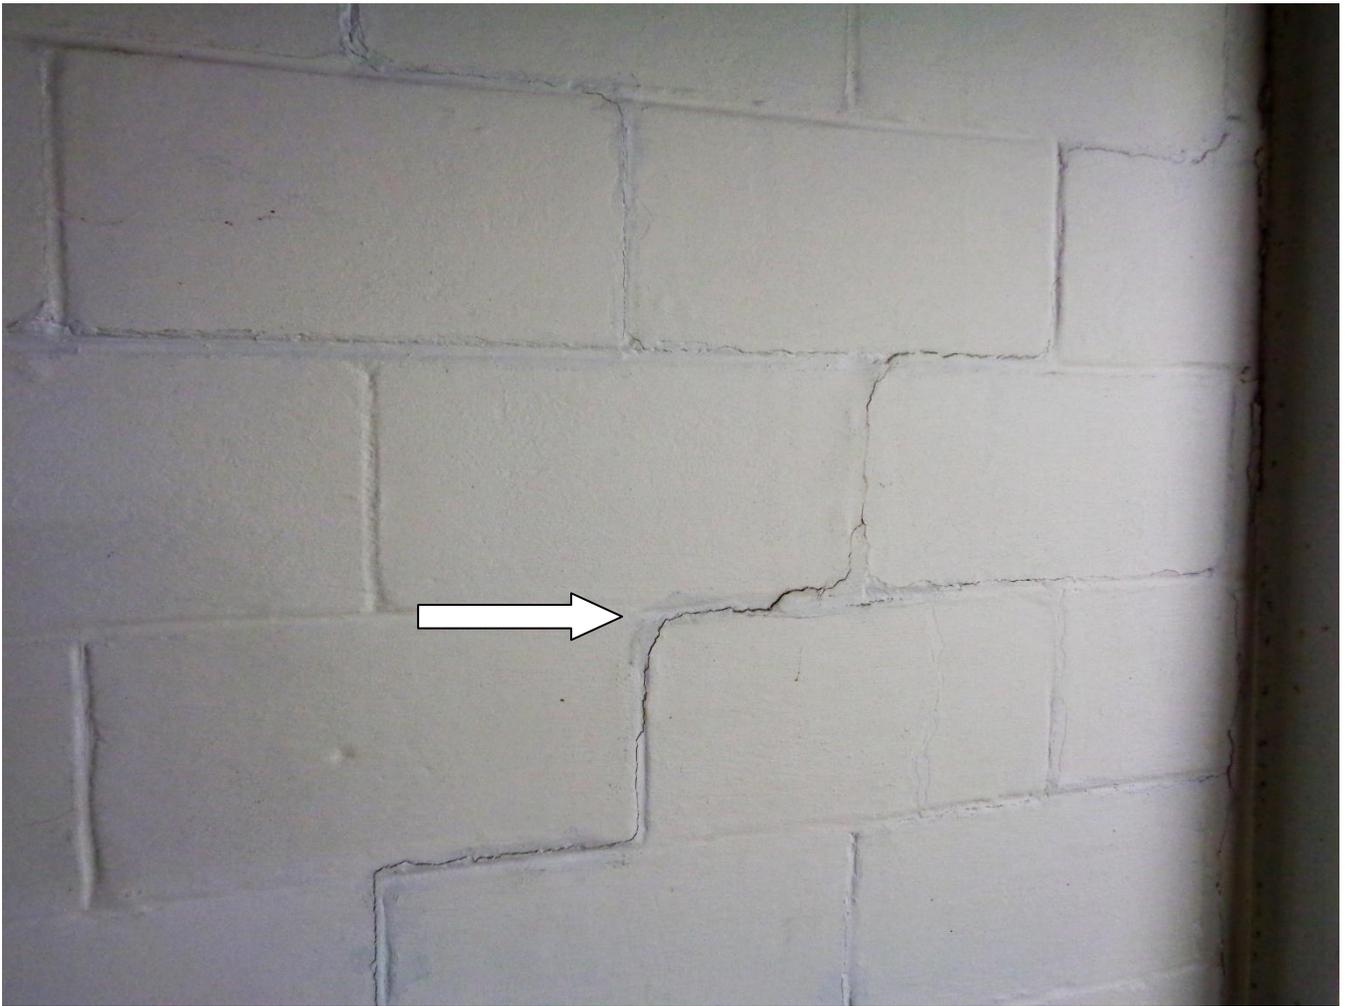
There is cracking, settling and bowing in the foundation walls.
There has been piers installed on foundation walls. There are signs of water intrusion in the basement.
Cracks are caused from poor surface drainage.

Monitor foundation cracking and bowing for movement.
Improving and maintaining the surface drainage will help keep foundation from cracking more.
Watering around foundation during dry spells will also help keep foundation from cracking more.

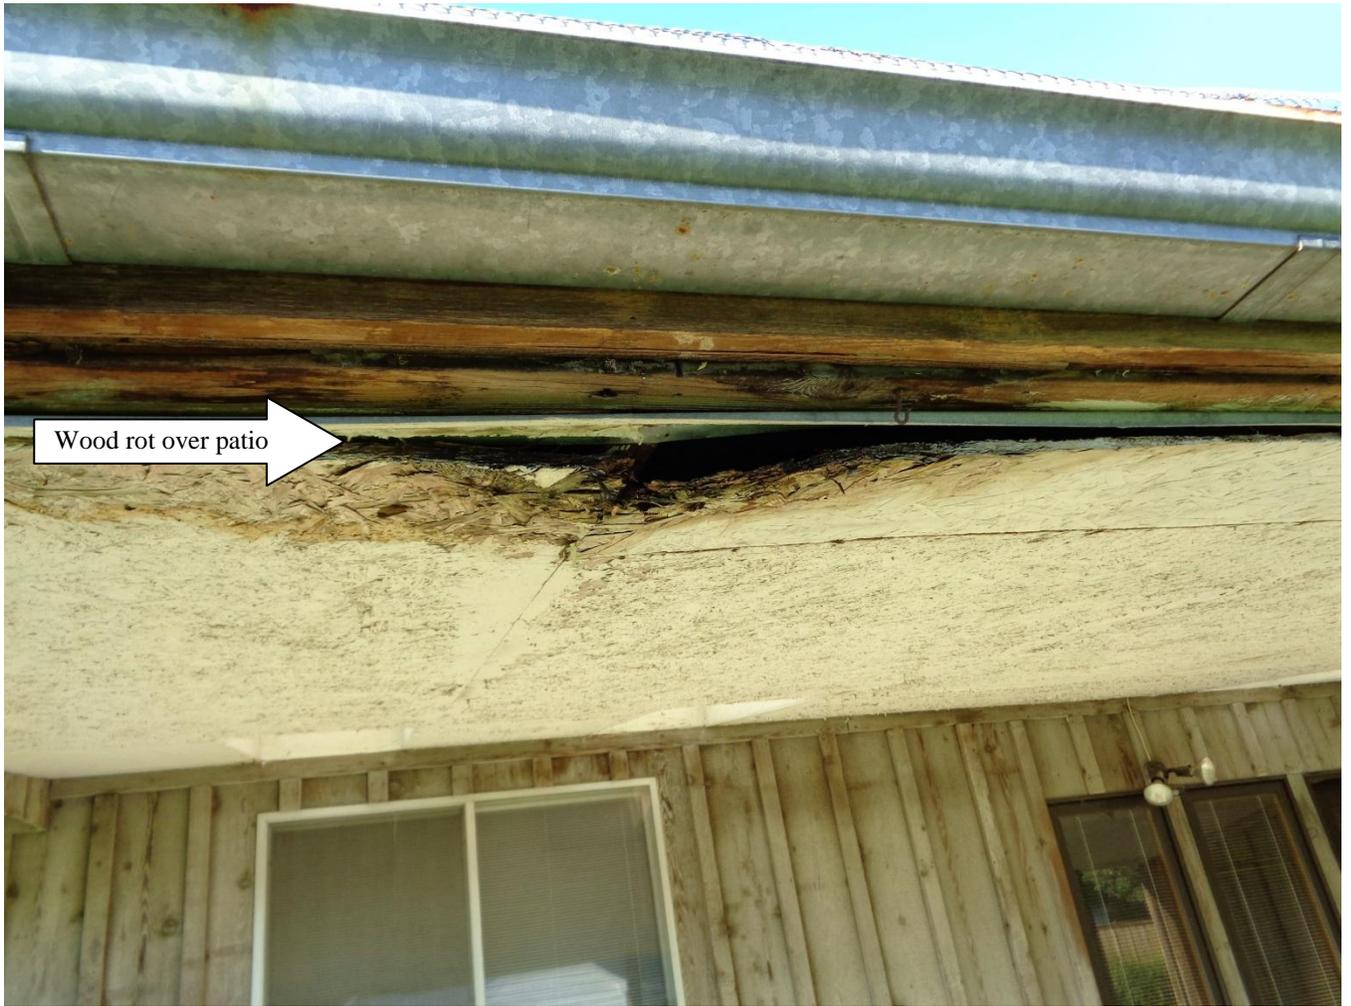
The surface drainage should have a positive slope away from house of 1/2-1, inch per foot for 5-6 feet away from house. The surface drainage needs improvement in some areas. This is the 2nd part of what caused foundation cracking. The west garage door springs do not have safety cables inside springs. There is some splitting in some areas of the wood siding, this could allow air & water behind siding. The patio has settling and separation in concrete pads, this again is caused from poor surface drainage. There is wood rot on the roof over the patio.

Wood rot over patio

Repair wood rot on roof over patio.

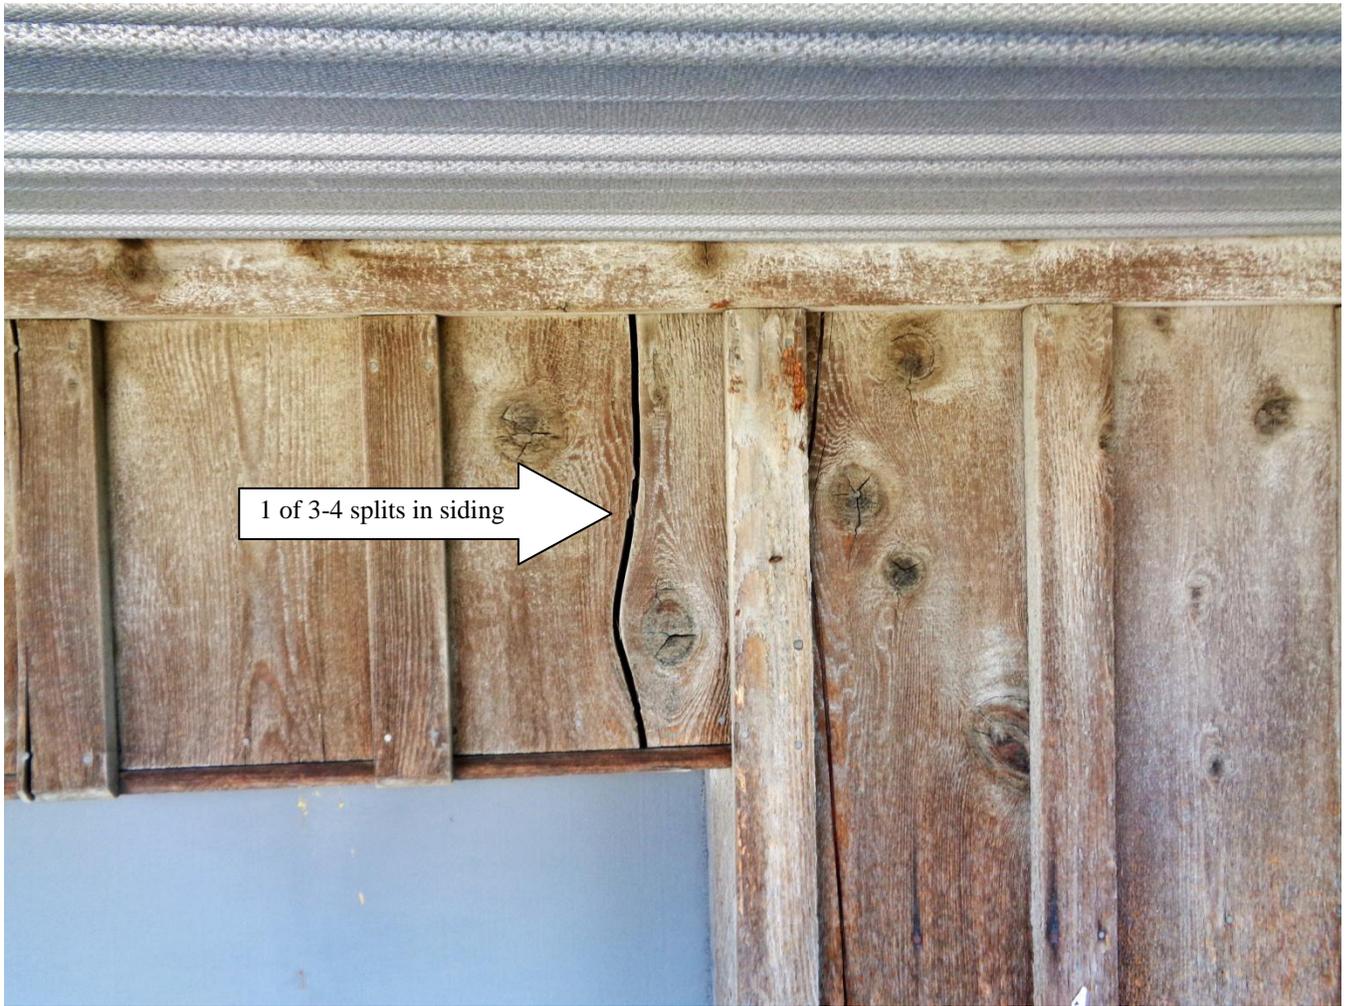
1 of 3-4 splits in siding

Replace split pieces on siding.

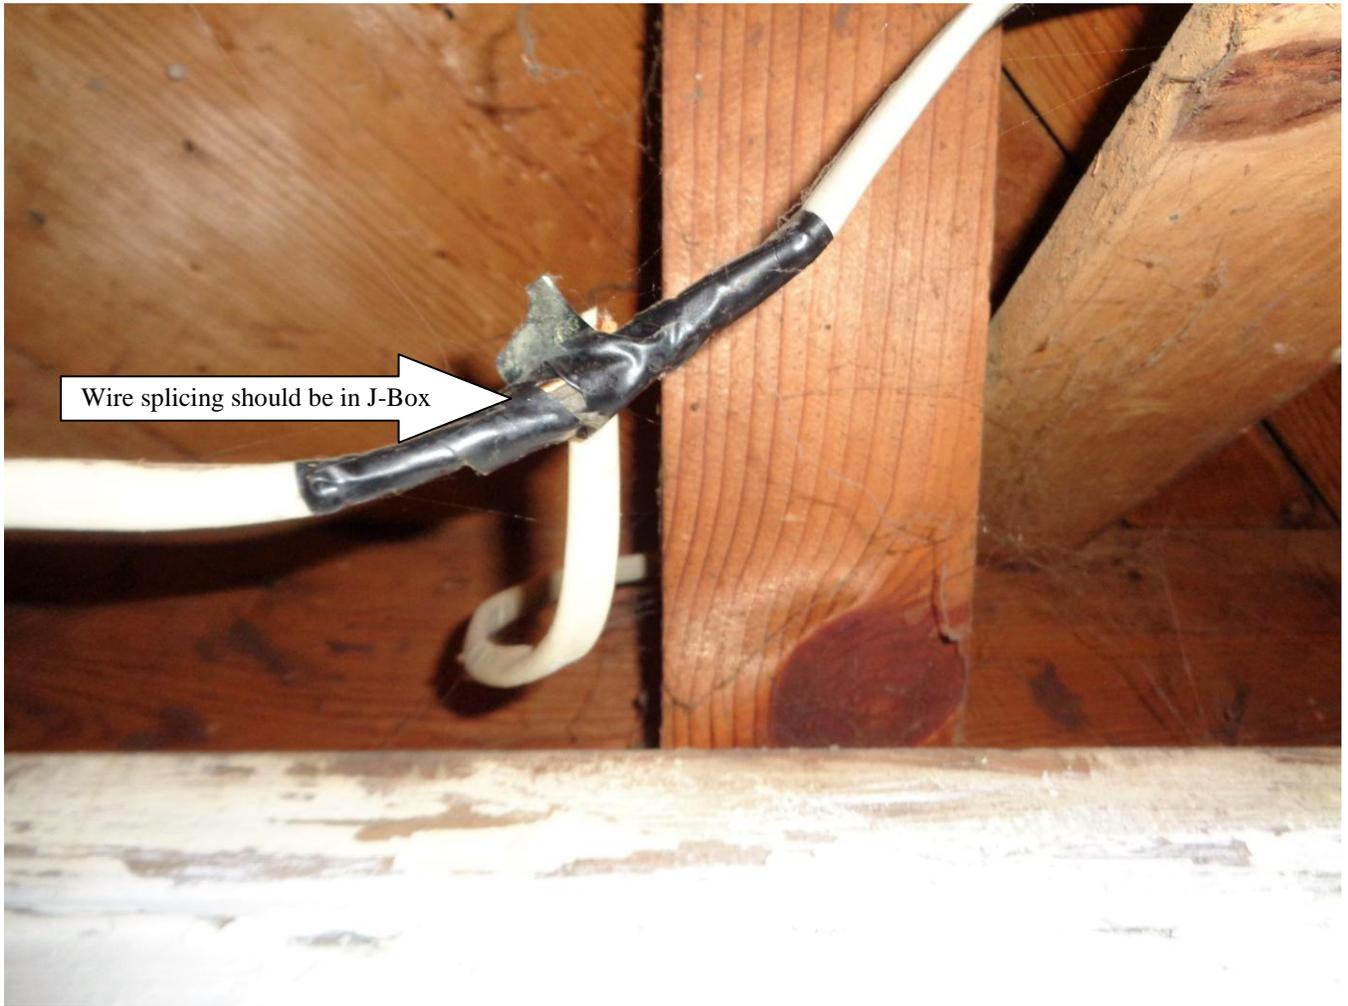
All exterior outlets, garage outlets and outlets within 6, feet of water should be GFCI protected.
 There is no GFCI protection for garage, exterior, bathroom or kitchen outlets.
 Many outlets in the house are 2 prong ungrounded outlets.
 There is wire splicing on the basement ceiling that is not in a junction box.
 The panel in the garage is 8 foot above the floor, panel should be no more than 6 feet above floor.
 1 main feeder wire in the garage panel has had 2-3 strands of wire cut off, this reduces the amperage capacity of the wire.
 The basement panel has a 60 breaker with 30 amp wire and a 40 amp breaker with 30 amp wire.
 There are also 2, 20 amp breakers with 15 amp wire.
 The screws for the electrical panel covers should be blunt tip screws so they don't puncture wiring inside panel. Both panels have pointed screws for the covers.
 The ledger on the electrical panel is not completely filled out.

Wire splicing should be in J-Box

Have licensed electrician install GFCI protection in proper locations and correct all other electrical concerns.
 The fire department recommends replacing smoke detectors every 10 years. They also now recommend a smoke detector in each bedroom and 1 in the hallway outside the bedrooms plus 1 on each level of the home.
 I would install all new smoke detectors in the proper locations.
 I would also add a carbon monoxide detector on each level of the home.

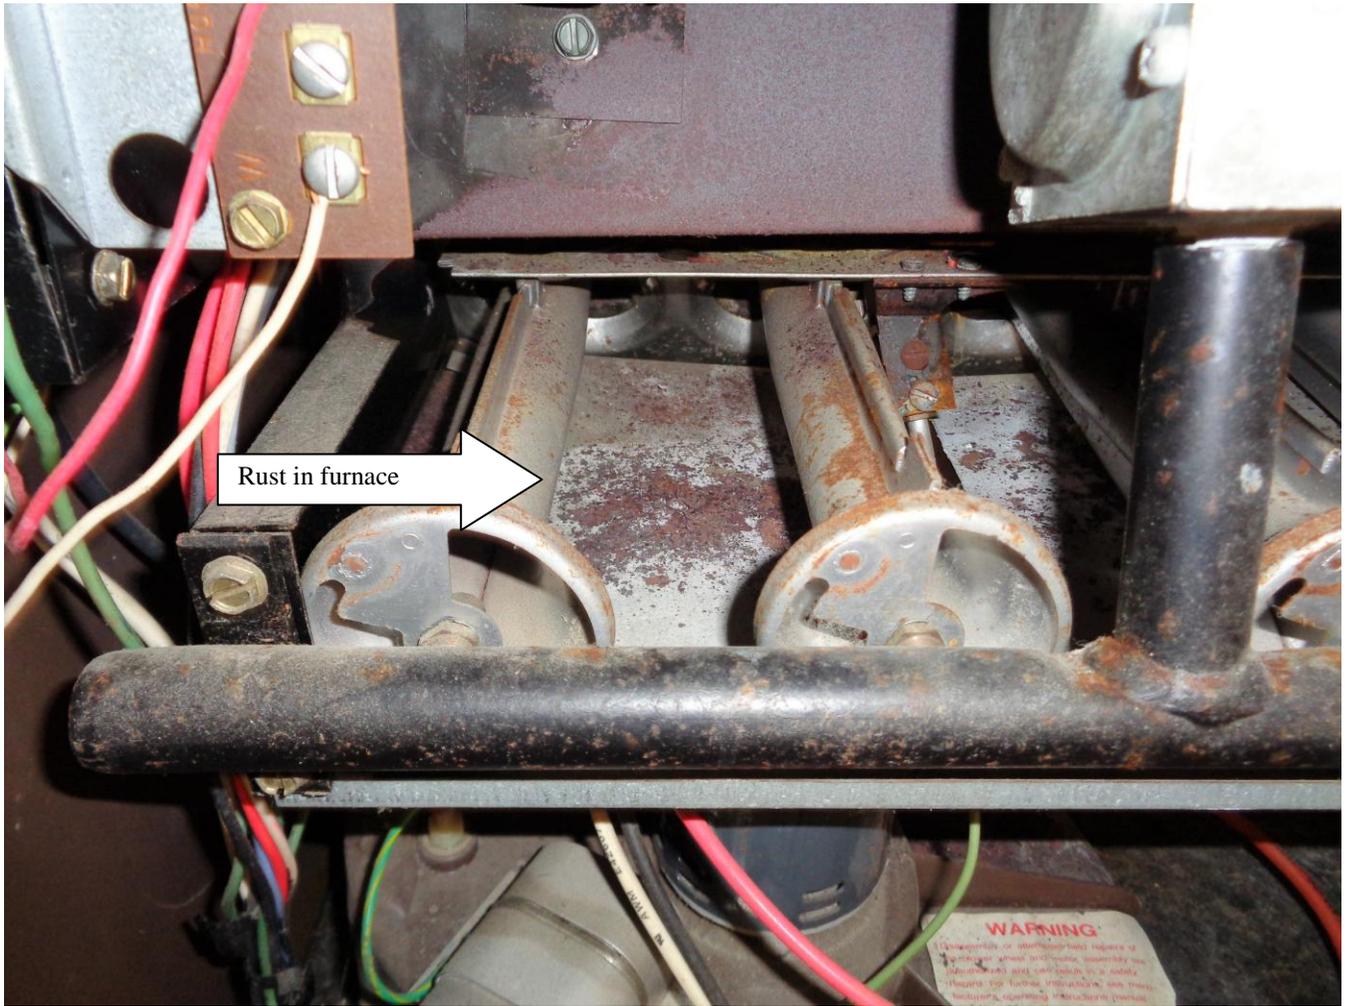
The furnace has rusting in the heat exchanger. Rusting in the heat exchanger can cause leaking of carbon monoxide into the house.

Rust in furnace

Have HVAC technician service, clean and test for leaking in the heat exchanger furnaces.

The furnace is at the end of its expected life I would budget to replace in the next year.

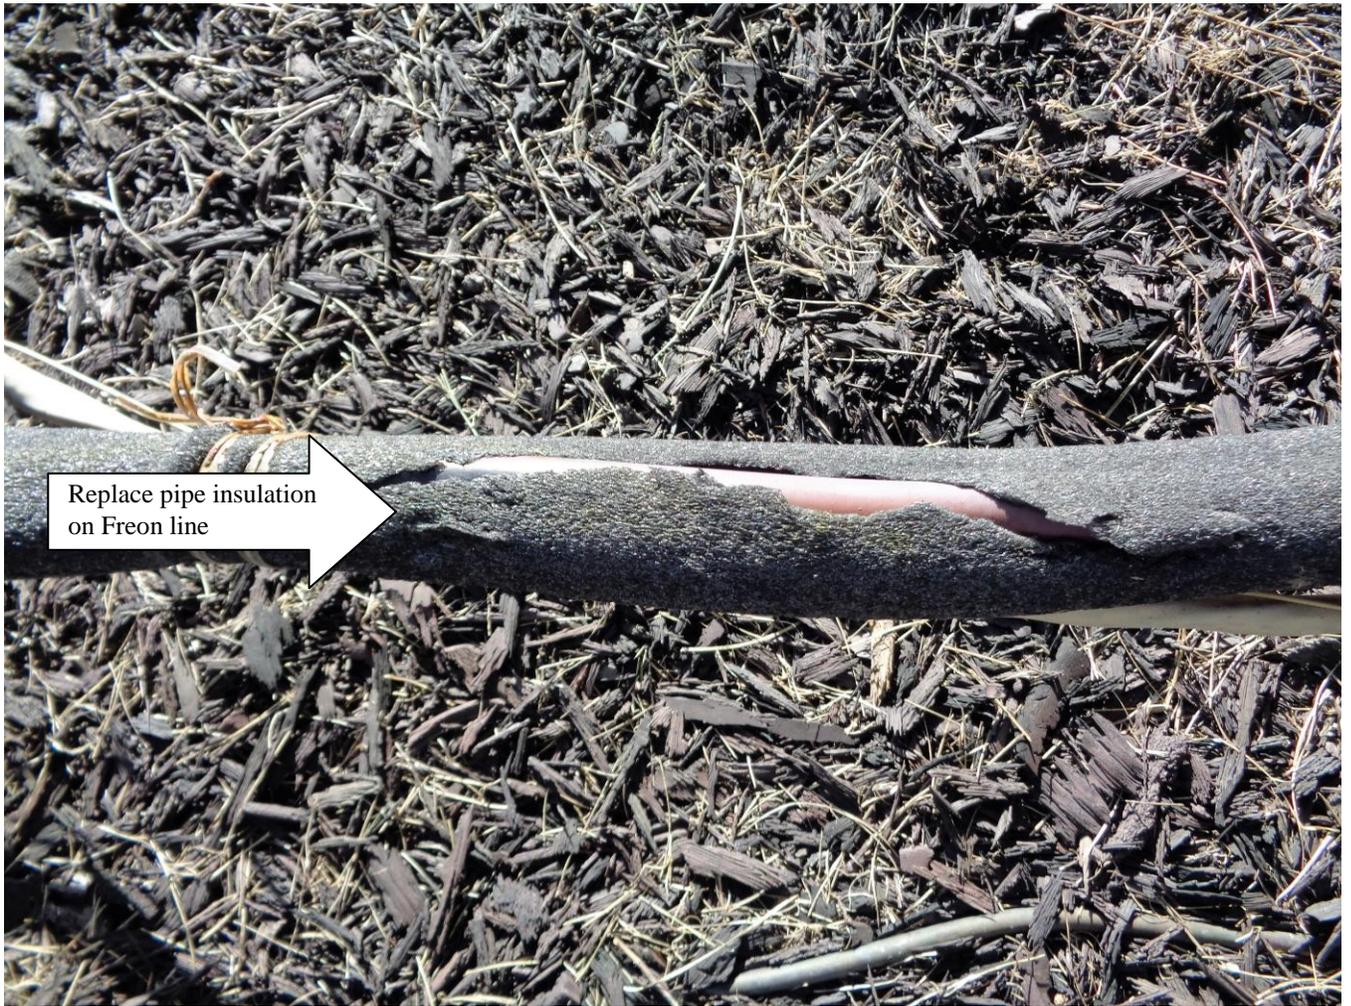
The A/C, unit is a 1986, Kenmore model. Model # NACFB36AB01867
The normal life of this type of unit is about 15-20 years.
The A/C, unit responded properly to testing. The temperature drop was 14-15, degrees.
The Freon line on the A/C unit needs new pipe insulation.
There are no service dates for the A/C unit.

Replace pipe insulation
on Freon line

Keep A/C unit clean, should be cleaned/rinsed at least twice a year by the home owner.
Keep filter clean in furnace.
Replace pipe insulation on the Freon lines.
Have HVAC technician service & clean A/C unit.
Have HVAC technician service A/C unit yearly for best performance and longest life.
The A/C unit is at or past the end of its expected life I would budget for replacement in the next year.

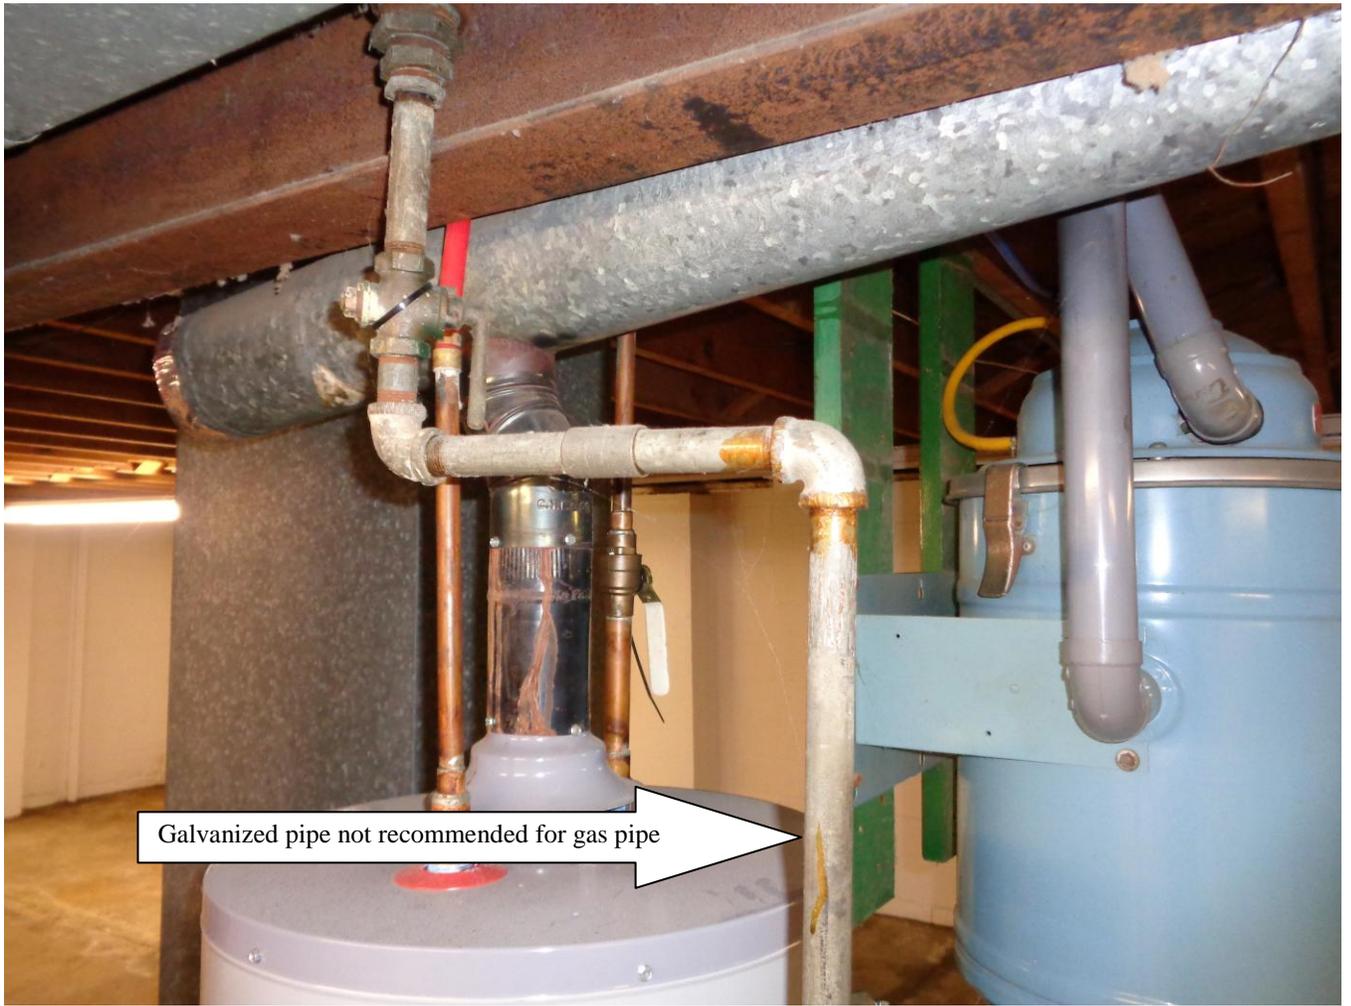
The water heater and the furnace have galvanized pipe used in the gas lines. Galvanized pipe is no longer recommended for gas pipe. Galvanized pipe should used for water only.

Galvanized pipe not recommended for gas pipe

Have plumber replace galvanized pipe in gas line.

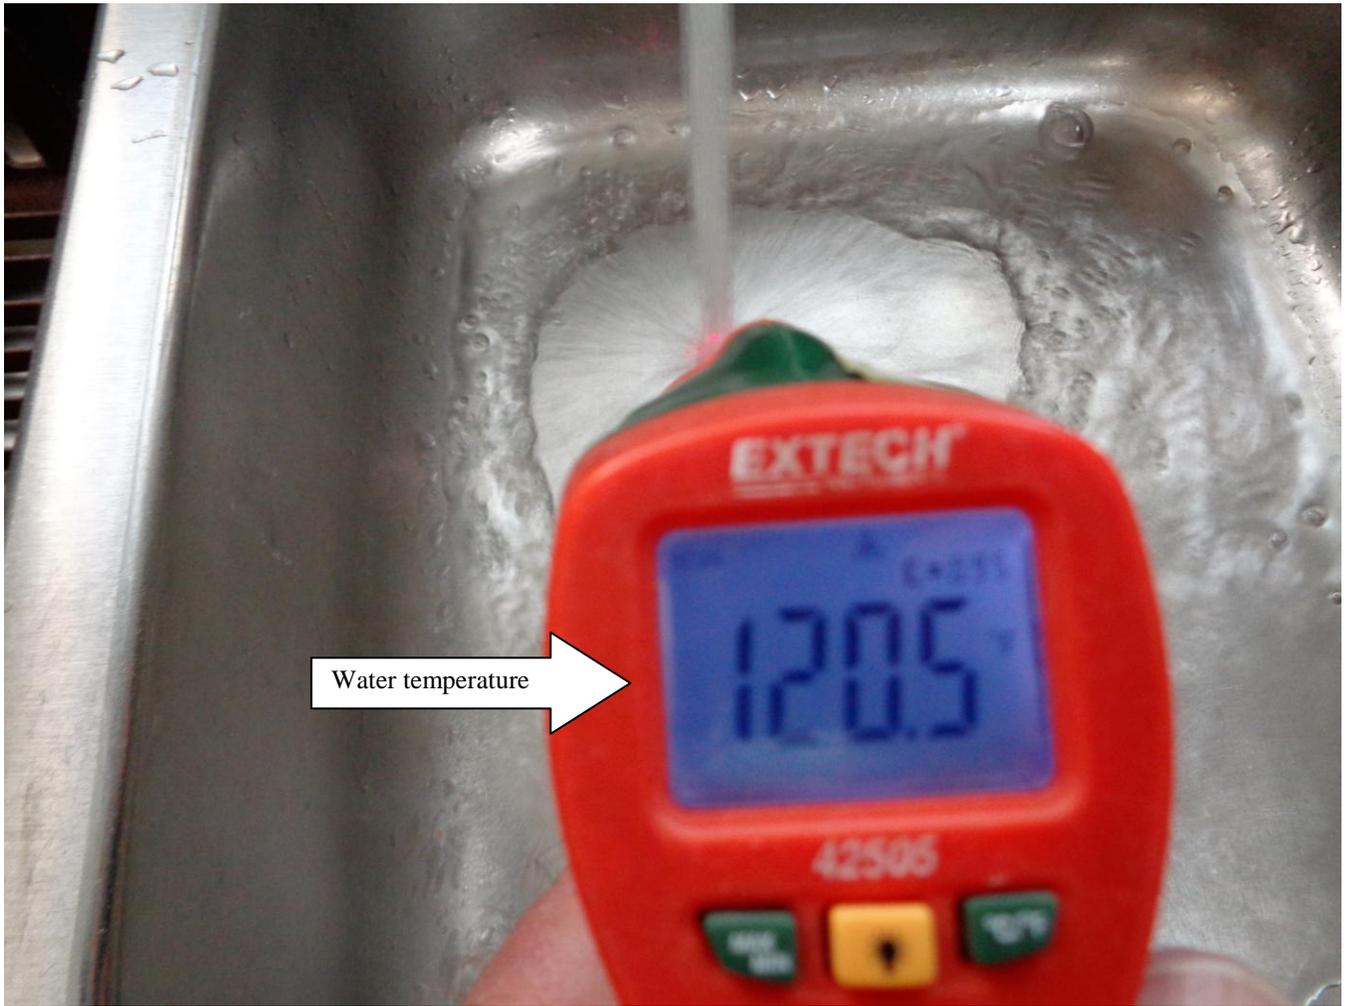
The water temperature at the kitchen sink is 120 degrees. Scalding can happen above 120, degrees.

Water temperature
