**Arizona Department of Agriculture
Office of Pest Management
WOOD DESTROYING INSECT INSPECTION REPORT**

1A. VA/HUD/FHA CASE #	DATE OF INSPECTION 19 July 2016
1B. <input checked="" type="checkbox"/> ORIGINAL REPORT <input type="checkbox"/> SUPPLEMENTAL REPORT	1D. WDIR # Mw072016T1157
1C. <input checked="" type="checkbox"/> SALE <input type="checkbox"/> REFINANCE <input type="checkbox"/> OTHER	1E. TARF # 9235146904390000

3A. NAME OF INSPECTION COMPANY MULE MOUNTAIN PEST CONTROL		5A. NAME OF PROPERTY OWNER/SELLER Styczkowski Estate	
3B. ADDRESS OF INSPECTION COMPANY (Street, City, ZIP) 4032 S. SANTA LUCIA AVE. SIERRA VISTA, AZ 85650		5B. PROPERTY ADDRESS (Street, City, ZIP) 4165 Highway 82 Elgin, AZ 85611	
3C. TELEPHONE NUMBER (Include Area Code) 520-234-3435	4. BUSINESS LICENSE # 9235	6A. INSPECTED STRUCTURES HOME, METAL STRUCTURE, & SHEDS	
6B. LIST ALL UN-INSPECTED STRUCTURES

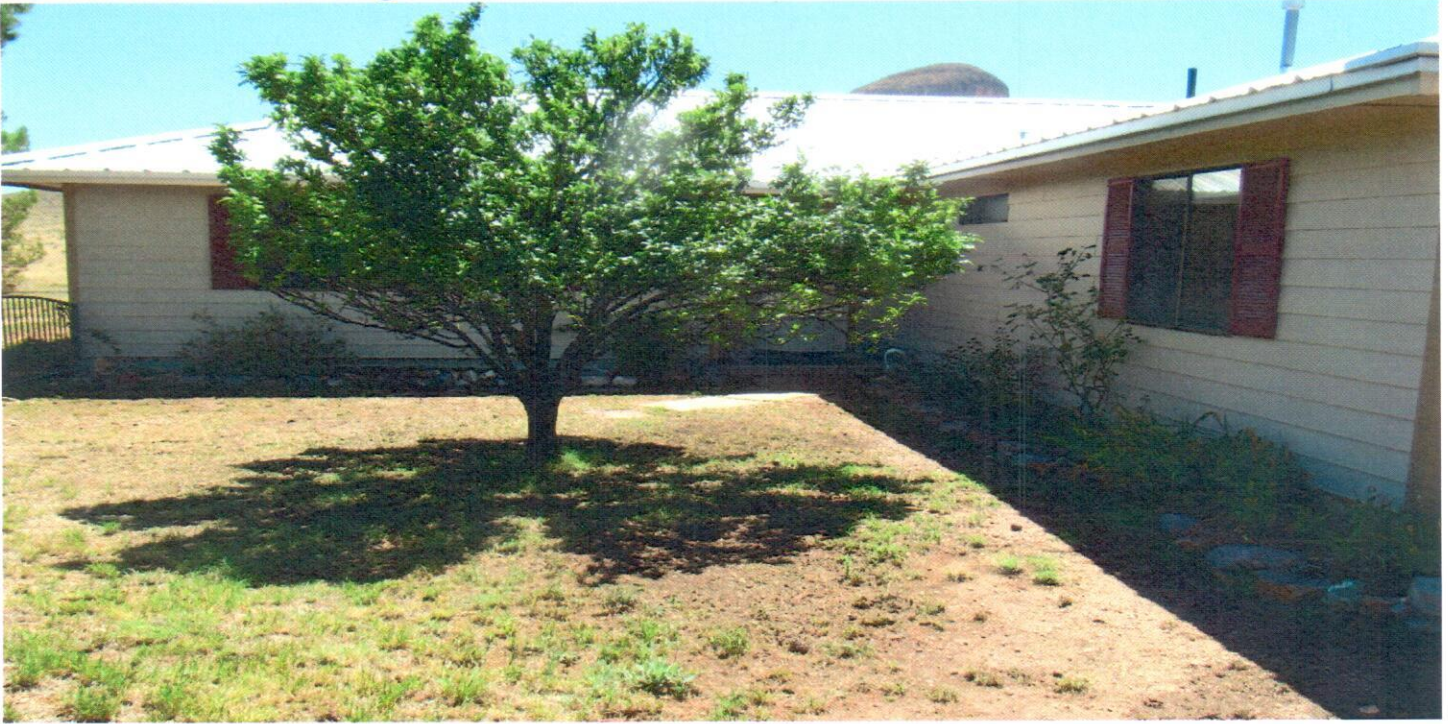
1. Front of home facing West.

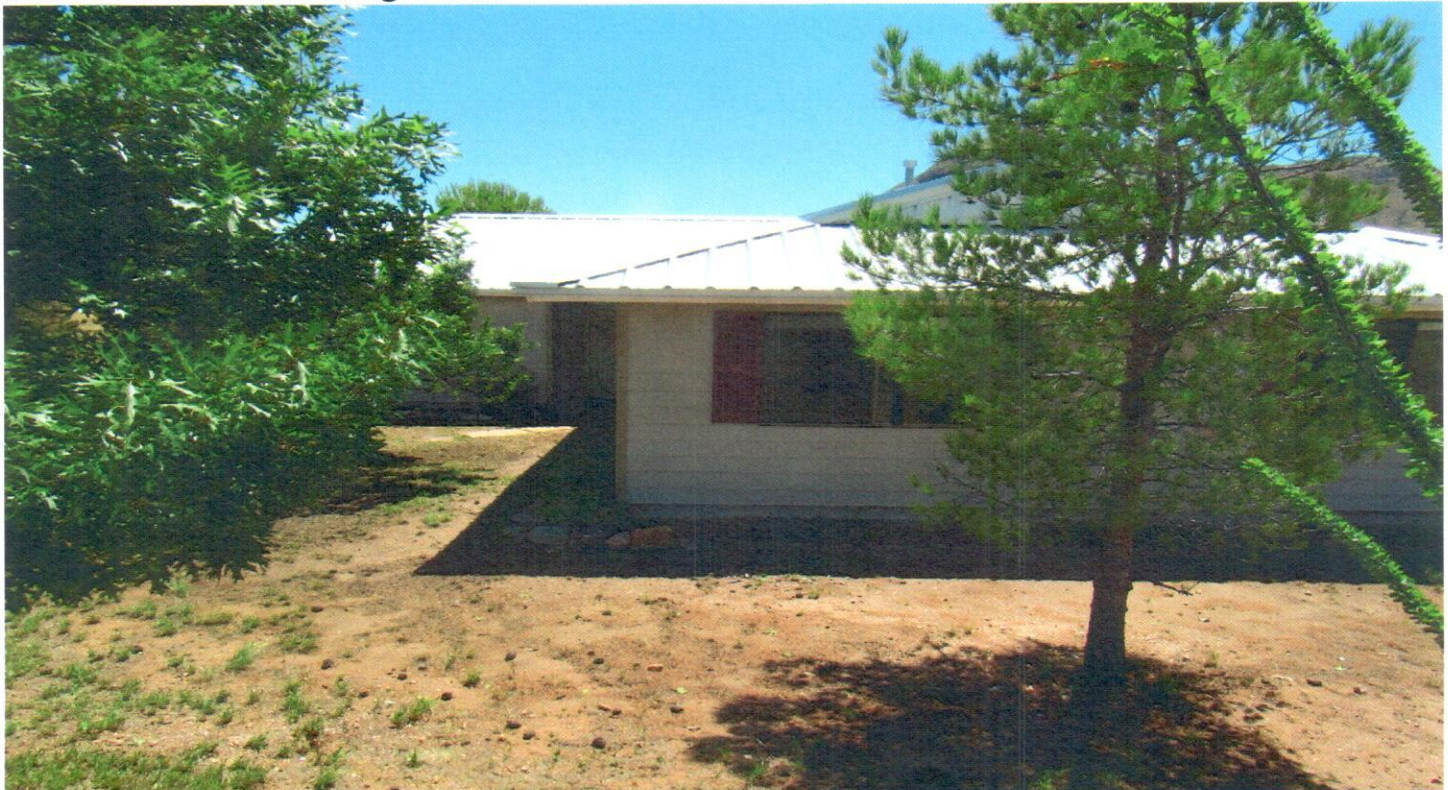
2. Front of home facing West.

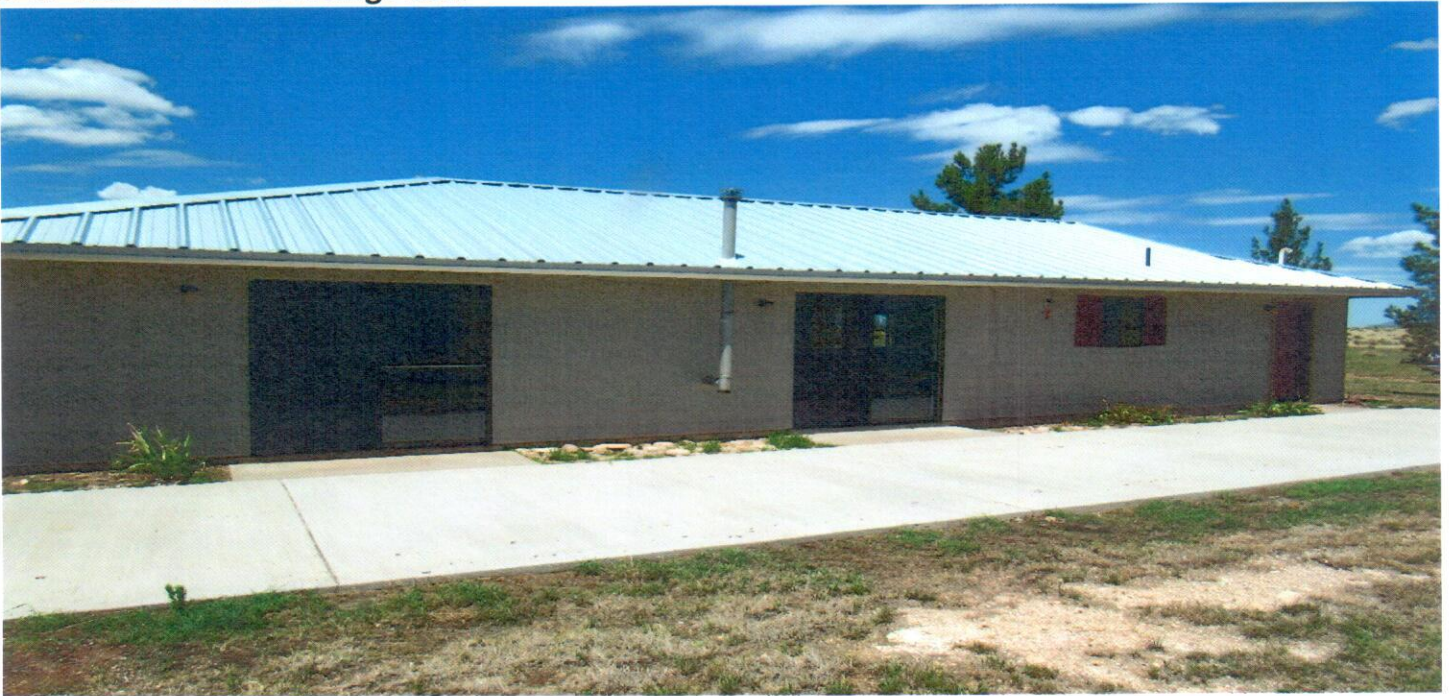
3. Rear of home facing East.

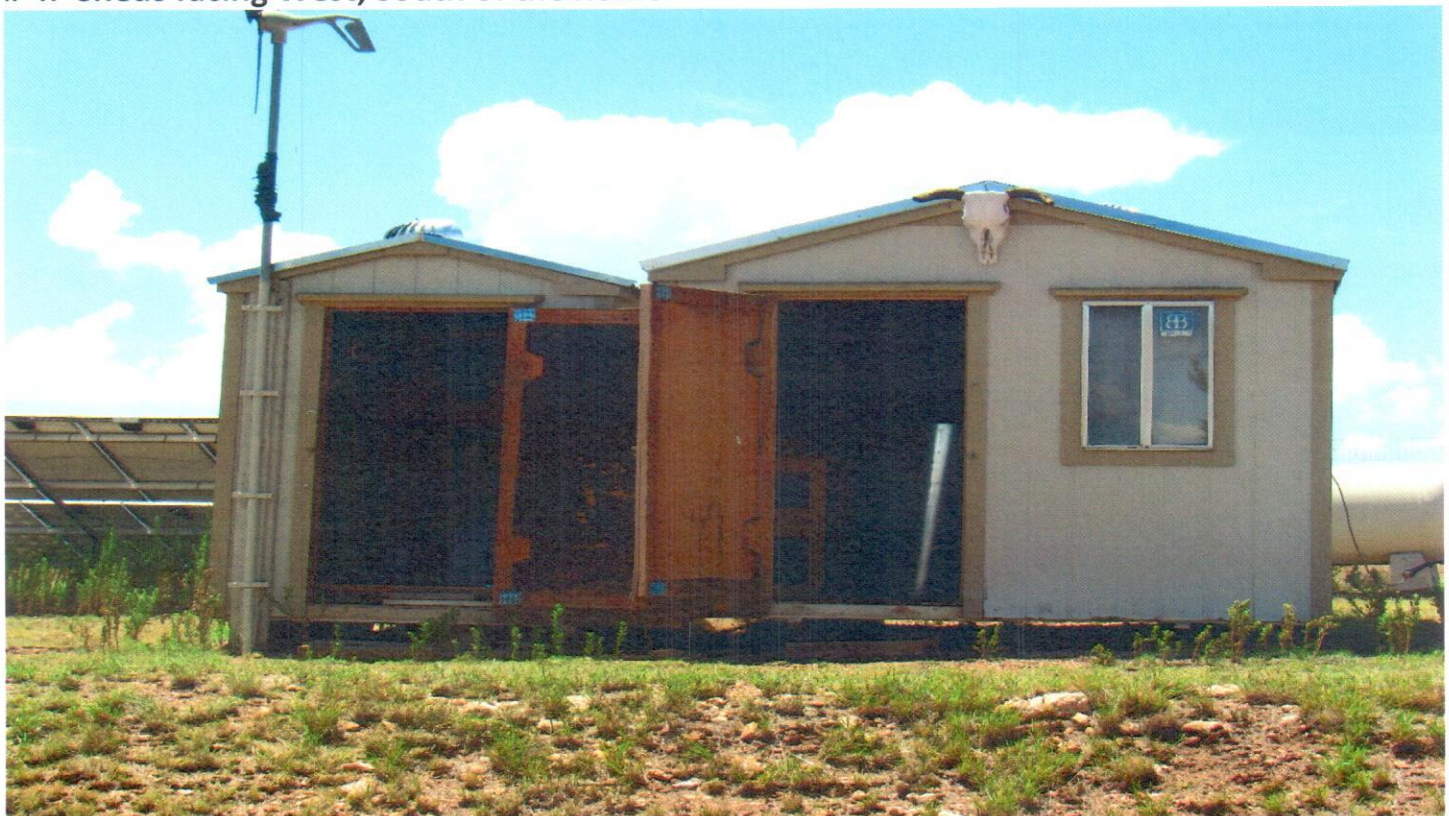
4. Sheds facing West, South of the home.

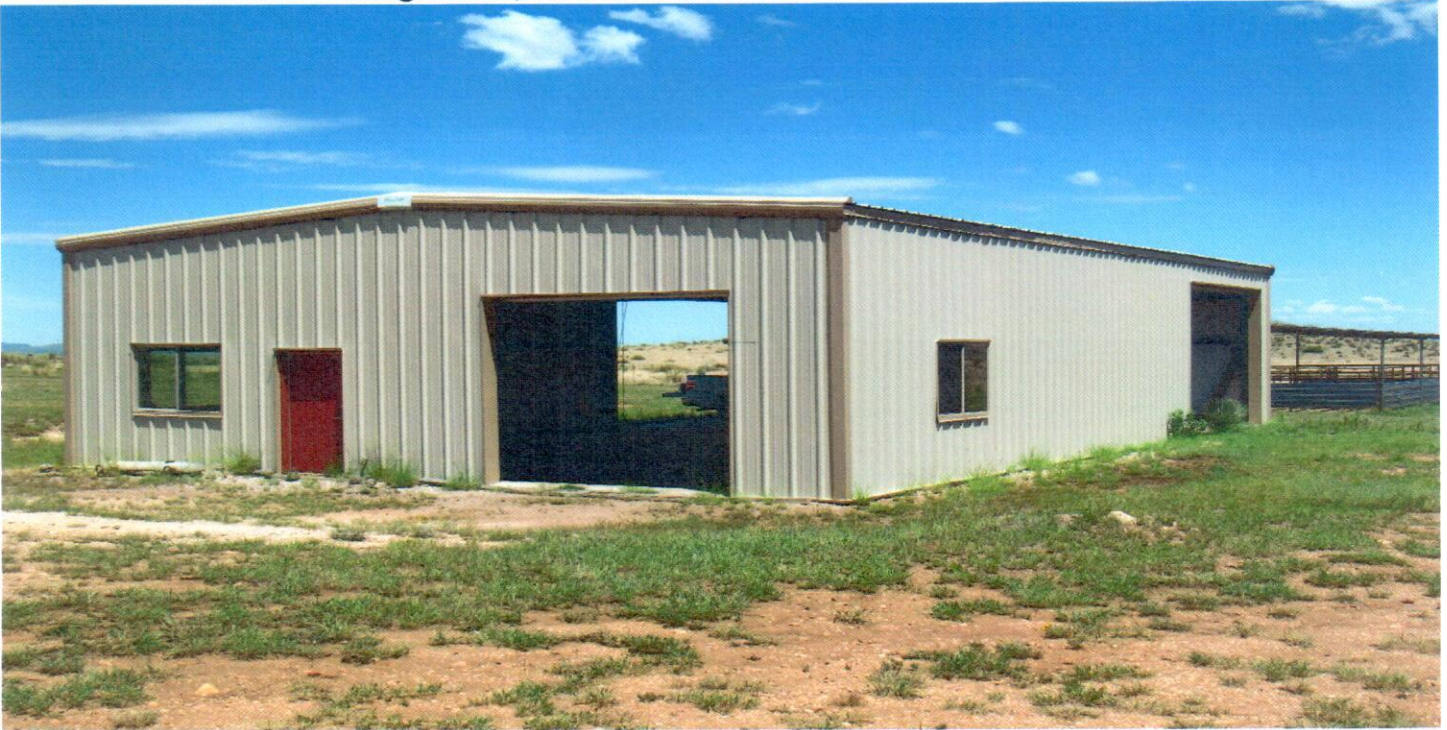
5. Metal structure facing South, North of home.

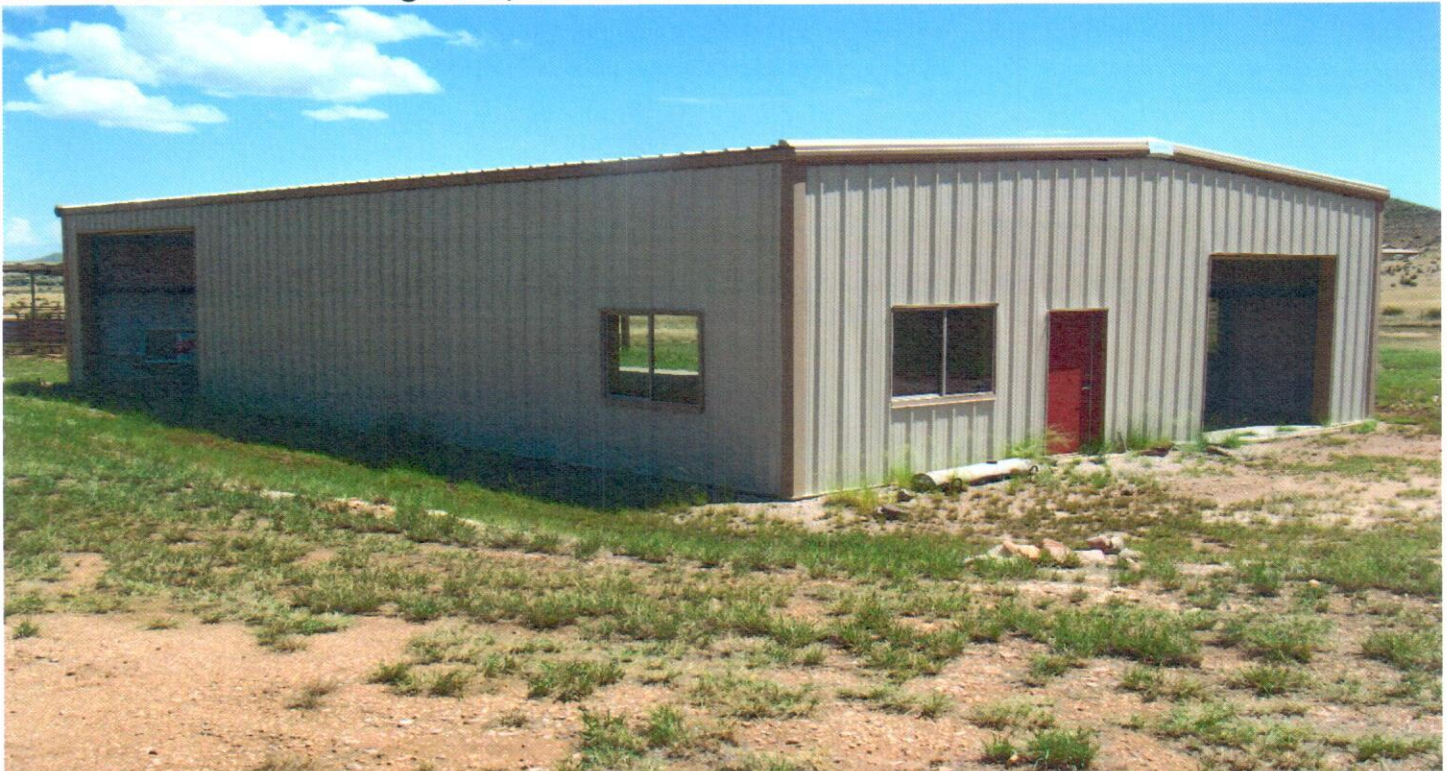
6. Metal structure facing West, North of home.
