PROPERTY INSPECTION REPORT

10035 Towne Rd.
Carmel IN

Property inspection performed on 10/20/2016 for property address: 10035 Towne Rd. Carmel, IN. Report prepared by

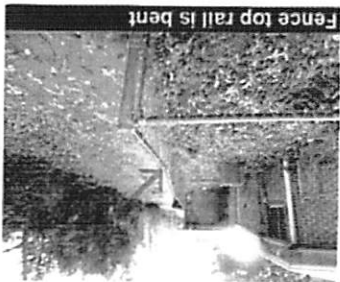
Observed at the left side yard: Fences are damaged. Top rail is bent and chain link is not secured to it. Fixing this will bring it back into a satisfactory condition. A competent repair person with the proper skills can accomplish the needed remedies, corrections, or repairs.

Fence top rail is bent

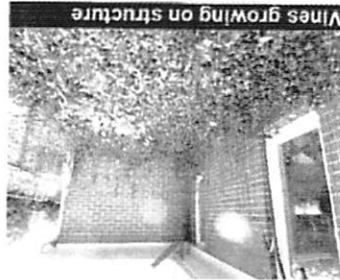
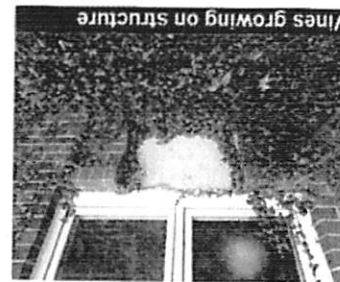
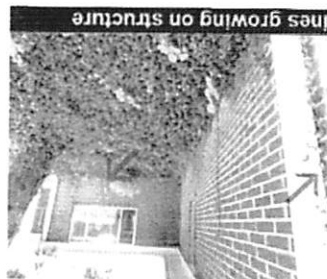
Observed at all yard areas: Vines climbing on the walls should be removed from the wall surfaces to prevent damage to the surface materials. Monitoring the situation is advised. Appropriate professionals should further evaluate if there are deficiencies suspected or confirmed in the future.

Vines growing on structure

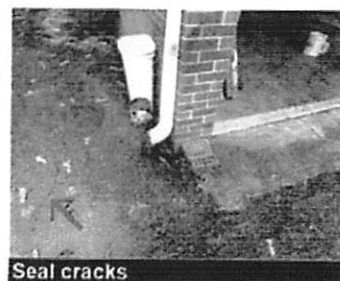
The driveway surface is cracked. Sealing the cracks with appropriate silicone or other suitable sealer is advised to prevent water intrusion under the driveway that can result with damage and deterioration. Monitoring the situation is advised. Appropriate professionals should further evaluate if there are deficiencies suspected or confirmed in the future.

Seal cracks

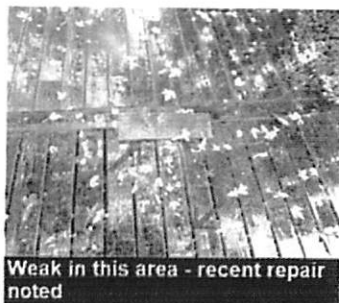
Observed at rear decks: Surface boards are weak in some areas. Framing, and supports are concealed as it is low to the ground. Minor repairs are anticipated to restore proper function of the deck. Monitoring the situation is advised. Appropriate professionals should further evaluate if there are deficiencies suspected or confirmed in the future.

Weak in this area - recent repair noted

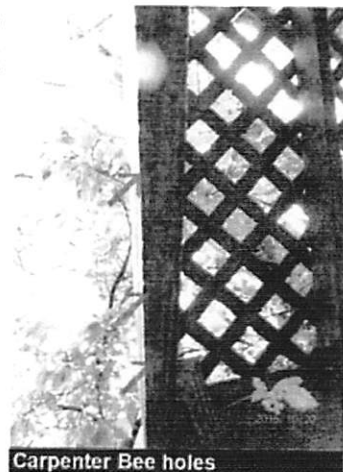
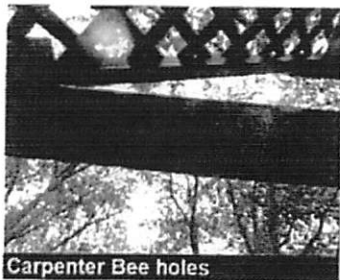
Observed at the underside of boards, evidence of Carpenter bees. This is also noted by Black Diamond Pest Control and with no signs of recent activity. Monitoring the situation is advised. Appropriate professionals should further evaluate if there are deficiencies suspected or confirmed in the future.

**Carpenter Bee holes**

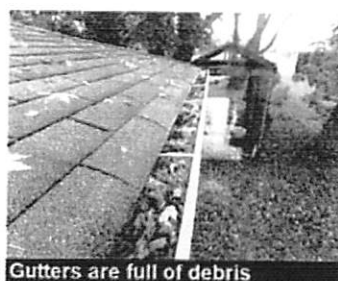
Observed various areas: Eaves are weathered. Soffits are weathered. Eave and soffit components are loose and/or damaged, properly maintaining the components is advised to preserve the trim components. This appears to be from gutters are full of debris and water not draining and overflowing due to no drip edge.

Gutters are full of debris

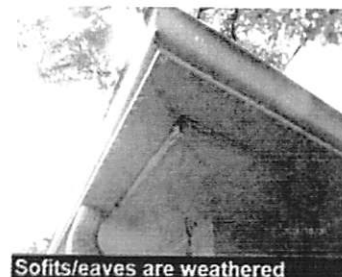
Sofits/leaves are weathered

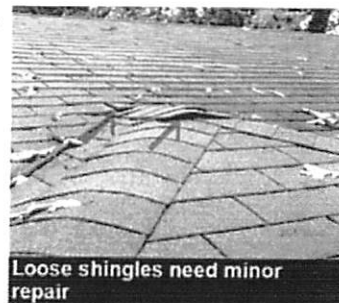
Noted in one area at front of house: Shingles are loose and damaged. The shingles need to be maintained to ensure effective water shedding capabilities. A competent repair person with the proper skills can accomplish the needed remedies, corrections, or repairs.

Loose shingles need minor repair

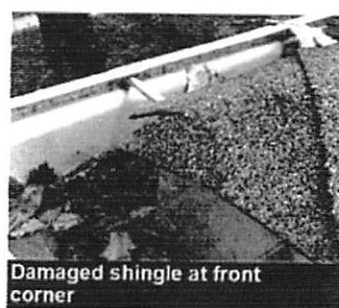
Damaged shingle at front corner

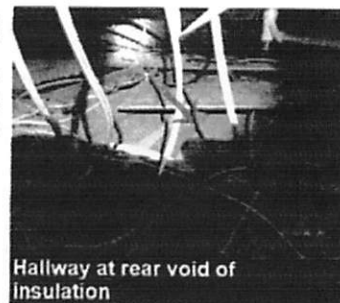
Observed at the rear and right attic area: Ceiling insulation is missing. Installing additional attic insulation where it is missing or lacking may be desired for added comfort and lowest possible energy cost. Proper and complete installation of the attic insulation is essential for best comfort and lowest possible energy cost. A competent repair person with the proper skills can accomplish the needed remedies, corrections, or repairs.

Hallway at rear void of insulation

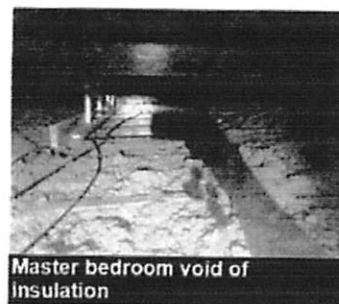
Master bedroom void of insulation

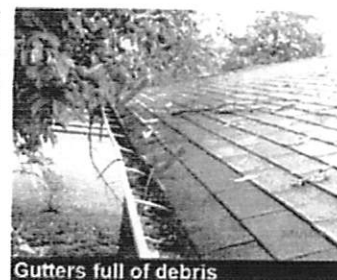
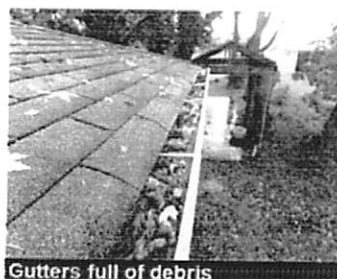
Debris is found in the gutters; the anticipated homeowner maintenance chore of cleaning out the gutters is needed. Patching leaks at gutter seams and/or end caps is essential to avoid water damage at the roof and/or trim components. A competent repair person with the proper skills can accomplish the needed remedies, corrections, or repairs.

**Gutters full of debris**

**Gutters full of debris****Extensions & Splash Blocks**

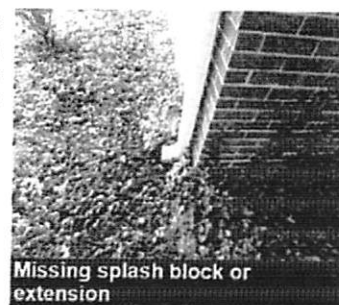
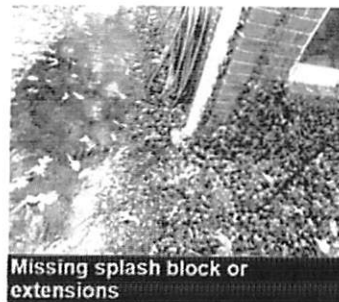
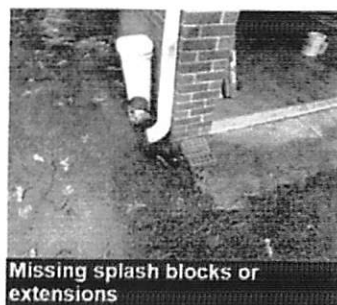
Observed at most downspouts: Splash blocks are not installed at the downspout terminations. Terminating downspouts next to the foundation can result with water related foundation issues, installing a means to effectively divert water away from the foundation is recommended. A competent repair person with the proper skills can accomplish the needed remedies, corrections, or repairs.

**Missing splash block or extension**

Missing splash block or
extensions

Missing splash blocks or
extensions

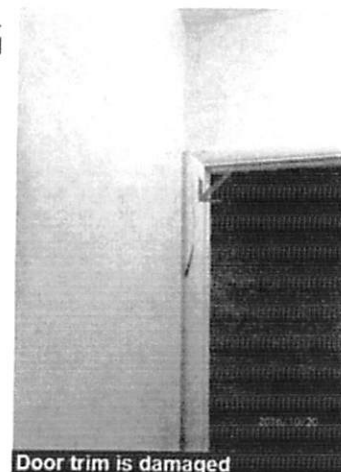
Observed at the rear bedroom left side of house entry door: Trim is damaged. A competent repair person with the proper skills can accomplish the needed remedies, corrections, or repairs.

Door trim is damaged

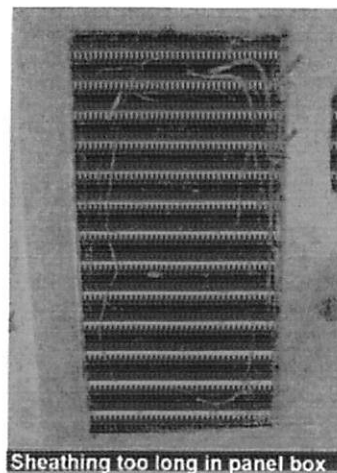
Inside of cabinet has insulation at bottom that could be a fire hazard, and needs to be removed. The sheathing on the wiring is too long inside the panel and should only be an 1" or less. There is a grommet missing for the wires entering top center of panel box, these should be secured. Due to the sensitive nature of electrical components and associated safety hazards working with electricity, and considering the long term integrity of the repairs, a licensed electrician is best suited to perform repairs no matter how trivial the repairs may seem.

Sheathing too long in panel box

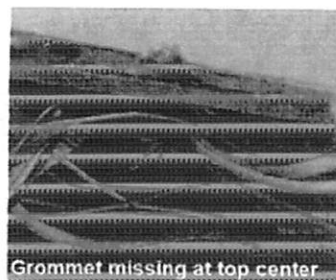
Grommet missing at top center

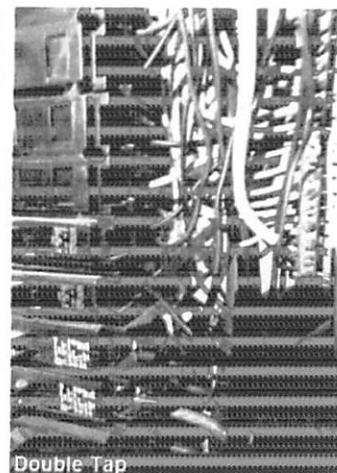
Breaker is double tapped into a single lug where only one wire should be connected. Multiple wires that are connected to a single connection lug have the potential to overheat at the connection and can cause an electrical fire inside the panel. It also appears some wires could be under sized or oversized, unable to fully determine all wires. Due to the sensitive nature of electrical components and associated safety hazards working with electricity, and considering the long term integrity of the repairs, a licensed electrician is best suited to perform repairs no matter how trivial the repairs may seem.

Double Tap

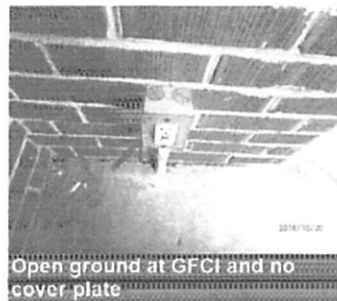
Observed at the front stoop receptacle: GFCI has an open ground. Also no cover plate on exterior receptacle. The GFCI will not operate correctly. Due to the sensitive nature of electrical components and associated safety hazards working with electricity, and considering the long term integrity of the repairs, a licensed electrician is best suited to perform repairs no matter how trivial the repairs may seem.

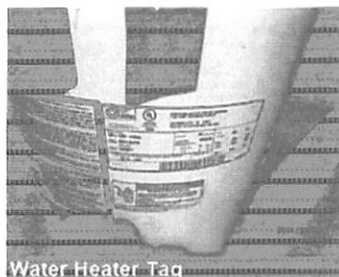
Water Heater Tag

The water heater is old and may have a limited service life because of its advanced age and could fail at any time. Budgeting for replacement of the water heater in the very near future is advised.

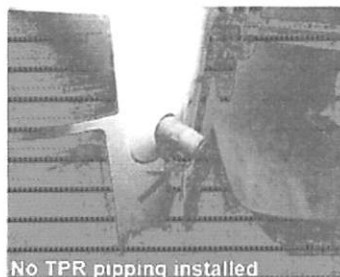
TPR piping is not installed. When the valve releases it disperses scalding water which should be directed close to the ground, terminating the TPR piping at a safe location on the exterior is strongly advised. A competent repair person with the proper skills can accomplish the needed remedies, corrections, or repairs.

No TPR piping installed

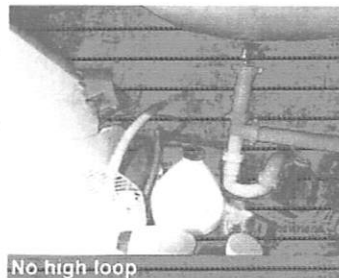
High loop on the drain line is not installed. High looping the drain line helps to protect the dishwasher from being contaminated with dirty water from the sink since they share the same drain line. Recommend installation of a clip to hold the disposal drain line in a "high loop position" where the sink cannot drain back into the dishwasher through gravity. A competent repair person with the proper skills can accomplish the needed remedies, corrections, or repairs.

No high loop

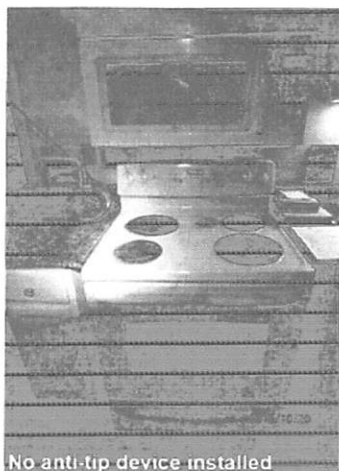
Anti-tip brackets are not installed, this can result with the range tipping forward when the oven racks are extended with weight. Properly installing these brackets is essential for safety. A competent repair person with the proper skills can accomplish the needed remedies, corrections, or repairs.

No anti-tip device installed

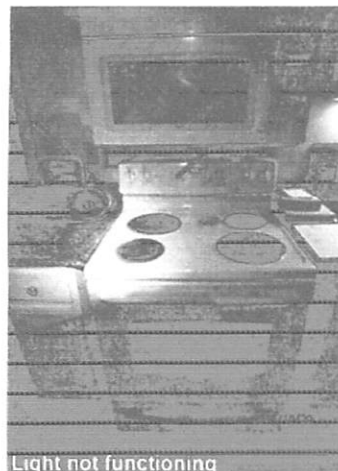
Over stove light bulb is possibly burned out. No light came on when activated. Monitoring the situation is advised. Appropriate professionals should further evaluate if there are deficiencies suspected or confirmed in the future.

Light not functioning

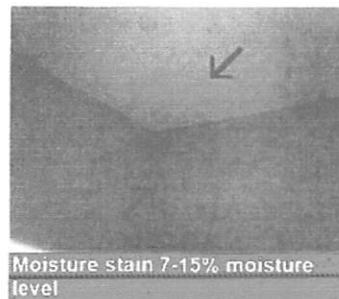
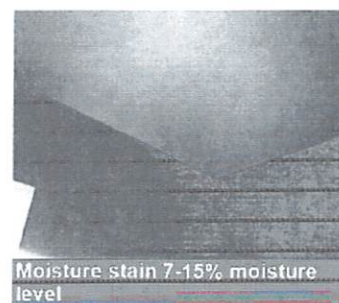
Water leak at the ceiling is evident, water stains are found in master bedroom in two corners. The water stains in corners show a moisture level between 7-15%. Older water stain in hallway bathroom had 0% moisture at this time. Cracks found in ceiling of master bedroom. A competent repair person with the proper skills can accomplish the needed remedies, corrections, or repairs.

Moisture stain 7-15% moisture level

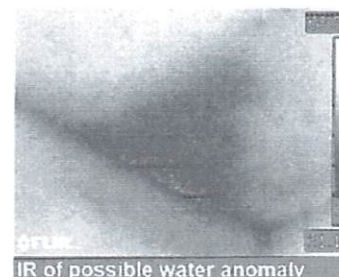
IR of possible water anomaly

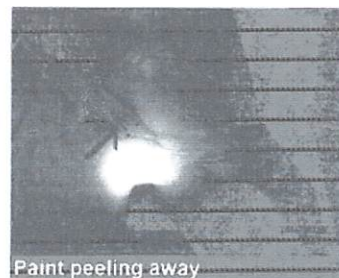
Typical cosmetic maintenance is needed, which usually consists of basic repair of the ceiling surfaces and painting. A competent repair person with the proper skills can accomplish the needed remedies, corrections, or repairs.

Paint peeling away

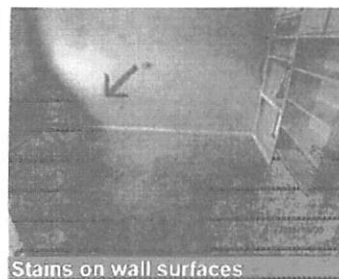
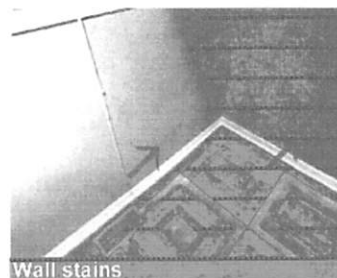
Observed at the front bedroom and rear bedroom wall surfaces: Typical cosmetic maintenance is needed, which usually consists of basic repair of the wall surfaces and painting. A competent repair person with the proper skills can accomplish the needed remedies, corrections, or repairs.

Stains on wall surfaces

Wall stains

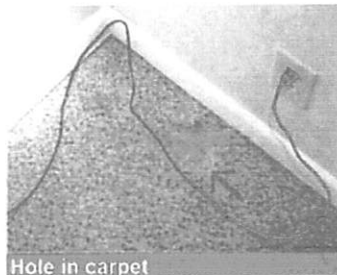
Carpet has a hole in it in living room. A competent repair person with the proper skills can accomplish the needed remedies, corrections, or repairs.

Hole in carpet

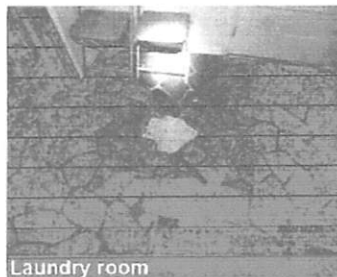
Laundry room

Observed at the laundry room, hall bathroom, and hallway floor areas: Tile flooring is delaminated in areas. A competent repair person with the proper skills can accomplish the needed remedies, corrections, or repairs.

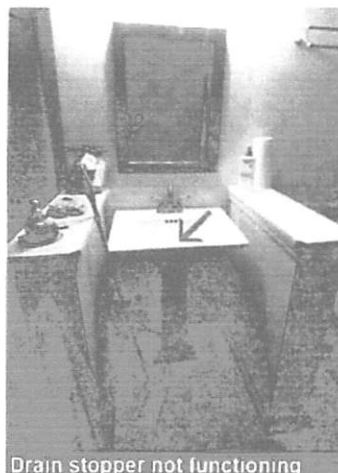
Observed in the # 1 and # 2 bathroom(s): Mechanical drain stoppers are not operational, replacing with a rubber plug is suggested. A competent repair person with the proper skills can accomplish the needed remedies, corrections, or repairs.

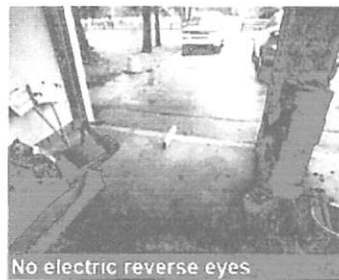
Safety device eyes are not installed. For safety it is recommended that the eyes be installed. A garage door technician is recommended to service as necessary.

No electric reverse eyes

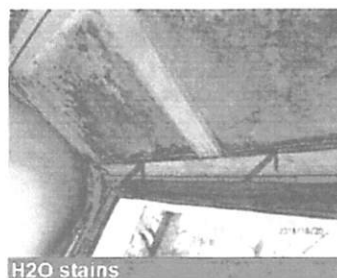
Garage door panels are weathered and signs of H₂O damage. Minor adjustments are anticipated to restore proper operation. A competent repair person with the proper skills can accomplish the needed remedies, corrections, or repairs.

H₂O stains

H₂O stains**Floor**

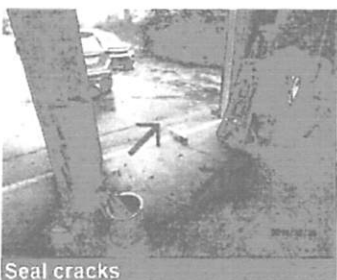
Sealing cracks with appropriate silicone or other suitable sealer is advised to prevent moisture intrusion and prevent an access point for subterranean insects to enter the garage. A competent repair person with the proper skills can accomplish the needed remedies, corrections, or repairs.

Seal cracks
