**Perfection Home Inspections**  
**1042 E. Fairbrook Circle**  
**Mesa, AZ 85203**  
**602-524-2916**  
**perfectionhomeinspections.com**

Client Information: Record Number 7458

**Champ, Joe**  
**373 N. Arizona Ave.**  
**Chandler, AZ 85249**

Inspected 12/13/17 1:30 PM  
Built 1941  
1300 sf

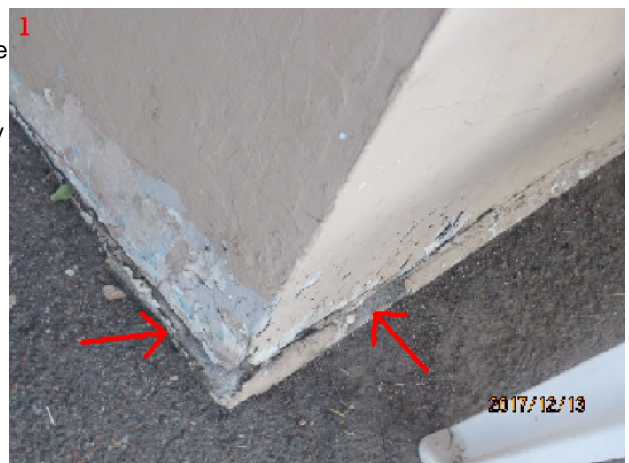
This home looks like it was set on a concrete slab. No visible foundation but the home walls do not extend over the slab they were built on. This may allow moisture to enter the walls or home from under the walls.  
Recommend a qualified contractor evaluate and make all necessary repairs.

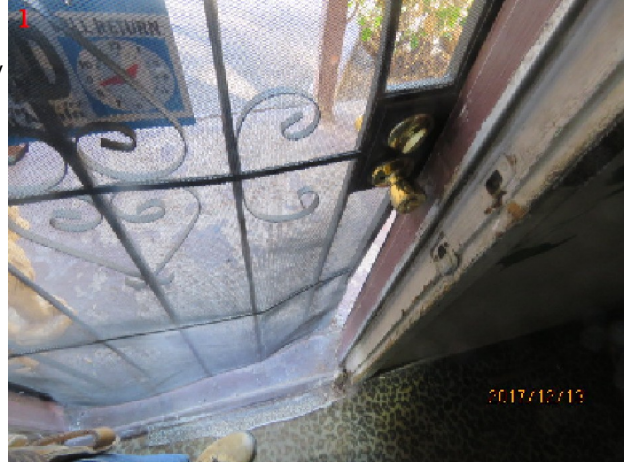
### **Service/Repair** Exterior Doors - Tested

Exterior entrance door tested and the security screen door is falling apart.  
Recommend a qualified contractor evaluate and make all necessary repairs.

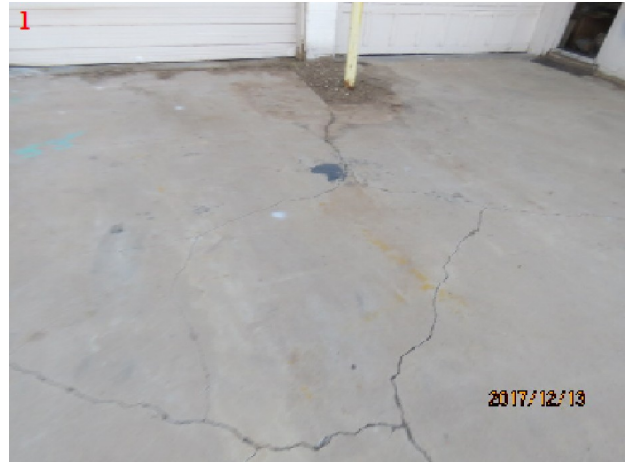
Cracks in driveway. Recommend sealing cracks to keep moisture out and help keep the cracks from spreading.

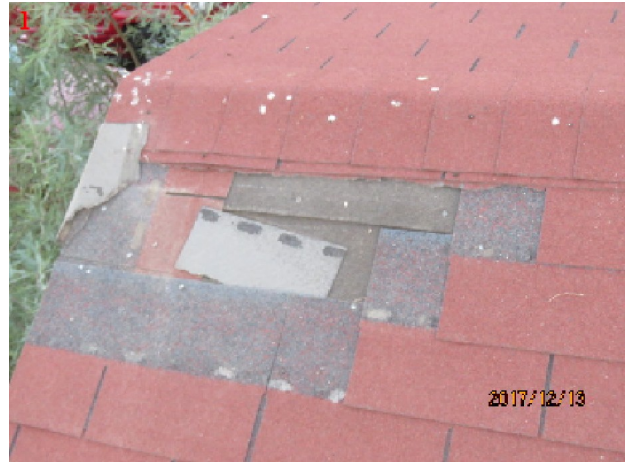
Missing roof shingles can cause a roof leak.  
Recommend a qualified roofing contractor evaluate the entire roof system and make all necessary repairs.

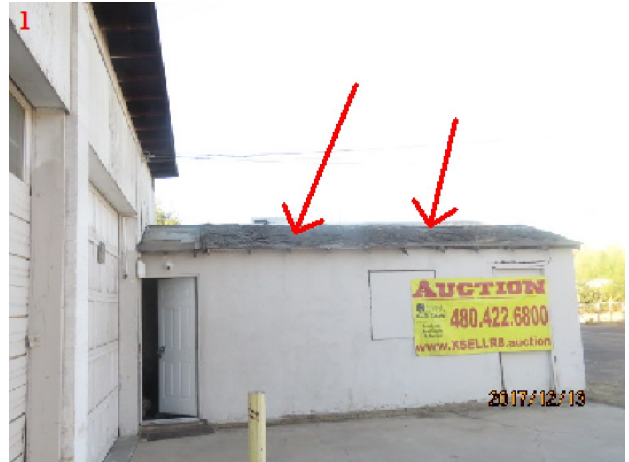
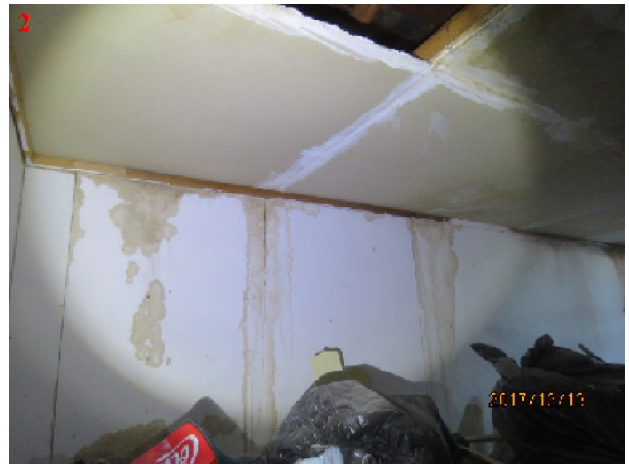
The far back section of garage with the gable roof and wood shake shingles is in poor condition with holes in the roof. This is allowing water to leak into this section of the garage. This section of the garage may need to be demolished. Recommend a qualified roofing contractor evaluate and make all necessary repairs.

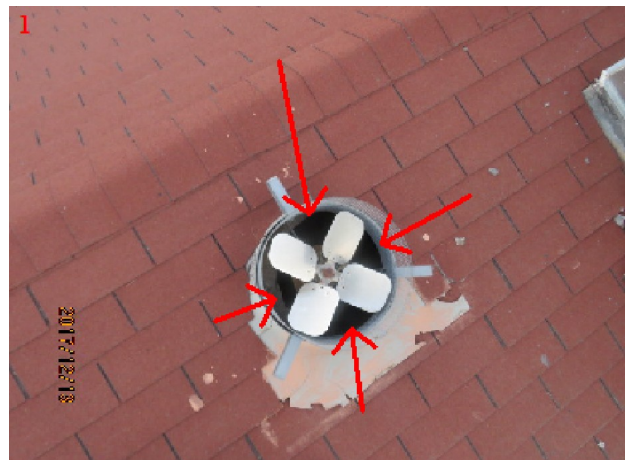
There is a hole in the house roof that will allow rain water to enter the attic if it rains. Recommend covering this hole before it rains! Recommend a qualified roofing contractor evaluate and make all necessary repairs.

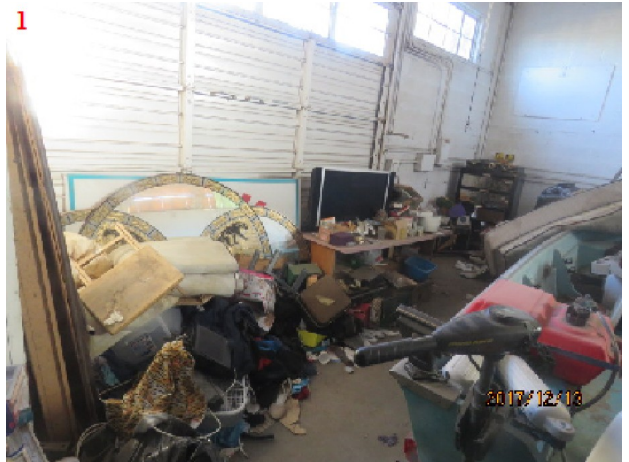
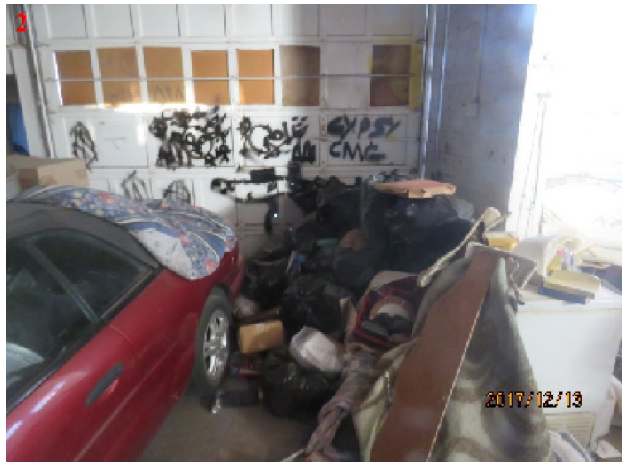
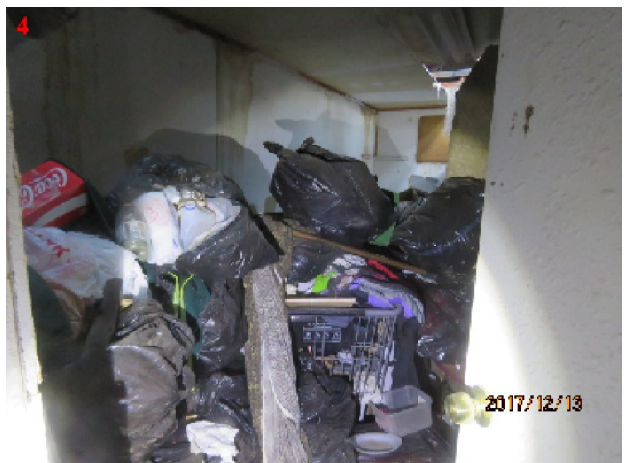
Stuff in the garage blocks view of the interior of the garage.  
Recommend inspecting garage area after the stuff is removed.  
None of the garage overhead door can be tested due to stuff in the garage.

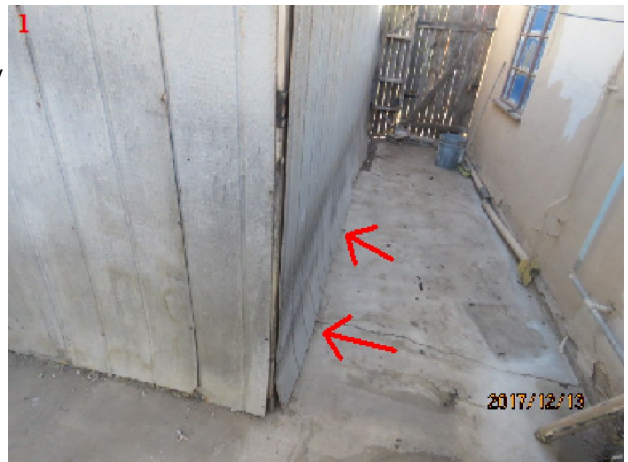
Wood siding for garage added bathroom making contact with the ground. This siding is warped at the bottom. Recommend a qualified contractor evaluate and make all necessary repairs.

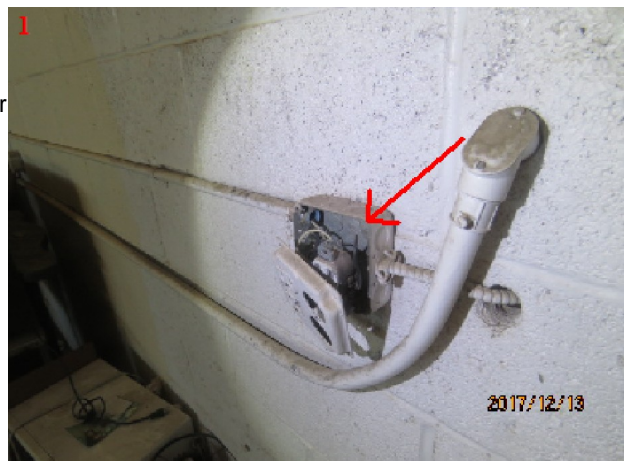
No electrical power to the garage. Garage outlets hanging off of the junction box and cover plate falling off. Recommend testing after power it turned on. This is a shock hazard. Recommend a qualified electrical contractor evaluate and make all necessary repairs. See picture

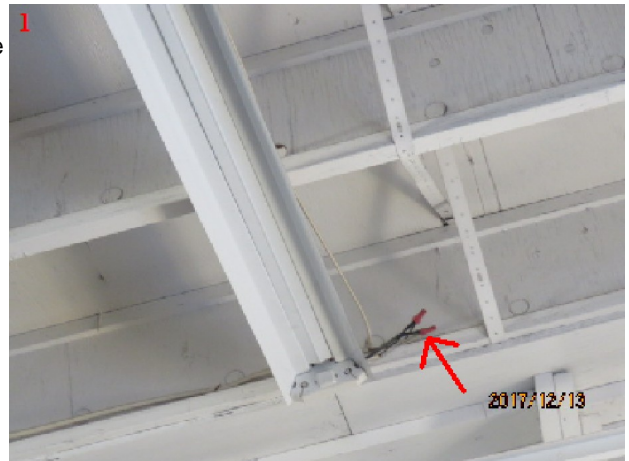
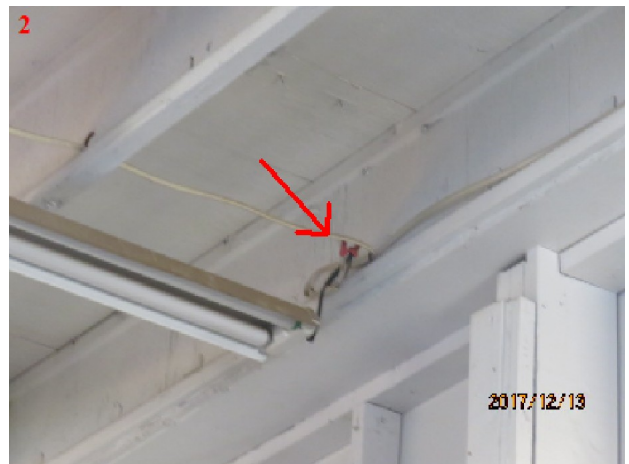
Exposed spliced wires to garage ceiling light fixtures  
This is a shock hazard. Recommend a qualified contractor evaluate and make all necessary repairs.

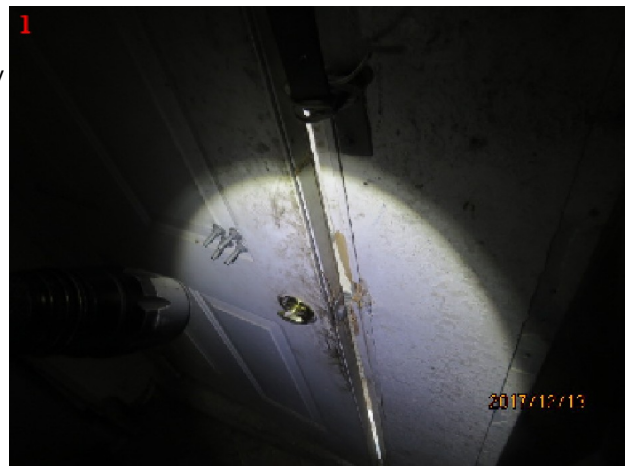
Garage door to the far back lot has been broken into and is now not lockable. This is a security issue.  
Recommend a qualified contractor evaluate and make all necessary repairs.

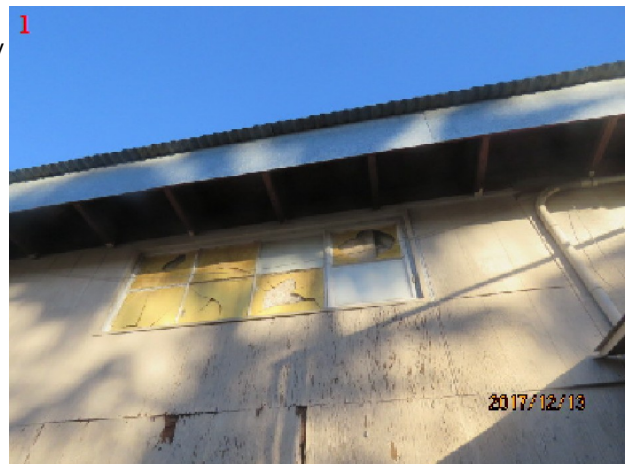
Multiple broken glass window panes in the garage.  
Recommend a qualified contractor evaluate and make all necessary repairs.

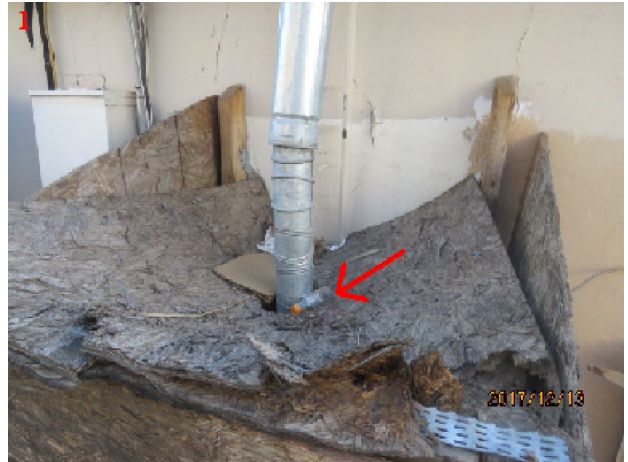
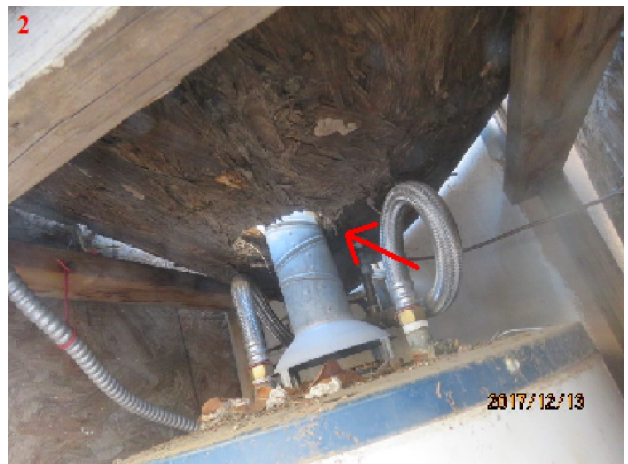
The water heater vent pipe is too close to combustibles. The roof section has collapsed onto the water heater vent pipe. This is a fire hazard. Recommend a minimum of 1 inch between a double vent pipe and all combustible material and 6 inch's between a single wall vent pipe and all combustible materials.

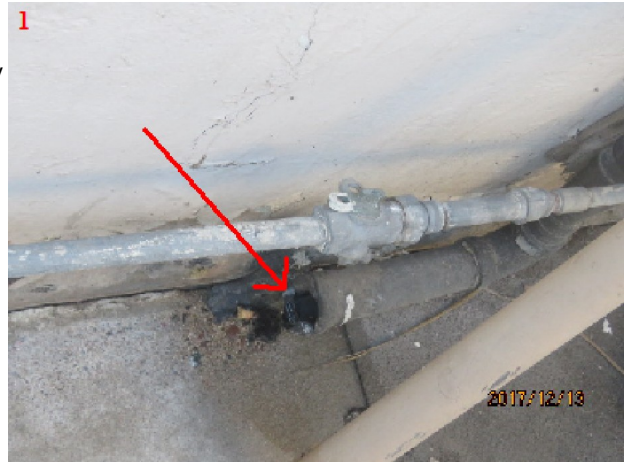
Water from the washer drains directly onto the ground. No drain provided.  
Recommend a qualified contractor evaluate and make all necessary repairs.

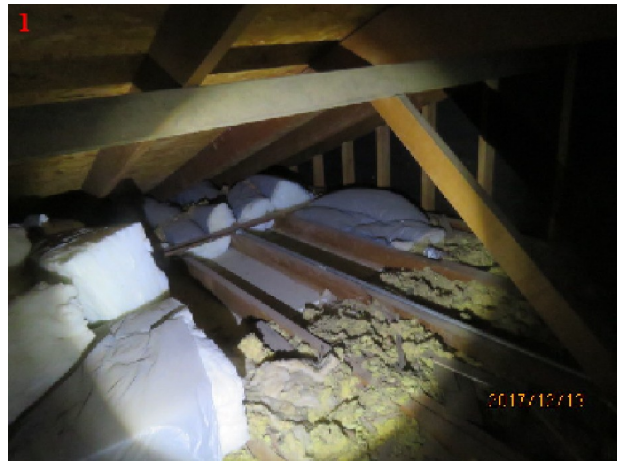
The average attic floor insulation depth is 6 inches from the three measurements taken. In some spots there is no insulation. An R-30 value is recommend for the attics. Recommend an average attic insulation depth for blown in cellulose and mineral wool of 8.4 inches and 12 inches for blown in fiber glass.

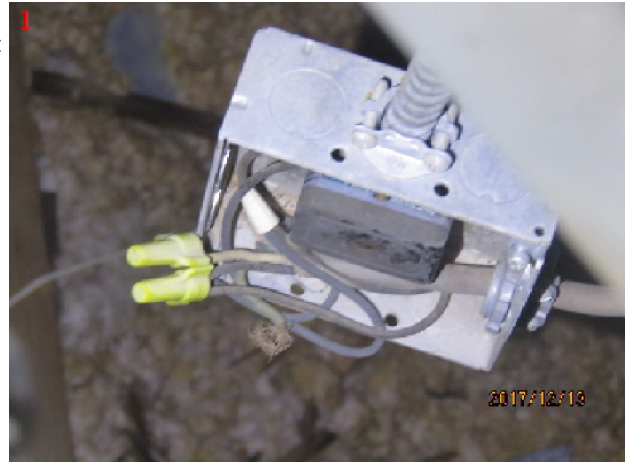
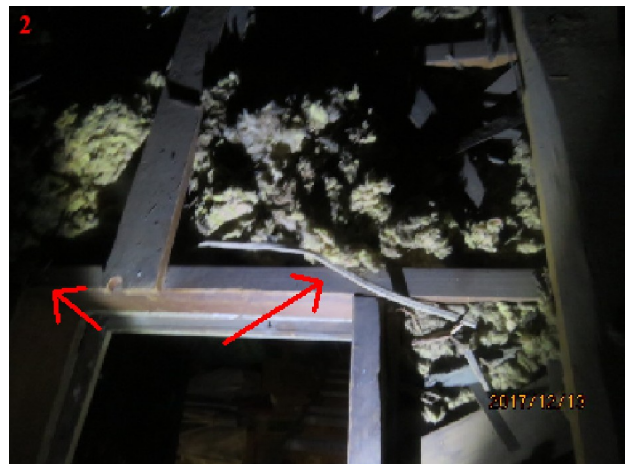
Exposed wires in attic need to be properly placed in a junction box or removed. This is a shock hazard and a possible fire hazard. Recommend a qualified electrical contractor make all necessary repairs. See Picture

Recommend a qualified electrical contractor make all necessary repairs. See Picture

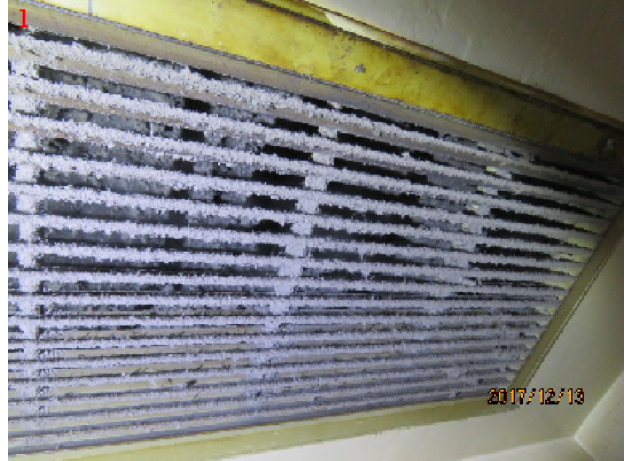
No AC filter installed. This allows dirt and other contaminants to flow freely into the heating and cooling system and helps to clog system coils. Recommend installing filter immediately. Recommend a qualified heating and air conditioning contractor evaluate and make all necessary repairs. I recommend Beyond Image Cleaning for duct cleaning 480-649-6497.

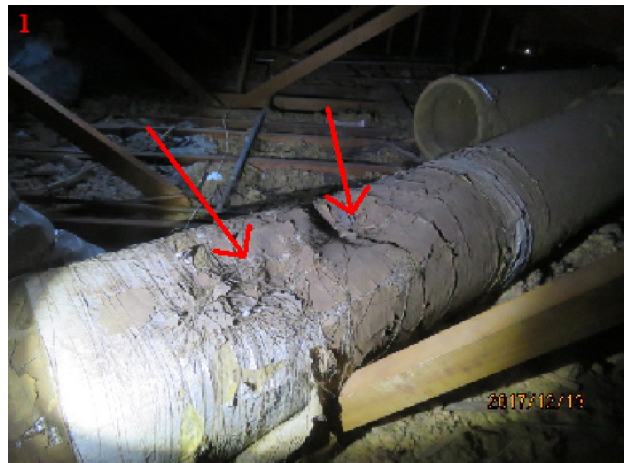
Section of HVAC ducting in the attic has been partly crushed. Recommend a qualified AC contractor evaluate and make all necessary repairs. See picture

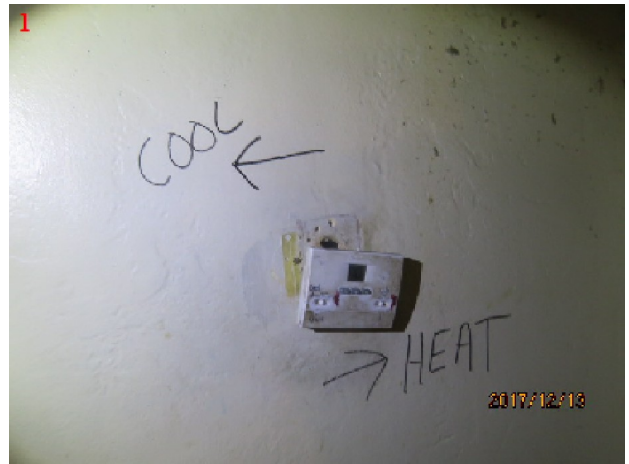
Thermostat is loose and not properly secured to the wall. This may cause a short in the thermostat wires.  
Recommend properly attaching all thermostats.

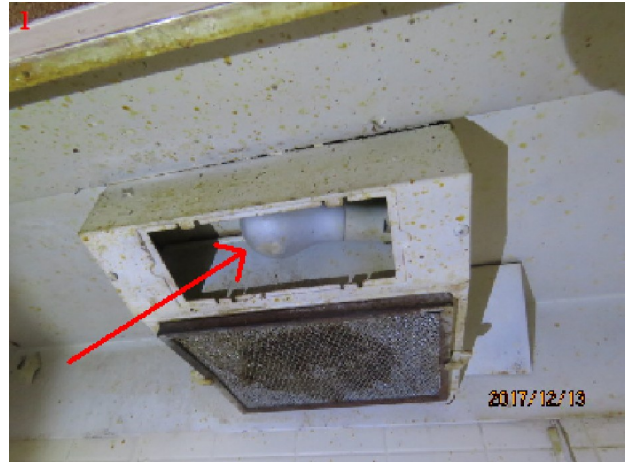
The light bulb cover for the stove hood is missing. This may allow steam from the stove top to explode the light bulbs.  
Recommend installing missing bulb cover. See picture

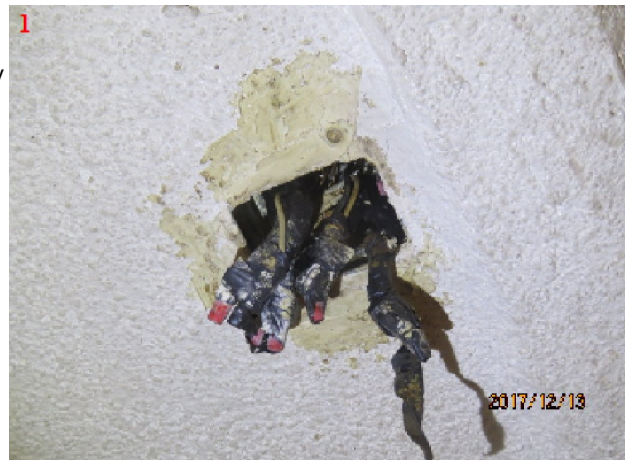
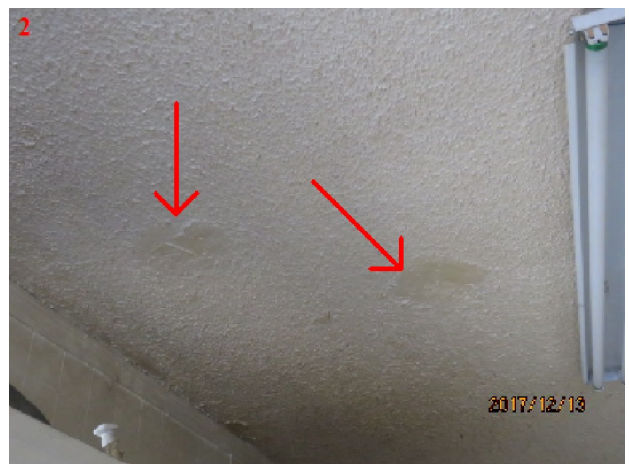
Wires sticking out of the ceiling, patched on the ceiling and wall.  
This is a shock hazard.  
Recommend a qualified contractor evaluate and make all necessary repairs.

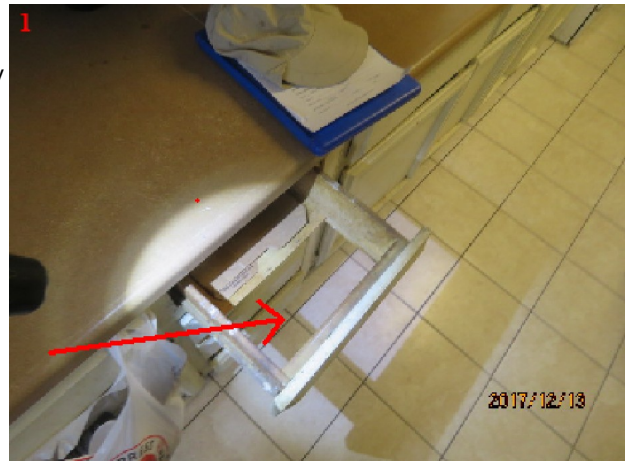
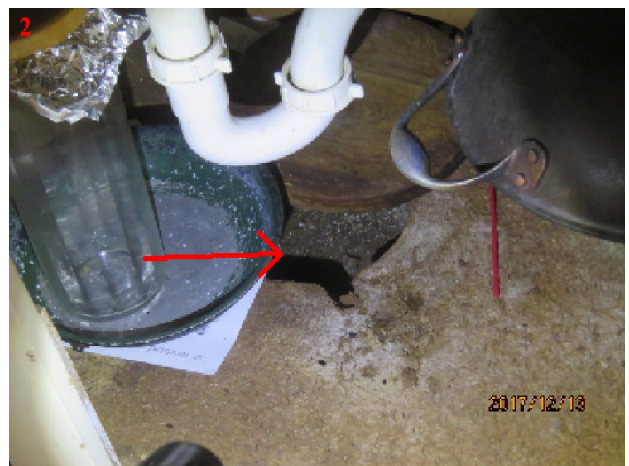
Kitchen drawer loose bottom the sink cabinet is bowed down from water damage and there is a hole in it.  
Recommend a qualified contractor evaluate and make all necessary repairs.

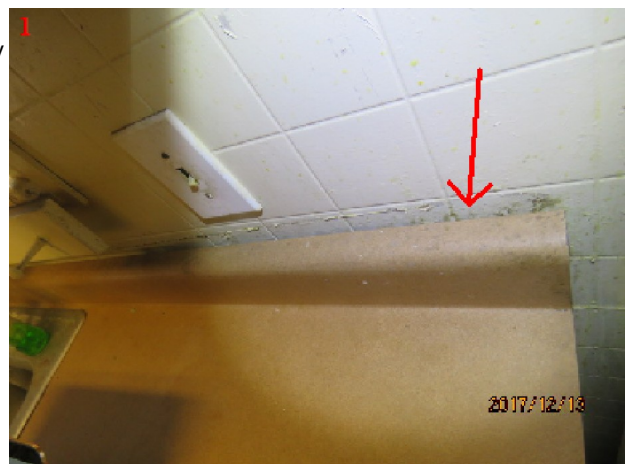
There is a gap between the kitchen counter top and the wall.  
Recommend a qualified contractor evaluate and make all necessary repairs.

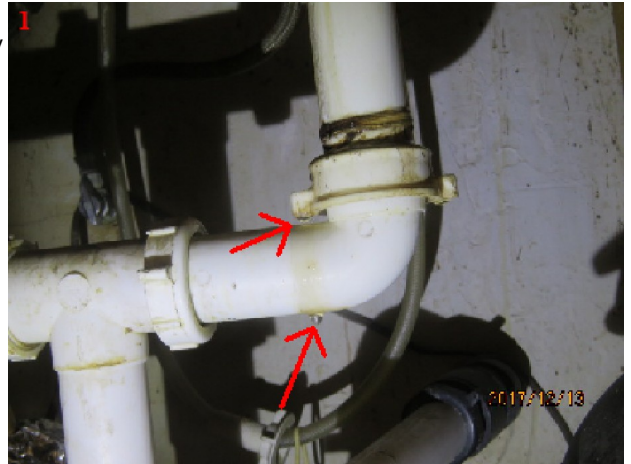
The kitchen sink drain leaks at the sink to tail pipe connection. Recommend a qualified contractor evaluate and make all necessary repairs.

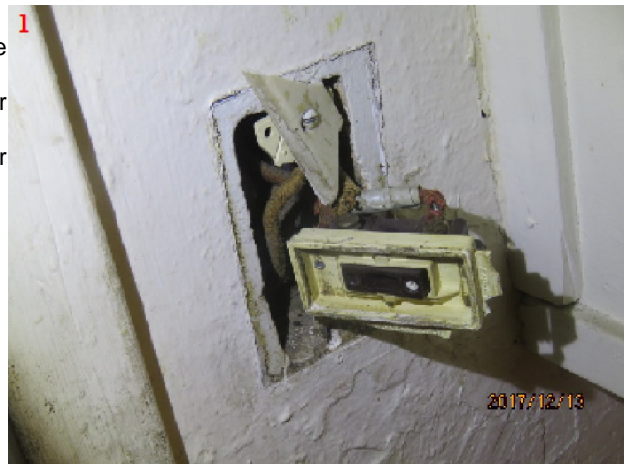
Kitchen light switch is hanging out of the wall.  
One kitchen bulb did not work when tested. Recommend testing the bulb.  
This is a shock hazard. Recommend a qualified electrical contractor evaluate and make all needed repairs.  
This is a shock hazard. Recommend a qualified electrical contractor evaluate and make all needed repairs.

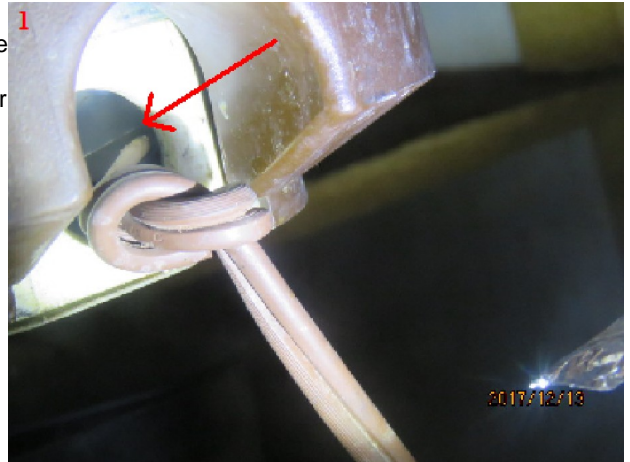
Electrical cable not properly attached to disposal. Recommend properly attaching cord to disposal, speaker wire used to supply wire with splices in the supply wire. This is a shock hazard. Recommend a qualified electrical contractor evaluate and make all needed repairs.

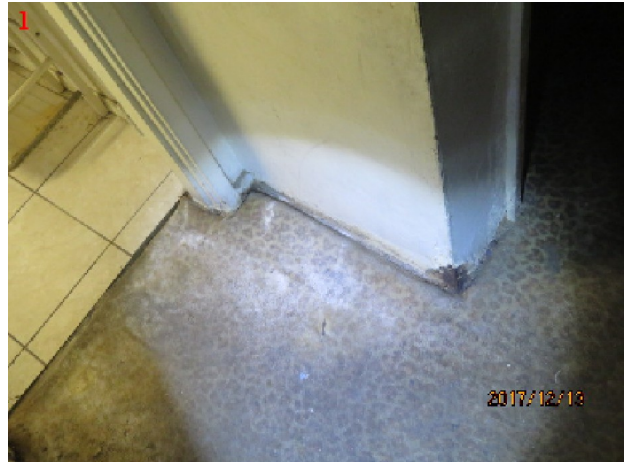
The carpet in the hall to the kitchen is rotted from water damage. Looks like a mold pit. Recommend a qualified contractor evaluate and make all needed repairs.

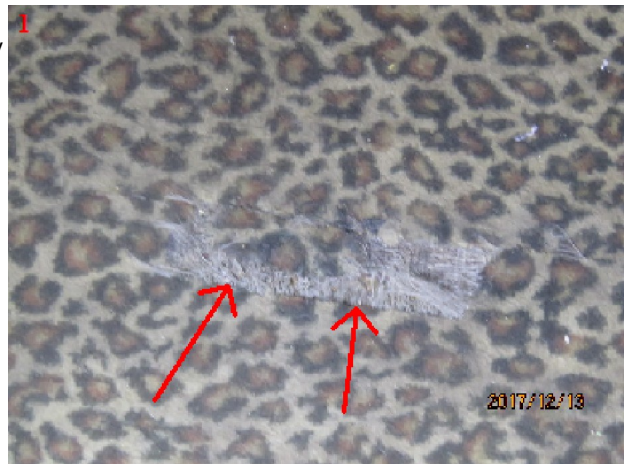
Ripped carpet in the living room is a trip hazard. Recommend a qualified contractor evaluate and make all necessary repairs.

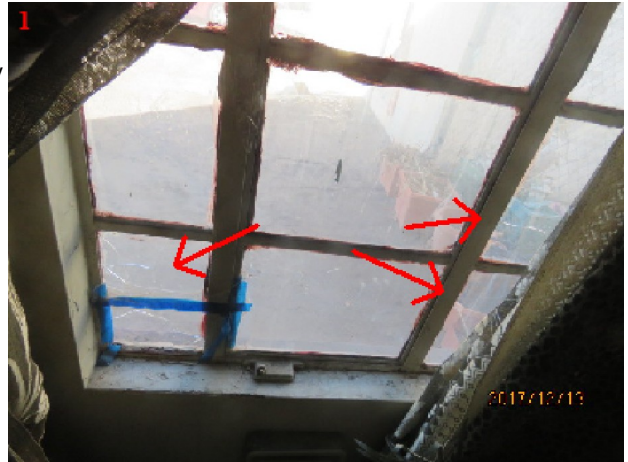
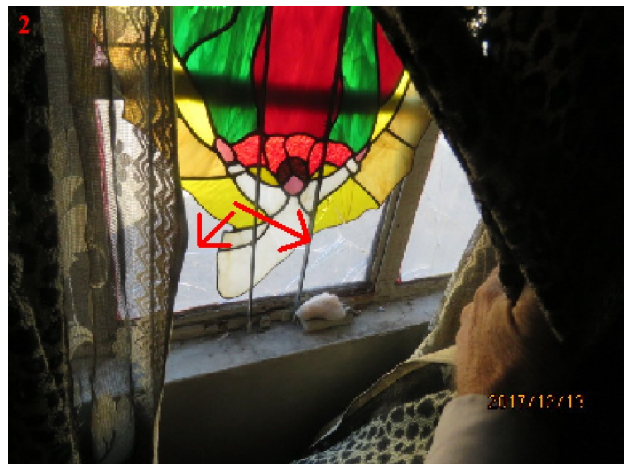
Multiple cracked window panes in the living room windows, missing window cranks and window locks. Recommend a qualified contractor evaluate and make all necessary repairs. see sample pictures

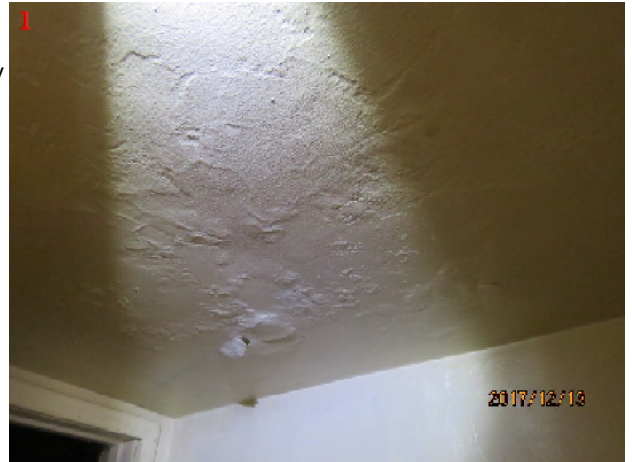
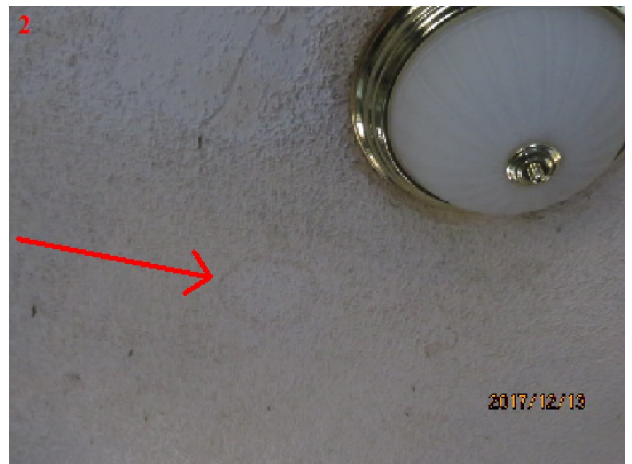
Water stain on the ceiling in the living room and in the hallway ceiling.  
Recommend a qualified contractor evaluate and make all necessary repairs.

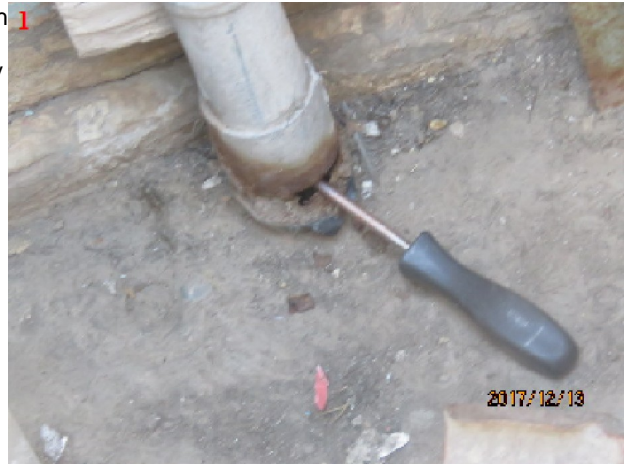
The main electrical service entrance conductor conduit is rusted with a hole in it at the ground level.  
Recommend a qualified contractor evaluate and make all necessary repairs. See picture

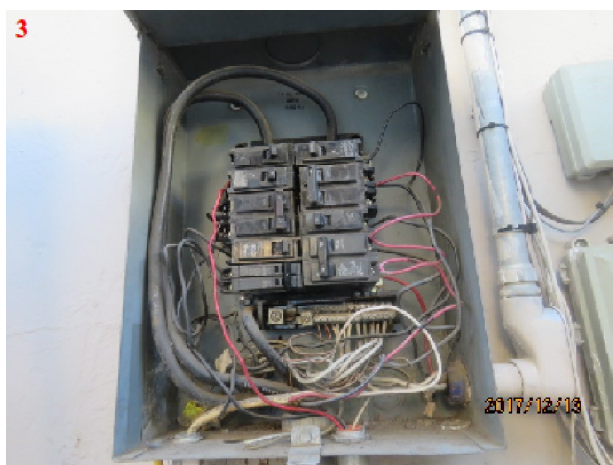
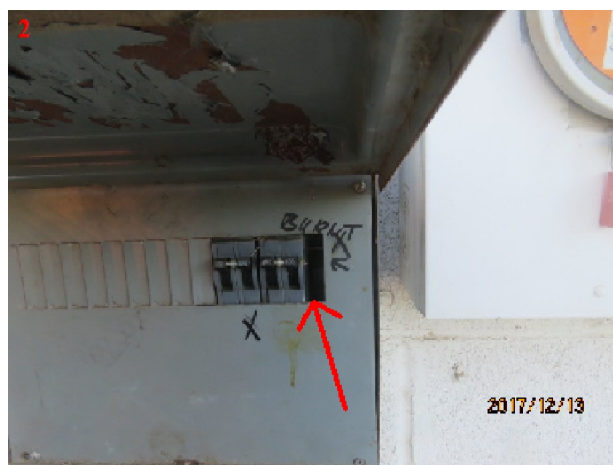
No breaker cover plate installed on the main electric panel.  
Recommend a qualified contractor evaluate and make all necessary repairs.  
Garage panel breaker cover reads "Burnt" Recommend further investigation.  
Knockouts are missing on two of the garage main electric panel cover plates. Recommend installing cover plugs to avoid electrical shocks. See picture

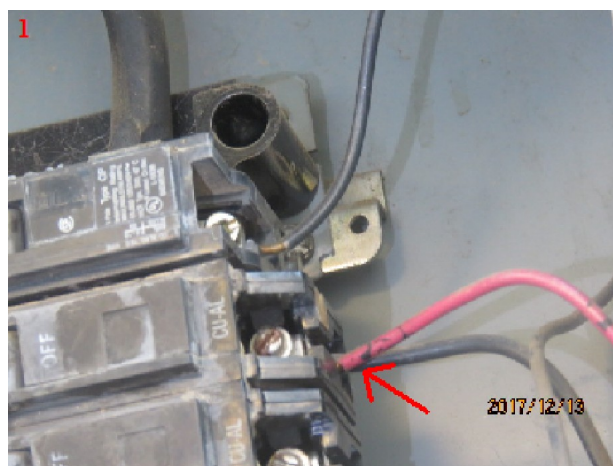
One breaker is double tapped this may create a loose connection and loose connections can cause electrical fires. Recommend only one wire per breaker. Recommend a qualified electrical contractor evaluate and make all necessary repairs. See picture

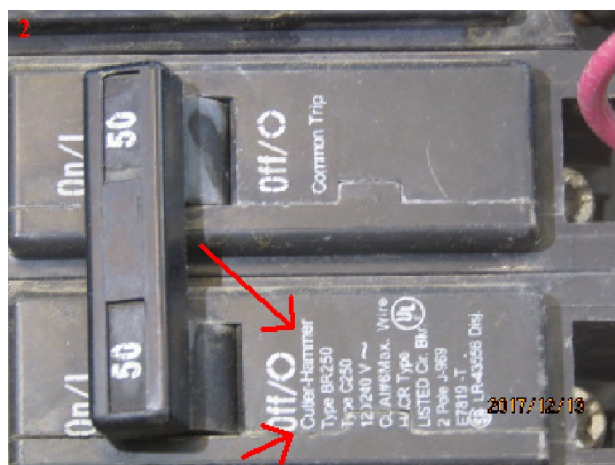
The electric panel calls for breakers made by the manufacturer of the panel and this panel has one or more breakers installed that are not made by the manufacturer. The wrong breakers can be a fire hazard and or a shock hazard. Recommend a qualified contractor evaluate and make all necessary repairs.

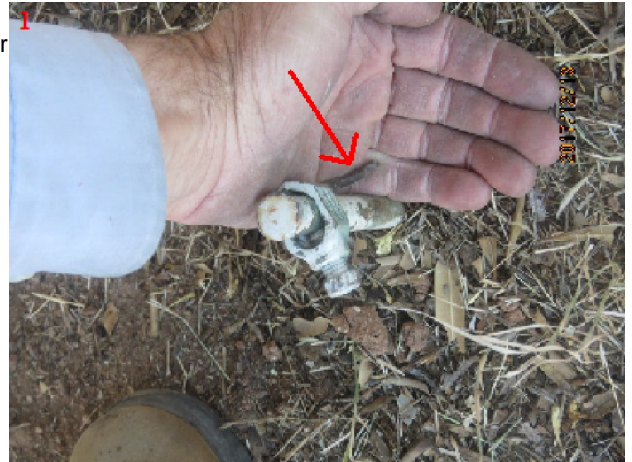
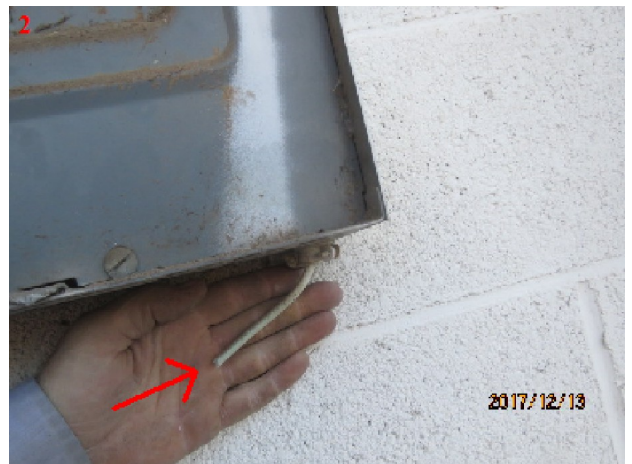
The garage main electric panel ground wire has been cut. This is a shock hazard. Recommend a qualified electrical contractor evaluate and make all necessary repairs. See Picture

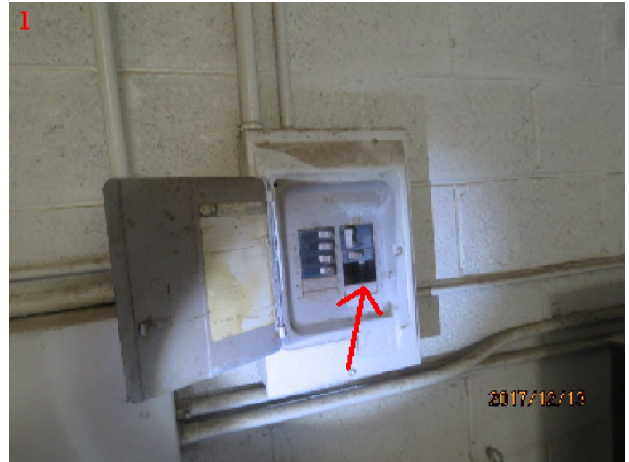
Knock out missing on the sub electric panel breaker cover plate.  
Recommend installing knockouts as needed.

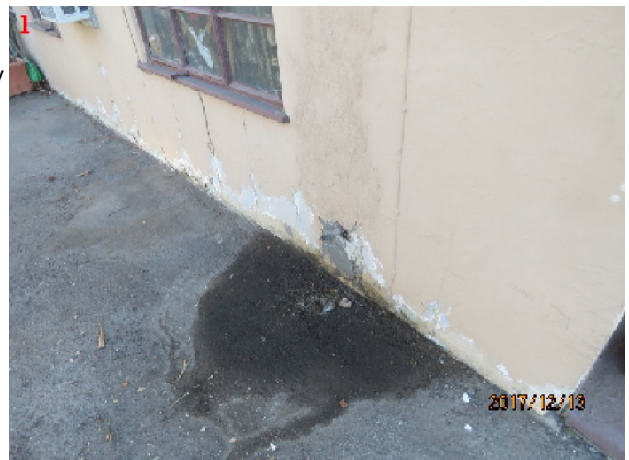
Tested all accessible exterior hose bibbs for water flow and leaks.  
Hose bibb on the side of the house is dripping continuously.  
Recommend a qualified contractor evaluate and make all necessary repairs.

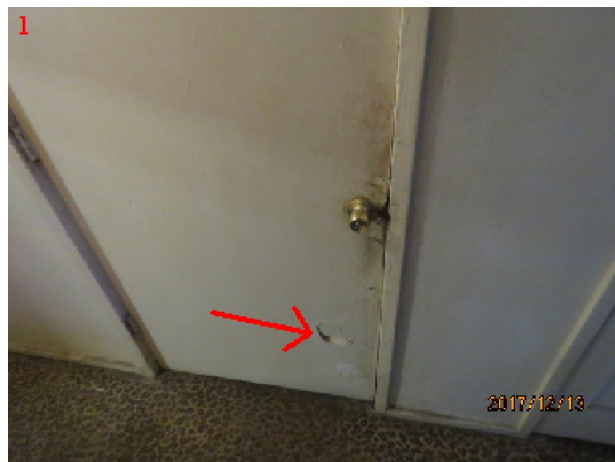
The master bathroom door has holes in it. Recommend replacing this door.

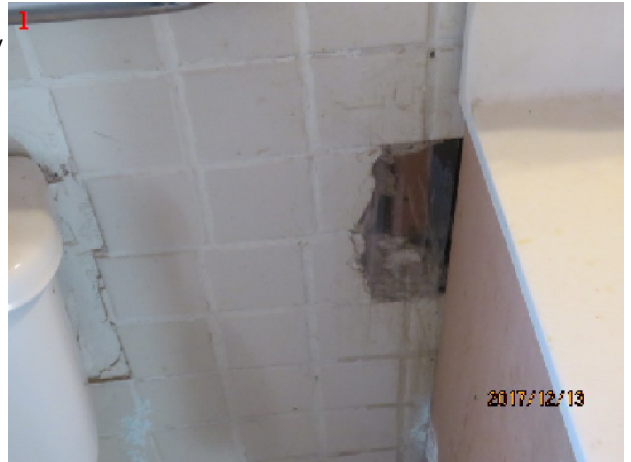
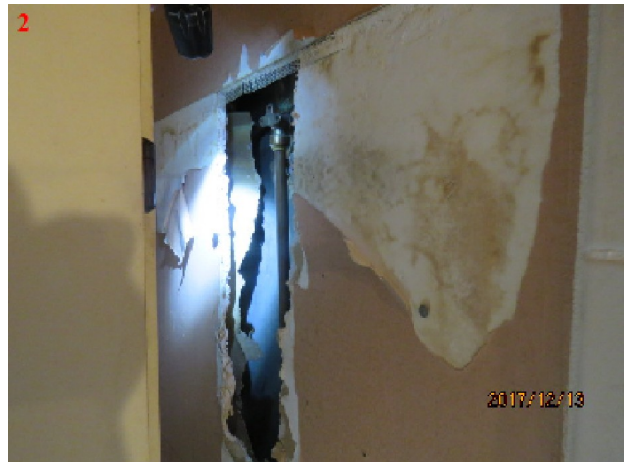
Holes in the walls and ceiling and missing wall tiles.  
Recommend a qualified contractor evaluate and make all necessary repairs.

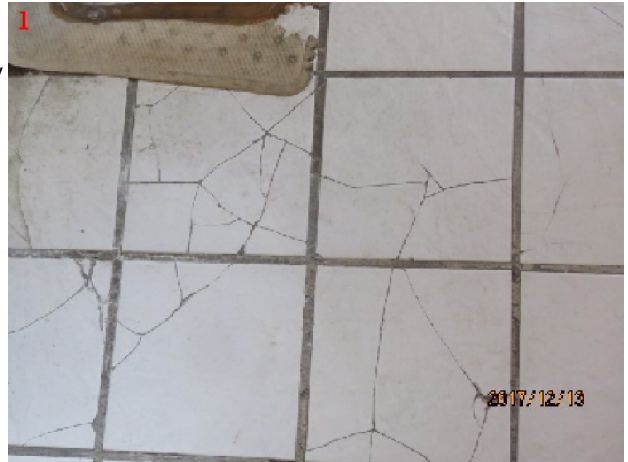
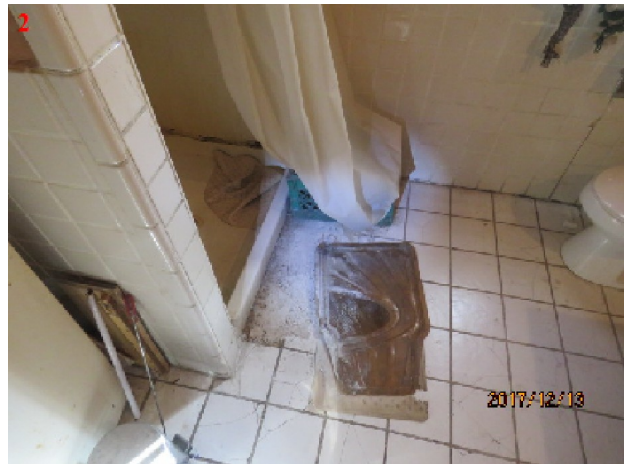
Multiple cracked floor tiles in the bathroom and the floor is sunk down in front of the shower.  
Recommend a qualified contractor evaluate and make all necessary repairs.

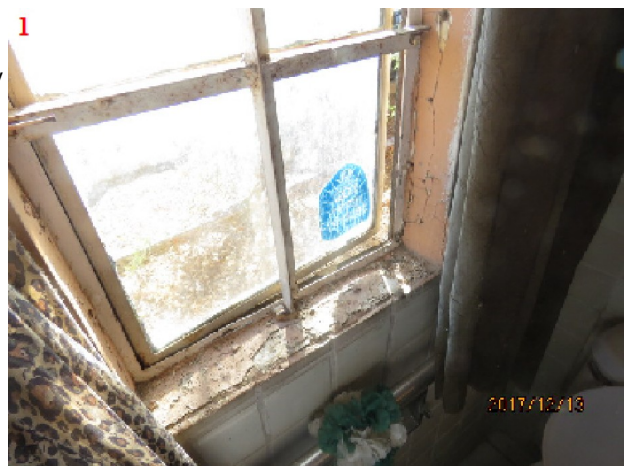
The master bathroom window does not lock and is missing a window crank. Water damage to the window sill area.  
Recommend a qualified contractor evaluate and make all necessary repairs.

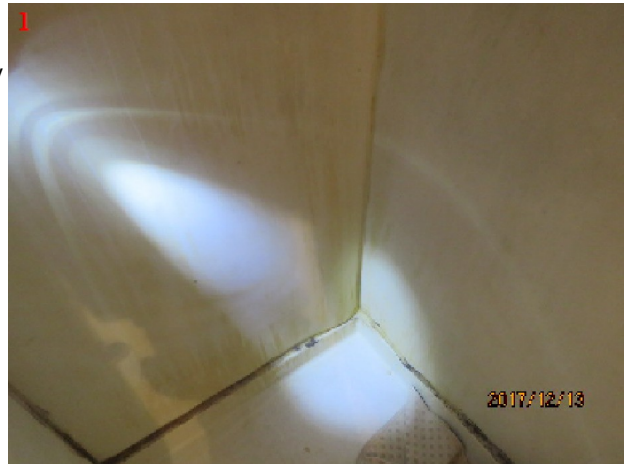
The shower walls are rippled and loose on the walls with mold on the base of the shower walls.  
Recommend a qualified contractor evaluate and make all necessary repairs.

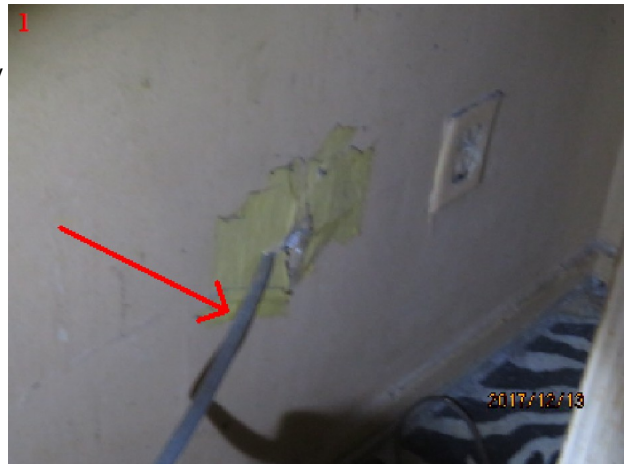
Electrical cord running through the master bedroom wall. This cord is not designed to be run through walls.  
Recommend a qualified contractor evaluate and make all necessary repairs.

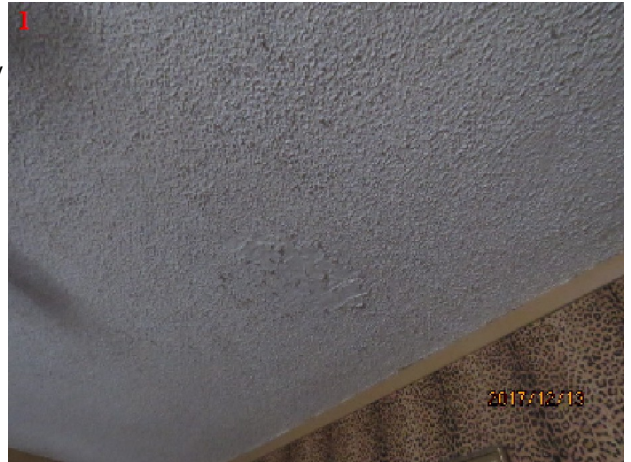
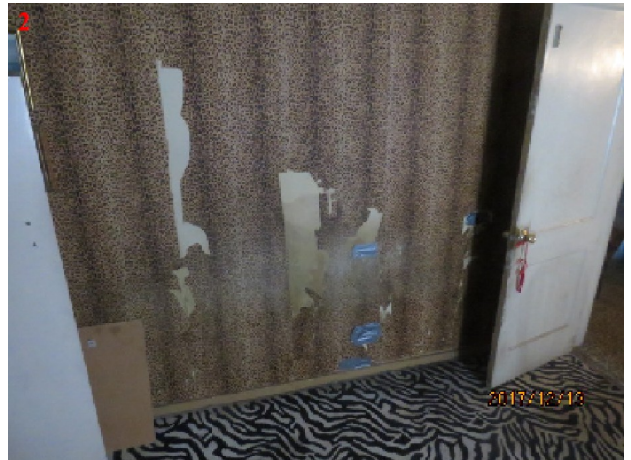
Wall paper falling off the walls and holes in the walls. Patches on the ceiling.  
Recommend a qualified contractor evaluate and make all necessary repairs.

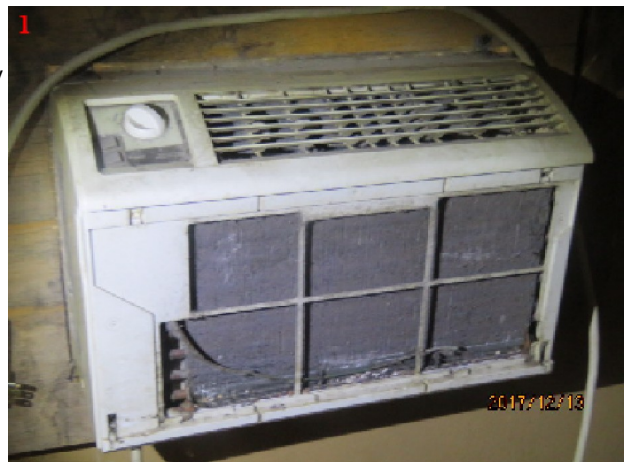
The wall unit did get cold when tested but it is in poor condition and needs cleaning.  
Recommend a qualified contractor evaluate and make all necessary repairs.

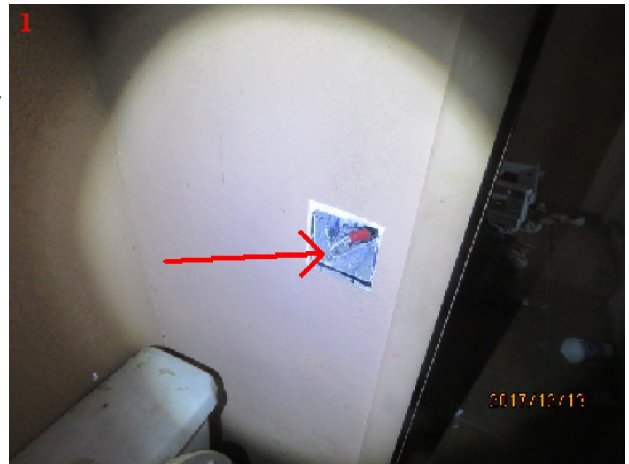
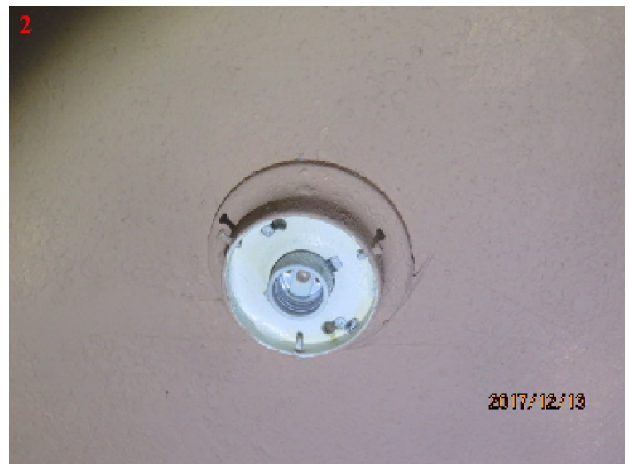
The bathroom light fixtures did not turn on when tested.  
Recommend checking bulbs.  
Bathroom wall switch missing and cover plate missing.  
This is a shock hazard. Recommend a qualified electrical contractor evaluate and make all needed repairs.

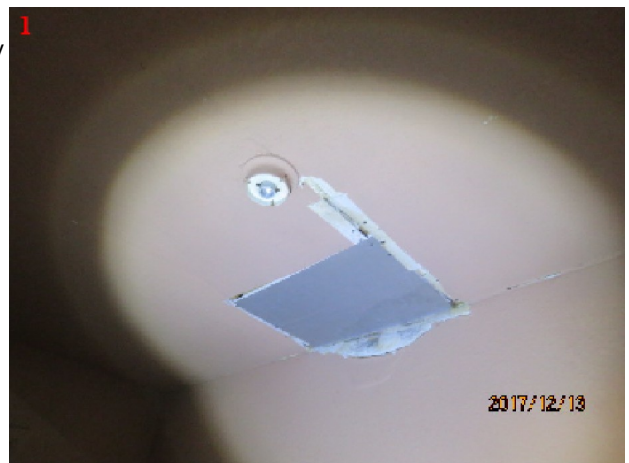
Holes in the ceiling and walls.  
Recommend a qualified contractor evaluate and make all necessary repairs.

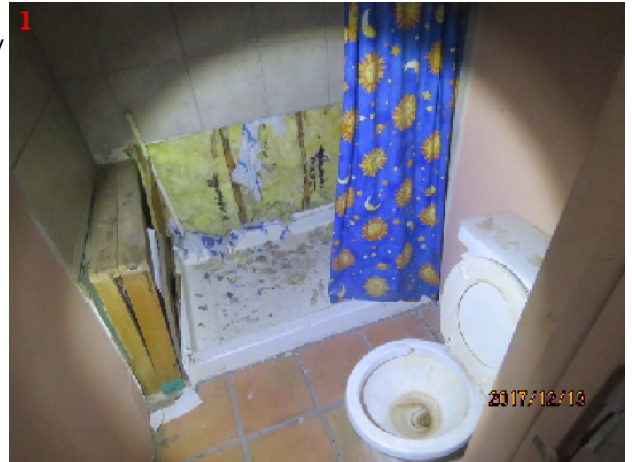
Massive hole in the shower enclosure wall.  
Recommend a qualified contractor evaluate and make all necessary repairs.

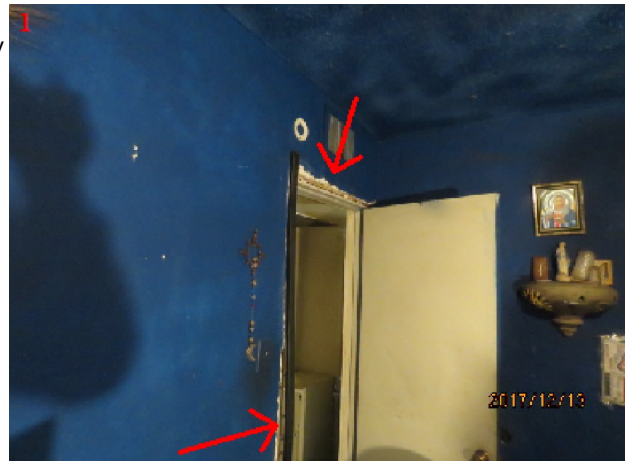
Door jamb loose on the wall and parts missing.  
Recommend a qualified contractor evaluate and make all necessary repairs.

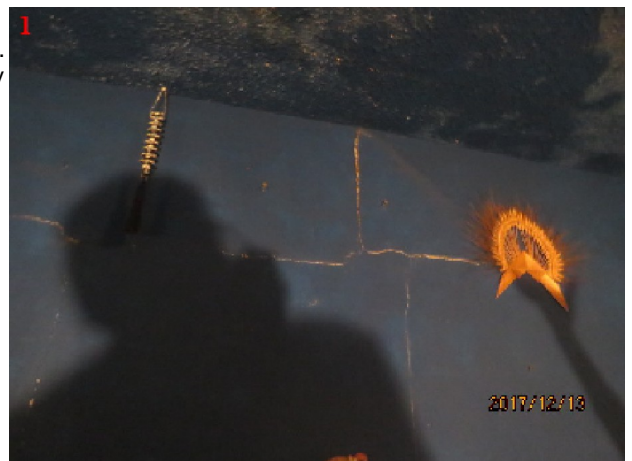
Wall has large cracks from ceiling to the floor with loose plaster.  
This wall backs to the shower wall with the damaged wall enclosure.  
Recommend a qualified contractor evaluate and make all necessary repairs.
