Termite Treatment Information

- *Protection Termite Control* – Termite Inspection Report on October 25, 2018 / Subterranean termite tube discovered in guest house. No termite activity noted in the main house.
- *Protection Termite Control* – Treatment Proposal / note that the Seller contracted to have the guest house treated with “Option A” that includes a one-year warranty to treat and warrant the guest house. The Buyer can extend the termite treatment warranty coverage up to 5-years, at its option at closing.
- *Atomic Pest Control, LLC* - termite treatment receipt and two-year warranty for treatment performed on the guest house in 2015.

35635 N Meander Way
Carefree, AZ 85377

Arizona Official State Termite Inspection Report (WDIIR)

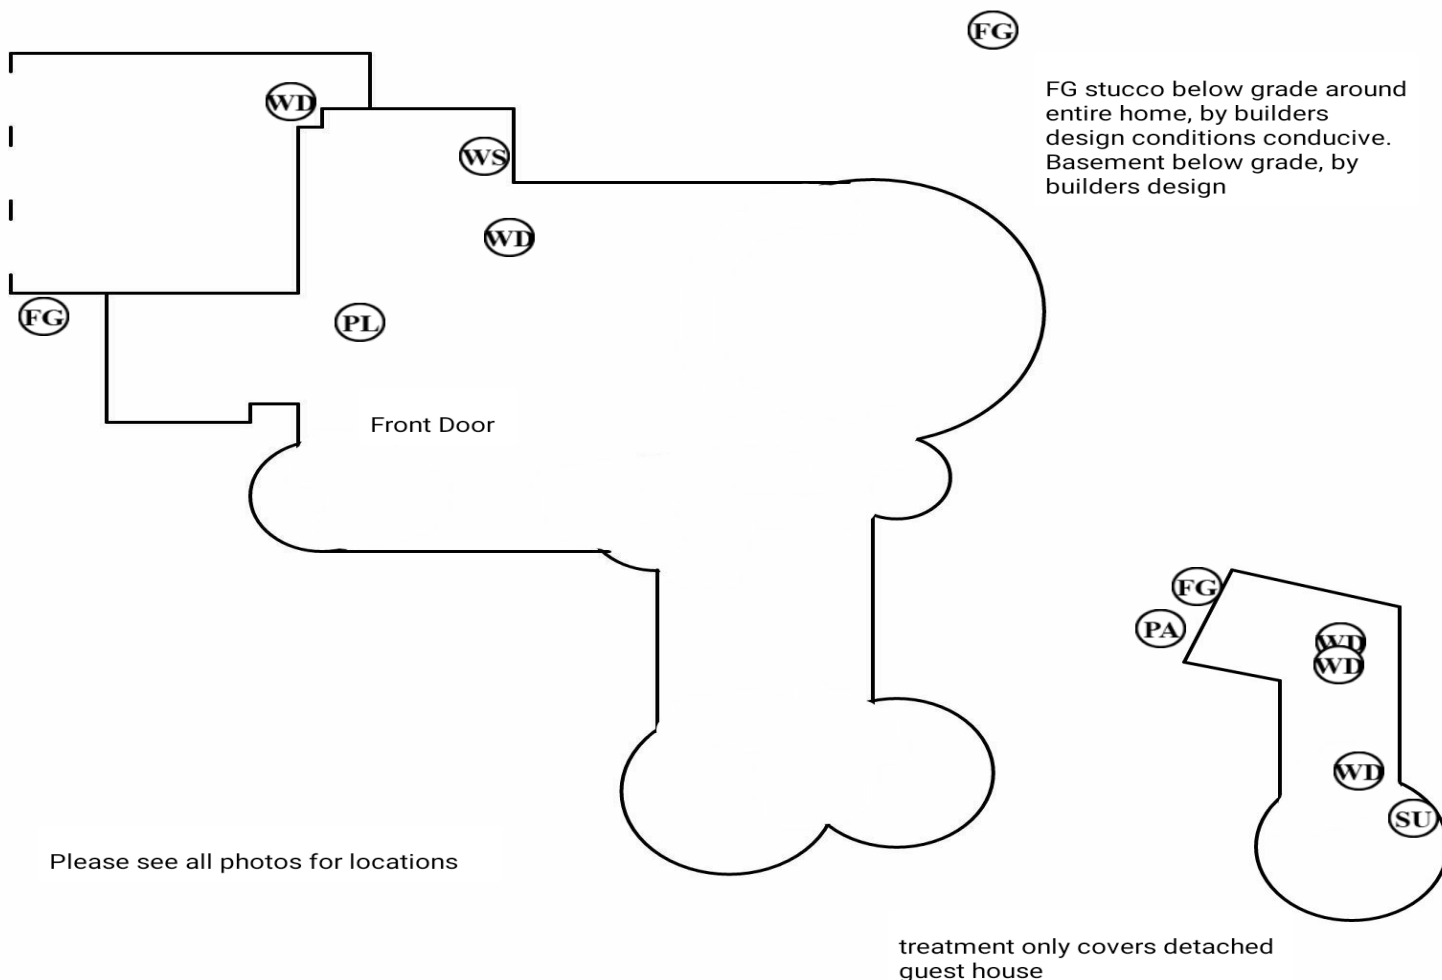
GRAPH OF STRUCTURE(S)

This structure has IA, please see comments on page 2 box 19 of AZ WDIIR Form

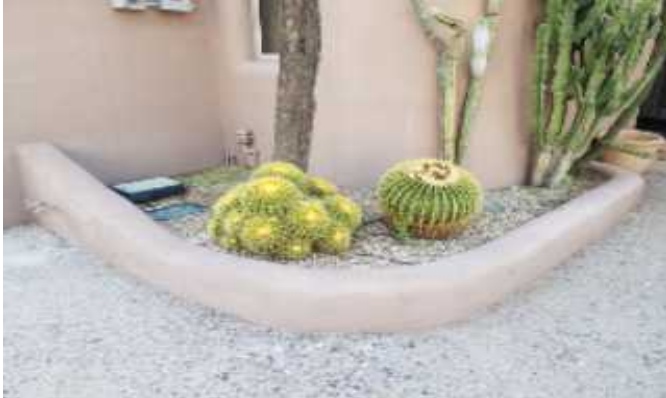
FG planterbox front of garage

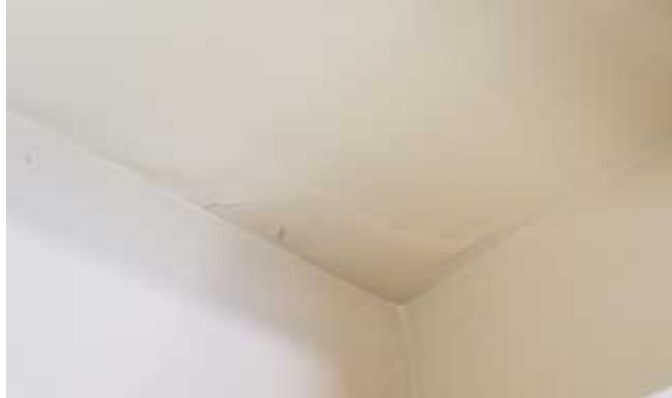
WD garage ceiling, tested dry at time of inspection

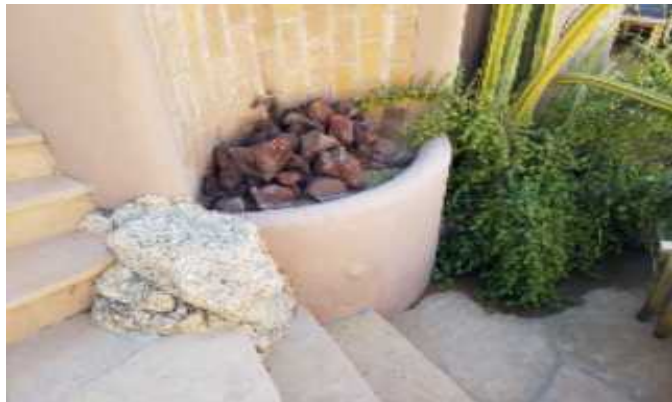
FG planterbox front of detached guest house

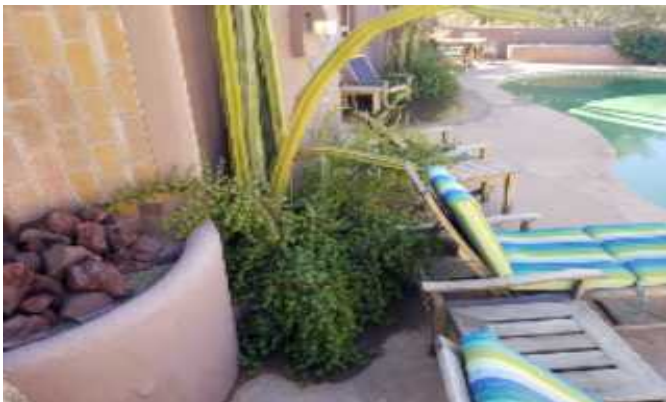
PA plants abutting detached guest house

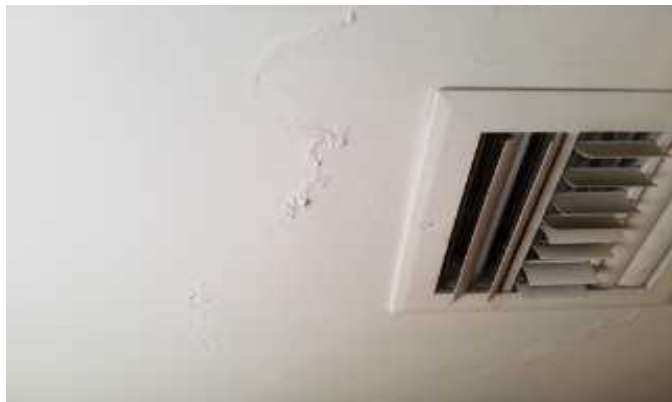
WD detached guest house bathroom ceiling, tested dry at time of inspection

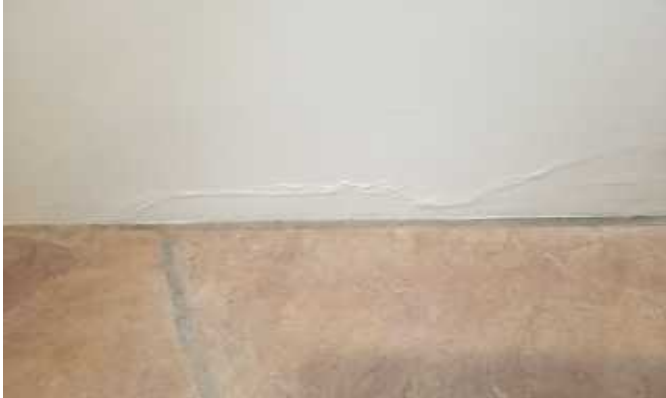
WD detached guest house wall bathroom area, tested dry at time of inspection

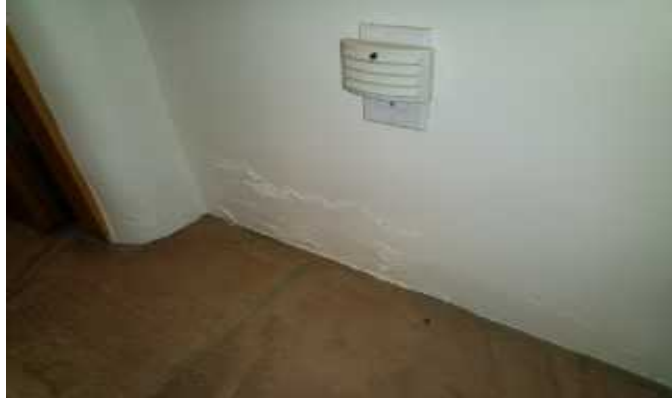
WD detached guest house wall bathroom area, tested dry at time of inspection

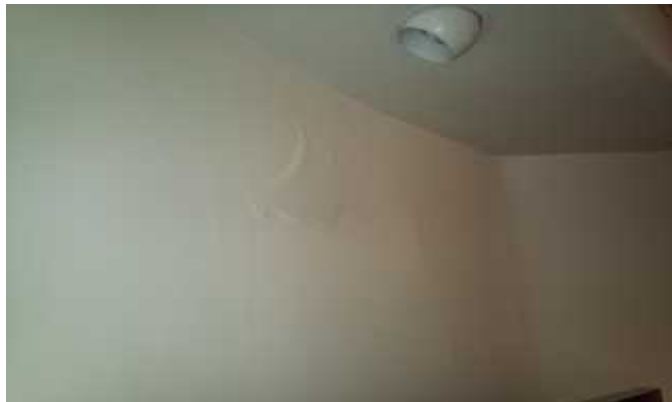
WD detached guest house wall

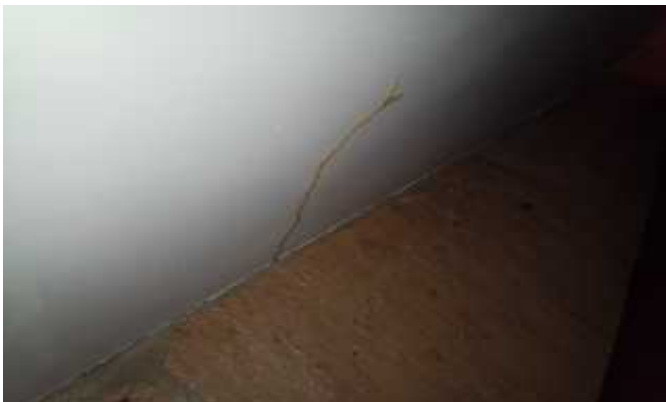
SU termite tube detached guest house wall

Recommendation from inspector: Treatment only covers detached guest house

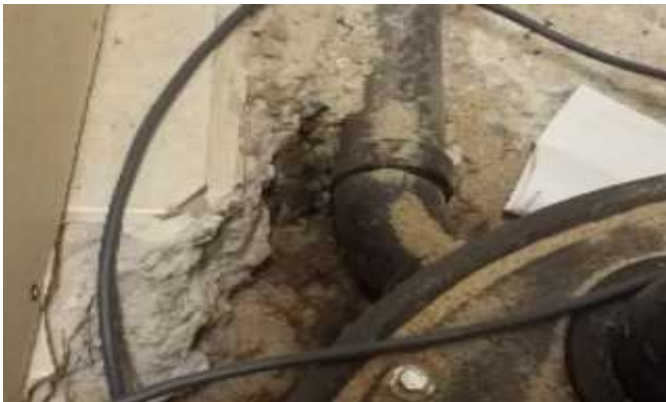
PL improper condensation line drainage

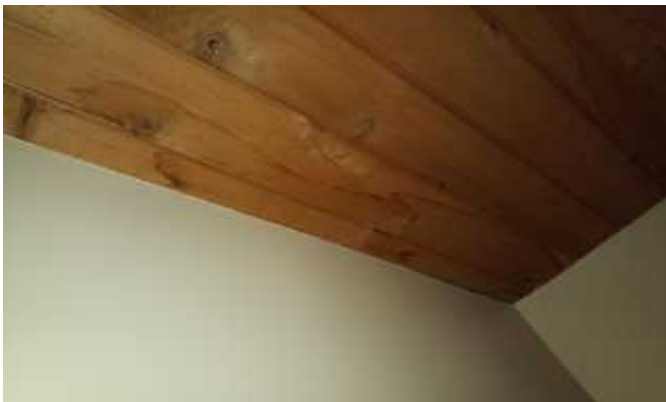
WS NE bedroom ceiling, tested dry at time of inspection

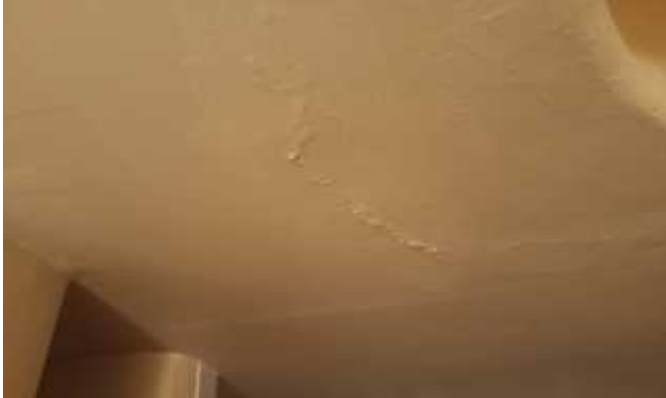
WD NE guest bathroom ceiling, tested dry at time of inspection

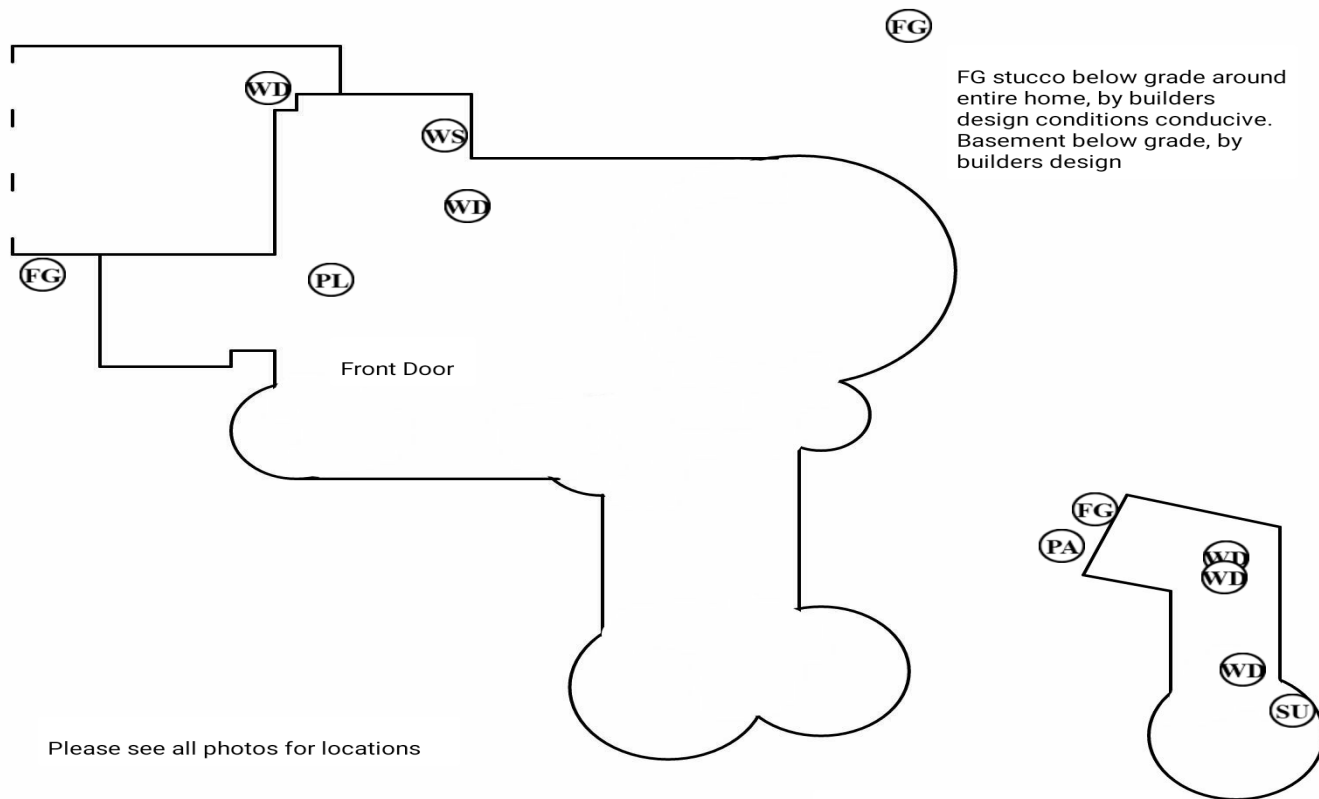
Please see all photos for locations

treatment only covers detached
guest house
