## House Inspection and Repairs

The property was inspected by King Home Inspections on February 15, 2019.

# Property Inspection Report

14016 S. Rockhill Rd., Phoenix, AZ 85048

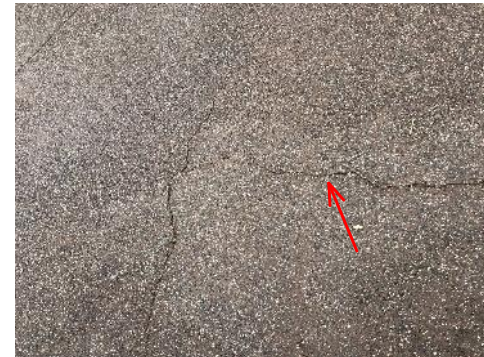
1. Driveway Concrete There are cracks with separation in the driveway.

| 1. | <input type="checkbox"/> | <input type="checkbox"/> | <input checked="" type="checkbox"/> | <input type="checkbox"/> | <input type="checkbox"/> | <input type="checkbox"/> | <u>Driveway</u> <b>Concrete</b> There are cracks with separation in the driveway. |

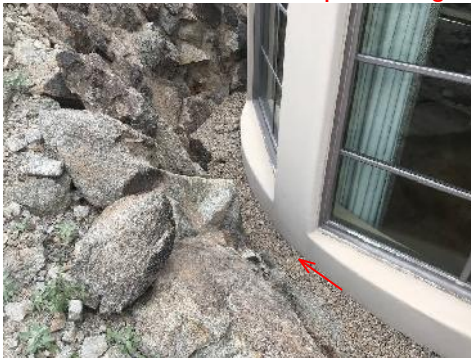
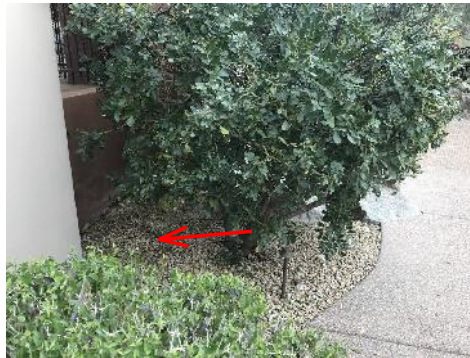
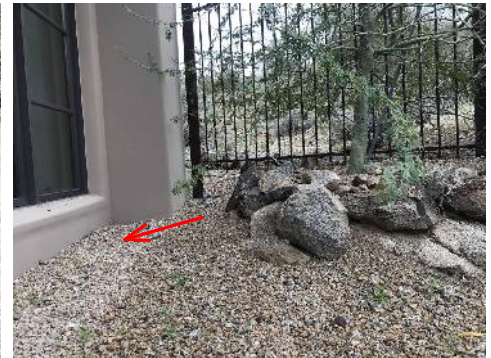
3. Drainage Issue The soil is above the slab onto the framed wall in multiple locations around the perimeter of the house. The soil slopes toward the house and there is evidence of water ponding between the house and the front walk.

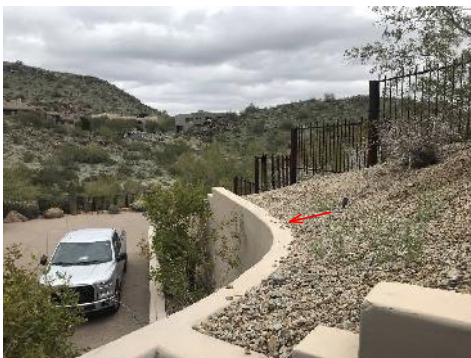
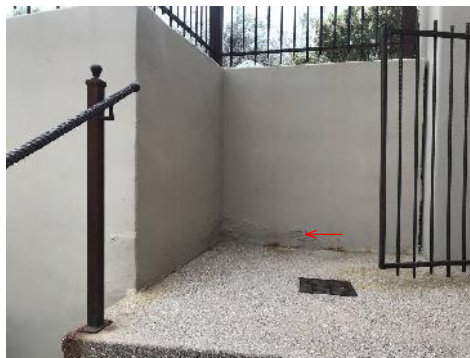
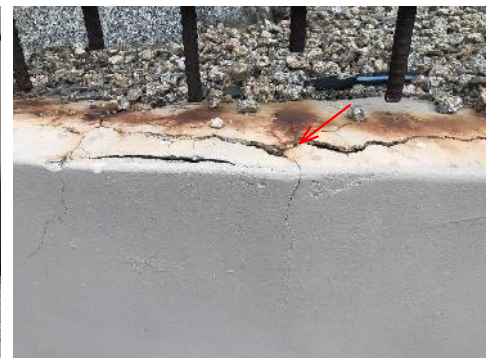
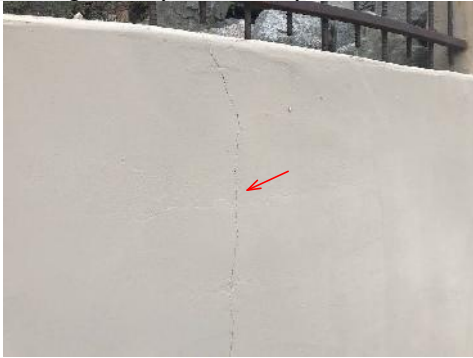
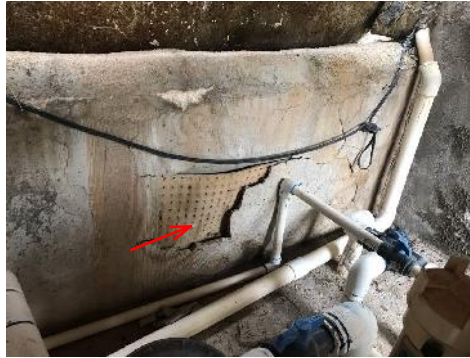
4. Retaining Wall Concrete There are walk offs greater than 30 inches with no guard rail in multiple places. There is evidence of moisture stains/damage/cracks to the face and top of the retaining walls in multiple places. There are no visible weep holes at the bottom of the retaining walls. The retaining wall surface is deteriorated in the pump area for the front waterfall.

| 10. | <input type="checkbox"/> | <input type="checkbox"/> | <input type="checkbox"/> | <input checked="" type="checkbox"/> | <input type="checkbox"/> | <input type="checkbox"/> | <u>Retaining Wall</u> <b>Concrete</b> There are walk offs greater than 30 inches with no guard rail in multiple places. There is evidence of moisture stains/damage/cracks to the face and top of the retaining walls in multiple places. There are no visible weep holes at the bottom of the retaining walls. The retaining wall surface is deteriorated in the pump area for the front waterfall. |

1. Retaining wall were constructed and installed per building code at the time of contraction. All walls have iron fencing around them.
2. Settling crack in rear patio roof inspected and is normal wear and tear.

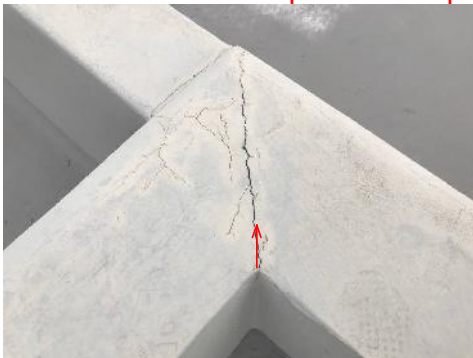
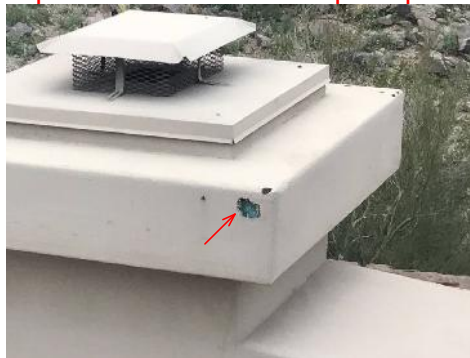
5. Wall Covering/Trim Material Stucco, Stone The stucco is damaged in multiple places. There are cracks at the top of the parapet wall in multiple places.

| 2. | <input type="checkbox"/> | <input type="checkbox"/> | <input checked="" type="checkbox"/> | <input type="checkbox"/> | <input type="checkbox"/> | <input type="checkbox"/> | <u>Wall Covering/Trim Material</u> <b>Stucco, Stone</b> The stucco is damaged in multiple places. There are cracks at the top of the parapet wall in multiple places. |

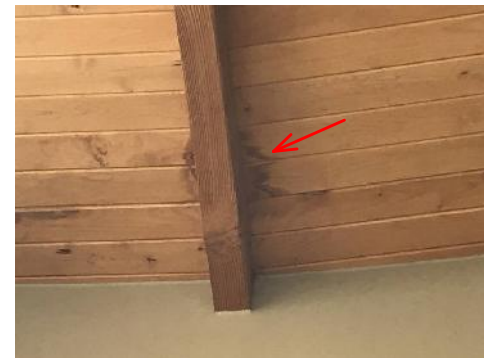
6. Eaves/Fascia/Soffits Material Wood There is evidence of moisture stains/damage to the eaves and fascia at multiple places.

| 3. | <input type="checkbox"/> | <input type="checkbox"/> | <input checked="" type="checkbox"/> | <input type="checkbox"/> | <input type="checkbox"/> | <input type="checkbox"/> | <u>Eaves/Fascia/Soffits Material</u> <b>Wood</b> There is evidence of moisture stains/damage to the eaves and fascia at multiple places. |

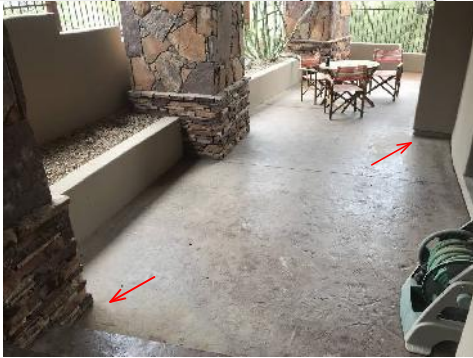
7. Patio/Courtyard Material Concrete There is evidence of water ponding in the outdoor entertainment area, the pool equipment area, the north west patio.

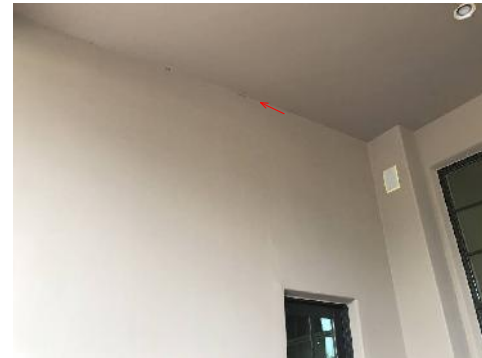
8. Patio Cover Material **Drywall** There are cracks in the edge of the rear patio cover at the north end.

| 5. | <input type="checkbox"/> | <input checked="" type="checkbox"/> | <input type="checkbox"/> | <input type="checkbox"/> | <input type="checkbox"/> | <input type="checkbox"/> | <u>Patio Cover Material</u> <b>Drywall</b> There are cracks in the edge of the rear patio cover at the north end. |

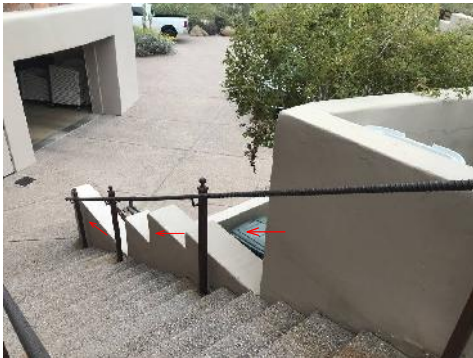
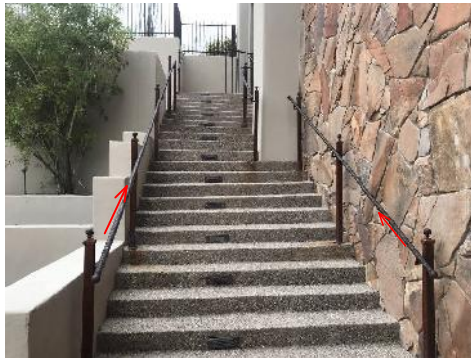
9. Exterior Stairs Material .. **Concrete** There are no vertical balusters for the guard rail on the exterior stairs at the east side of the house. The handrails are loose on the east side of the house.

| 10. | <input type="checkbox"/> | <input type="checkbox"/> | <input type="checkbox"/> | <input checked="" type="checkbox"/> | <input type="checkbox"/> | <input type="checkbox"/> | <u>Exterior Stairs Material</u> .. <b>Concrete</b> There are no vertical balusters for the guard rail on the exterior stairs at the east side of the house. The handrails are loose on the east side of the house. |

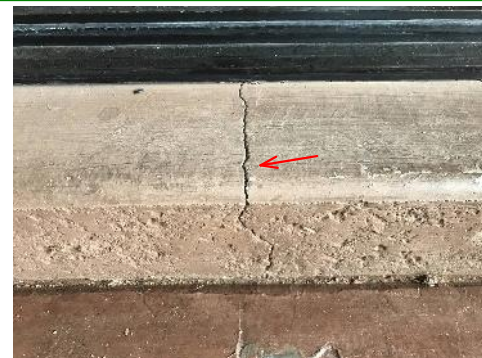
10. Stem Wall/Slab **concrete** There are cracks in the stem wall in multiple places.

2. ☐ ☐ ☒ ☐ ☐ ☐ Stem Wall/Slab concrete There are cracks in the stem wall in multiple places.
3. ☐ ☐ ☐ ☐ ☐ ☒ Post Tension Slab
4. ☒ ☐ ☐ ☐ ☐ ☐ Floor Construction concrete

3. Stem wall cracks do not manifest themselves through to the walls of the house and are normal for age of house.
4. \$6,000 spent on roof repairs and sealing.

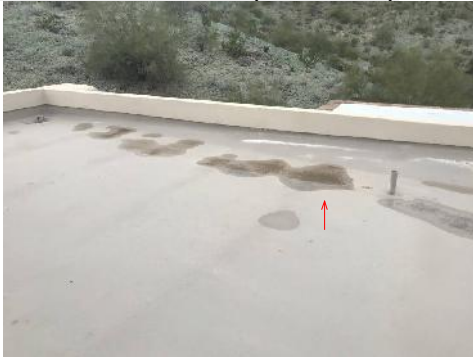
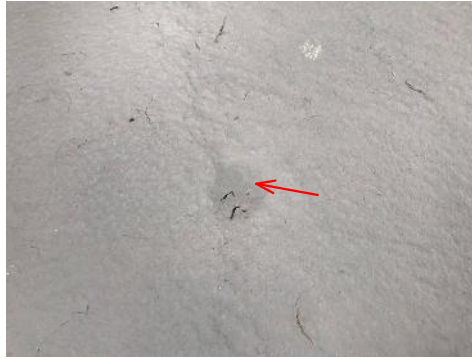
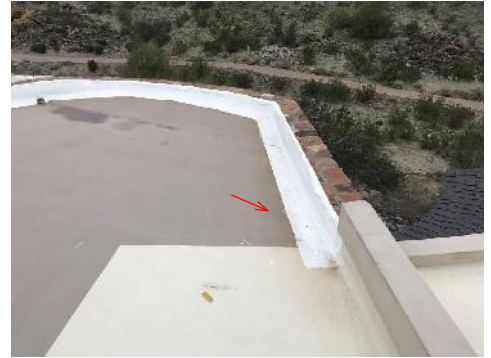
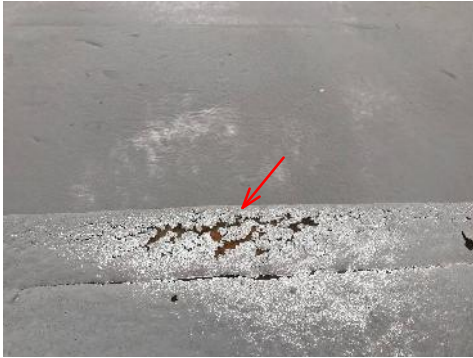
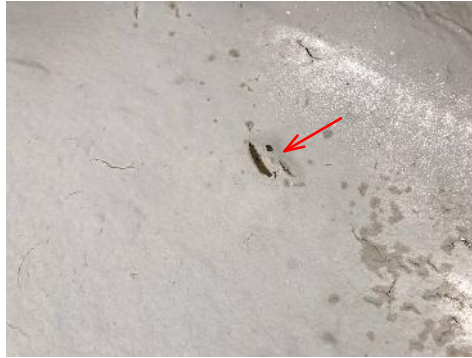
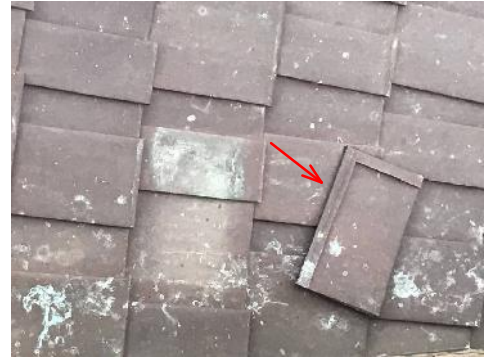
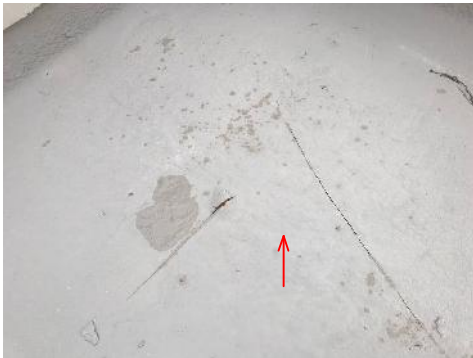
11. Condition of Main Roof **Issue** There is evidence of water ponding in multiple locations on the roof. There are blisters/cracks/openings in the roof surface in multiple places. There is evidence of prior repairs in multiple places.

1. Roof Styles at Property Flat/Low Slope
2. How Roofs were Inspected Walked
3. Main House Material Foam
4. ☐ ☐ ☒ ☐ ☐ ☐ Condition of Main Roof Issue There is evidence of water ponding in multiple locations on the roof. There are blisters/cracks/openings in the roof surface in multiple places. There is evidence of prior repairs in multiple places.
5. Patio Cover Material Copper shingles
6. ☐ ☐ ☒ ☐ ☐ ☐ Condition of Patio/Deck Covers Issue The copper shingles are displaced in a few places.
7. ☒ ☐ ☐ ☐ ☐ ☐ Flashings Visibly Acceptable
8. ☒ ☐ ☐ ☐ ☐ ☐ Roof Penetrations Visibly Acceptable
9. ☐ ☒ ☐ ☐ ☐ ☐ Skylights Issue The sealant is deteriorated at the edges of the skylights.
10. ☐ ☐ ☒ ☐ ☐ ☐ Rain Gutters Issue  
The downspout drains in a negative direction on the back of the master bedroom.
11. Guest House Material N/A
12. ☐ ☐ ☐ ☐ ☐ ☒ Condition of Guest House Roof

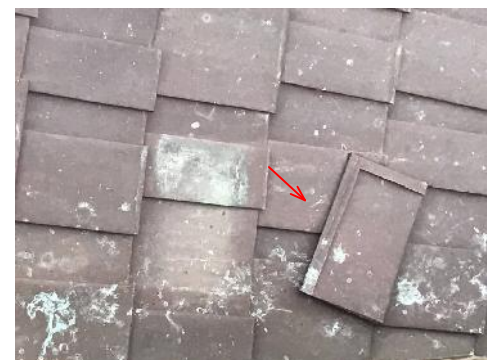
12. Condition of Patio/Deck Covers **Issue** The copper shingles are displaced in a few places.

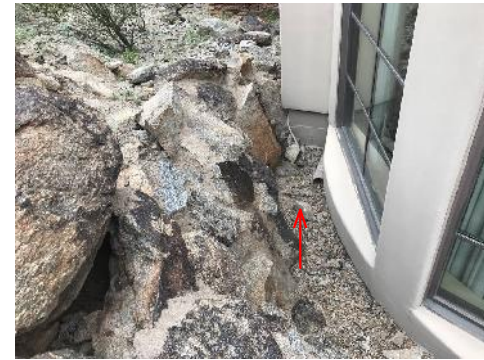
### 14. Rain Gutters Issue

The downspout drains in a negative direction on the back of the master bedroom.

5. Skylights resealed with caulk
6. The "reverse direction drain" is not a drain but a passthrough for exterior water to get to a drain in the corner of the house.

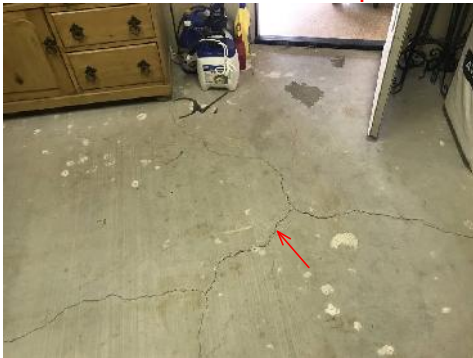
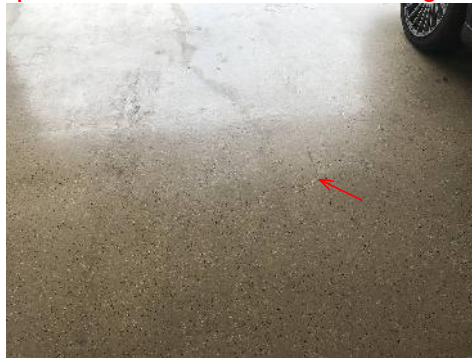
### 15. Floor Issue There are cracks with separation in the storage room floor in the garage. There is evidence of prior repairs to cracks in the garage floor.

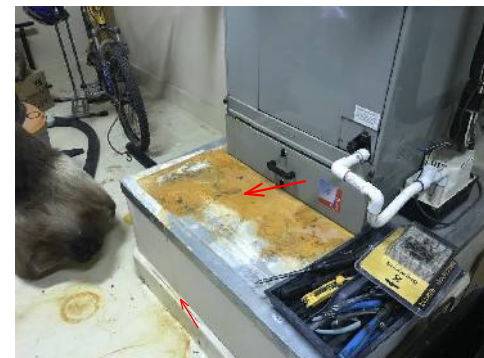
### 16. Walls Issue There is rust and evidence of moisture stains/damage to the air handler platform in the garage.

7. Rust on the a/c unit pedestal was remedied 2 years ago when the drain pipes were cleaned and maintained.
8. Door knob in internal room in garage installed

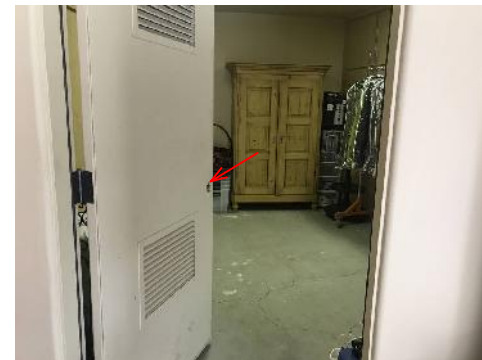
18. Pedestrian Door Issue There is no door knob on the door to the storage closet in the garage.

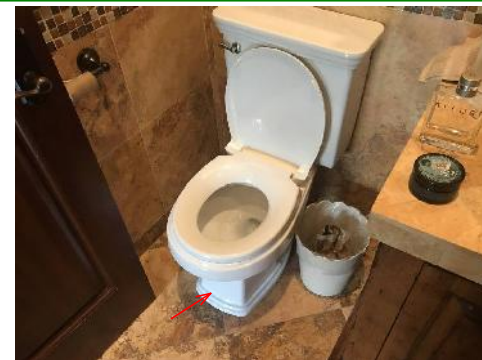
19. Toilets Issue The toilet is loose from the floor in the north east secondary bedroom bathroom.

| 1. | <input type="checkbox"/> <input checked="" type="checkbox"/> <input type="checkbox"/> <input type="checkbox"/> <input type="checkbox"/> <input type="checkbox"/> | <u>Toilets</u> <span style="color: green;">Issue</span> The toilet is loose from the floor in the north east secondary bedroom bathroom. |

9. Toilet secured in north east bathroom
10. Sink stopper connected in north east bathroom.
11. No evidence of new leakage in pool room....just received 2 inches of rain.

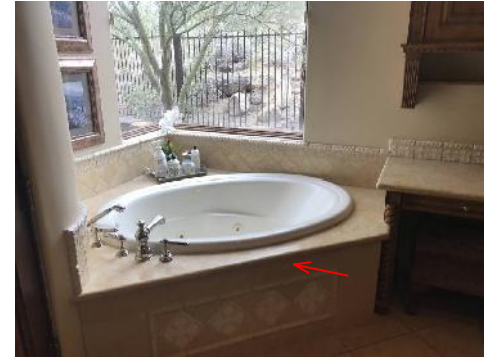
21. Tubs Issue It does not appear the jetted tub is GFCI protected in the master bathroom.

16. Jetted Tub is GFCI
17. Based reconnected in Guest bedroom
18. New filters for R/O installed and soft water system served Friday, Feb 22.

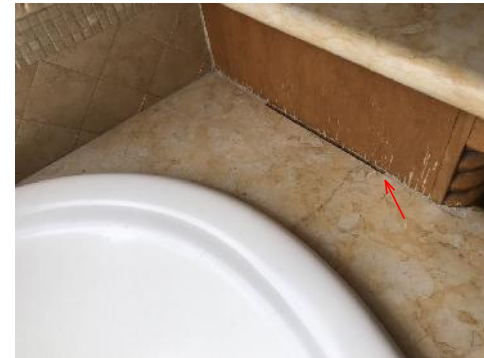
22. Tub Surrounds Issue The grout is missing between the tub surround and the cabinet in the master bathroom.

| 6. | <input type="checkbox"/> <input checked="" type="checkbox"/> <input type="checkbox"/> <input type="checkbox"/> <input type="checkbox"/> <input type="checkbox"/> | <u>Tub Surrounds</u> <span style="color: green;">Issue</span> The grout is missing between the tub surround and the cabinet in the master bathroom. |

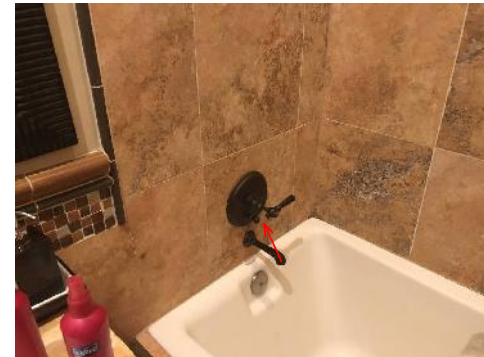
23. Tub Faucets Issue The shower diverter does not close all the way in the off position in the north east secondary bathroom.

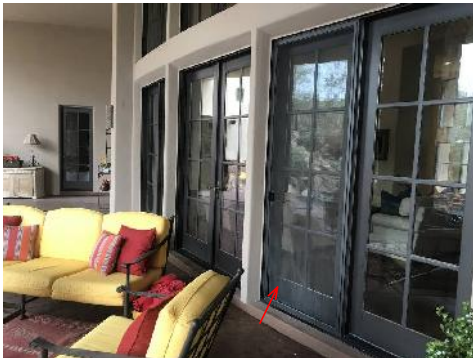
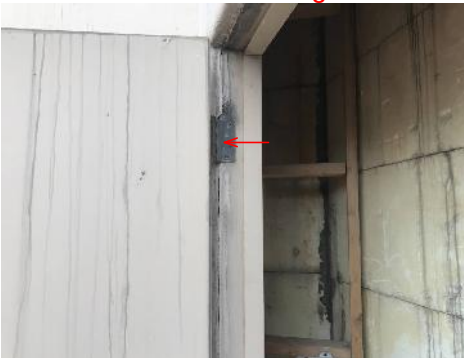
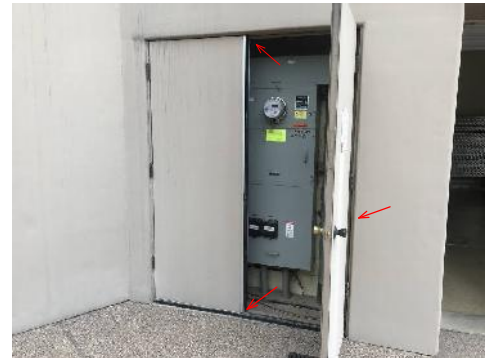
24. Exit Doors/Others Issue The screen door is damaged on the rear of the house. The screws are stripped at the top hinge, the header/threshold pins do not engage on the double door and the door knob does not function for the main electrical service panel closet. The exterior doors difficult to close at the eating nook.

| 3. | <input type="checkbox"/> <input checked="" type="checkbox"/> <input type="checkbox"/> <input type="checkbox"/> <input type="checkbox"/> <input type="checkbox"/> | <u>Exit Doors/Others</u> <span style="color: green;">Issue</span> The screen door is damaged on the rear of the house. The screws are stripped at the top hinge, the header/threshold pins do not engage on the double door and the door knob does not function for the main electrical service panel closet. The exterior doors difficult to close at the eating nook. |

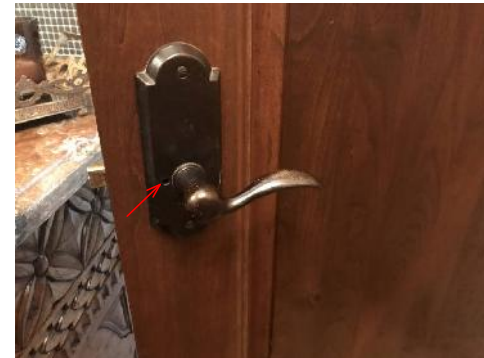
25. Interior Doors **Issue** The lock button has been removed in multiple places on the interior doors.

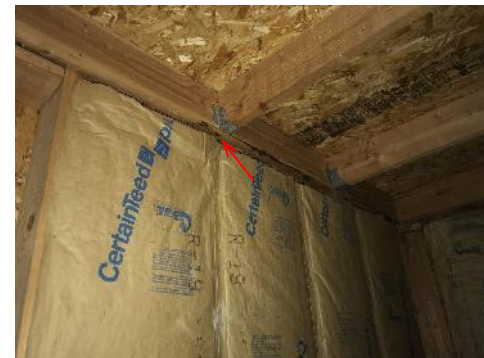
26. Ceilings **Issue** There is evidence of moisture stains/damage to the ceiling in the pool equipment room.

| 5. | <input type="checkbox"/> <input type="checkbox"/> <input checked="" type="checkbox"/> <input type="checkbox"/> <input type="checkbox"/> <input type="checkbox"/> | <u>Ceilings</u> <span style="color: green;">Issue</span> There is evidence of moisture stains/damage to the ceiling in the pool equipment room. |

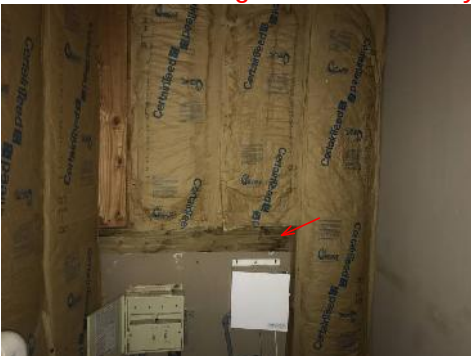
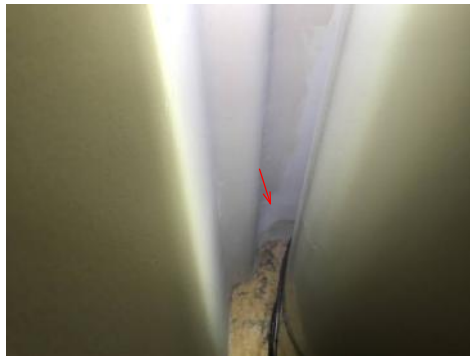
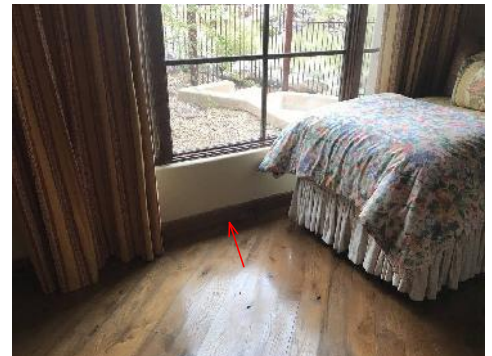
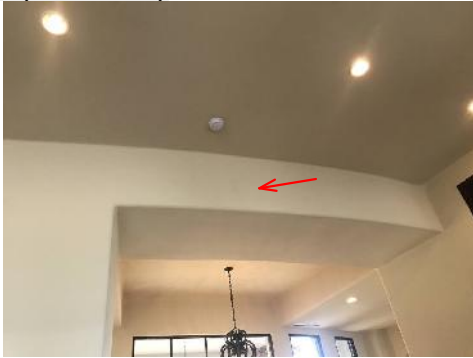
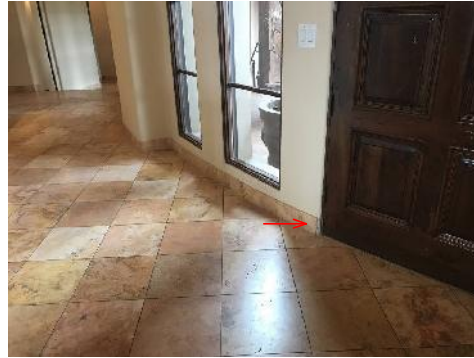
27. Walls **Issue** There is evidence of moisture stains/damage to the walls in the pool equipment room. There is evidence of moisture stains behind left water heater in the water heater closet. The base is pulled away from the wall in the guest bedroom. There are stains on the wall in the living room above the entry stairs. There is a small piece of tile missing at the entry door.

| 6. | <input type="checkbox"/> <input type="checkbox"/> <input checked="" type="checkbox"/> <input type="checkbox"/> <input type="checkbox"/> <input type="checkbox"/> | <u>Walls</u> <span style="color: green;">Issue</span> There is evidence of moisture stains/damage to the walls in the pool equipment room. There is evidence of moisture stains behind left water heater in the water heater closet. The base is pulled away from the wall in the guest bedroom. There are stains on the wall in the living room above the entry stairs. There is a small piece of tile missing at the entry door. |

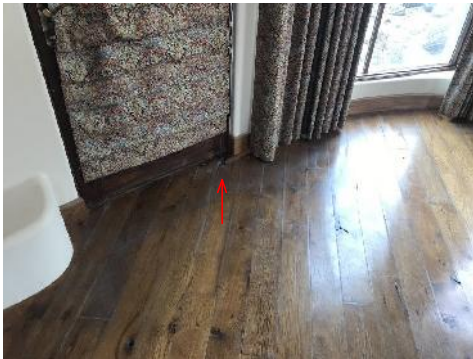
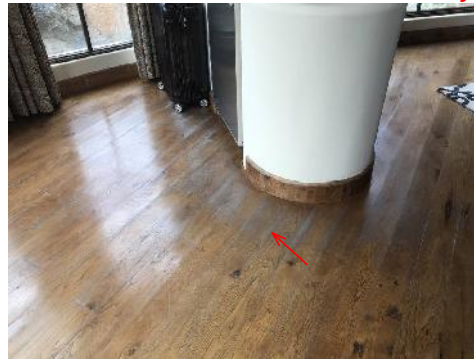
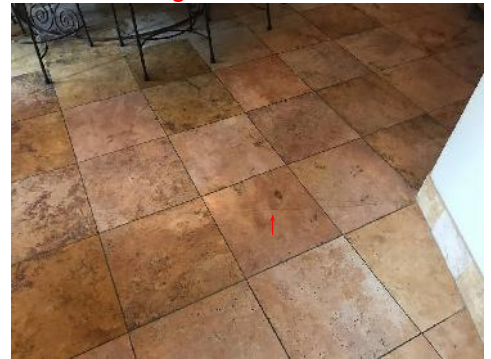
**28. Floors Issue** There is evidence of moisture stains/damage to the floor in the master bedroom. There is a crack in the tile between the entry and eating nook.

| 7. | <input type="checkbox"/> <input type="checkbox"/> <input checked="" type="checkbox"/> <input type="checkbox"/> <input type="checkbox"/> <input type="checkbox"/> | <u>Floors</u> <span style="color: green;">Issue</span> There is evidence of moisture stains/damage to the floor in the master bedroom. There is a crack in the tile between the entry and eating nook. |

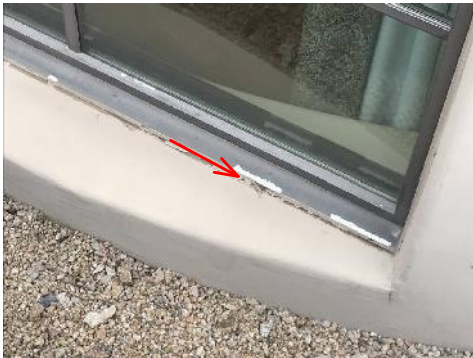
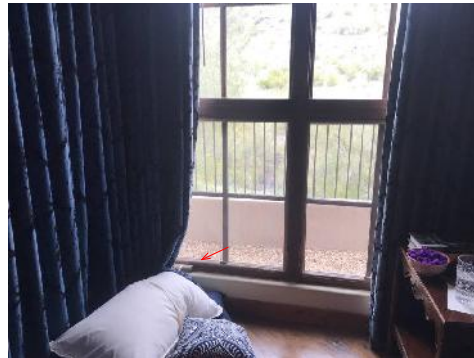
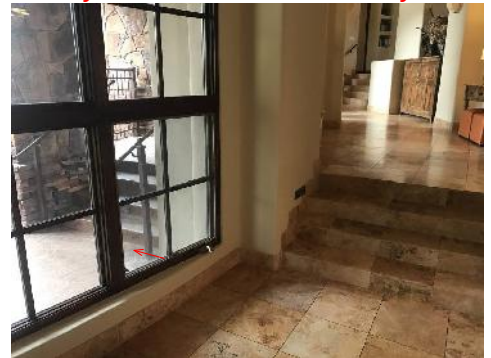
**29. Windows Issue** The caulking is deteriorated on the exterior windows in multiple places. The window lock does not function on the north east secondary bedroom and entry hallway.

| 8. | <input type="checkbox"/> <input type="checkbox"/> <input checked="" type="checkbox"/> <input type="checkbox"/> <input type="checkbox"/> <input type="checkbox"/> | <u>Windows</u> <span style="color: green;">Issue</span> The caulking is deteriorated on the exterior windows in multiple places. The window lock does not function on the north east secondary bedroom and entry hallway. |

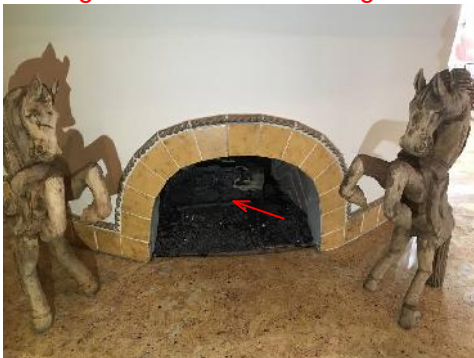
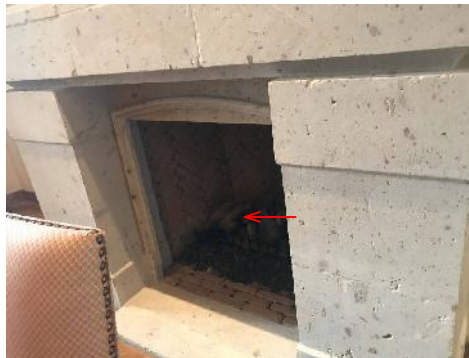
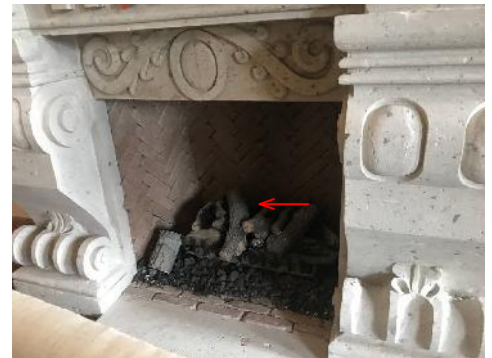
34. Glass Door/Screen Issue There is no screen/glass door on the fireplace in the kitchen dining room and living room.

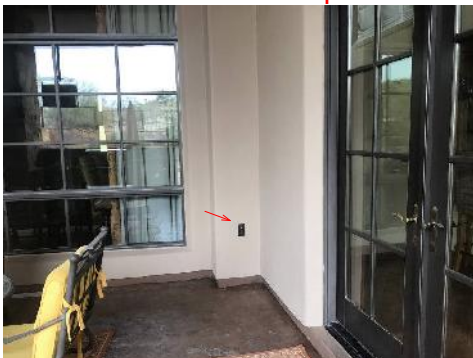
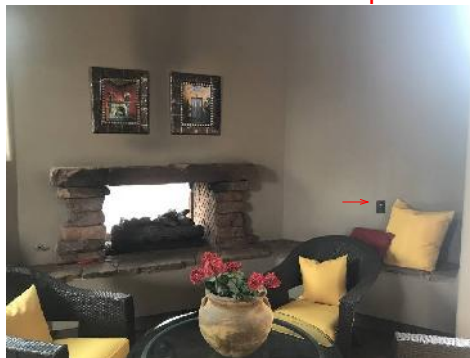
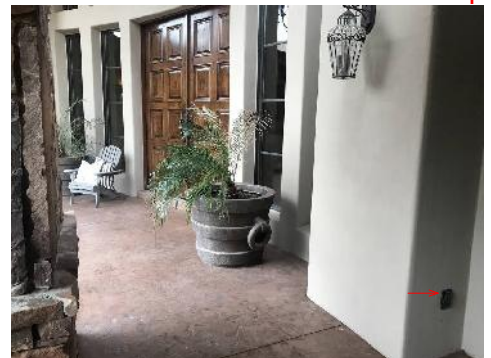
- 40. GFCI's Issue** The GFCI outlet tested no power and will not reset at the rear patio. The GFCI does not respond to the test button at the outdoor entertainment area. The GFCI outlet does not respond to the test button or inspectors test button at the front patio.

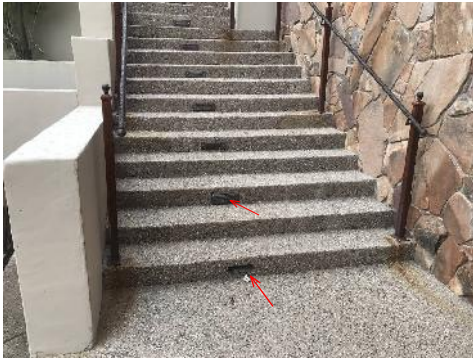
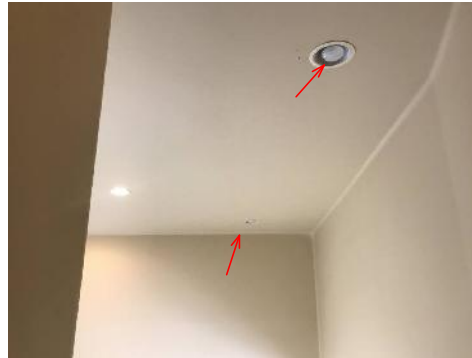
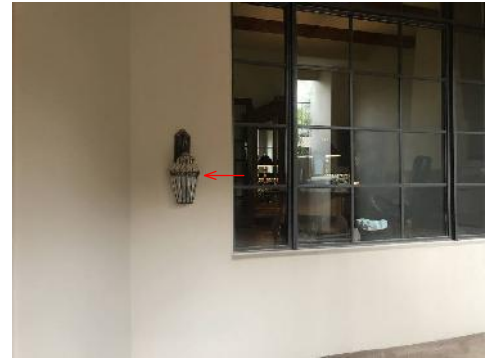
- 41. Lights Issue** The lights are missing/damaged in the exterior stairs in multiple places. Light/Lights did not respond to a switch in multiple places on the interior and exterior.

12. New sink fixture installed in outside kitchen
13. Bedroom fuse replaced.
14. Replaced bulbs in house and outdoor fixtures.
15. Blower and "lo" notice on spa to be addressed and fixed on Monday Feb. 25.

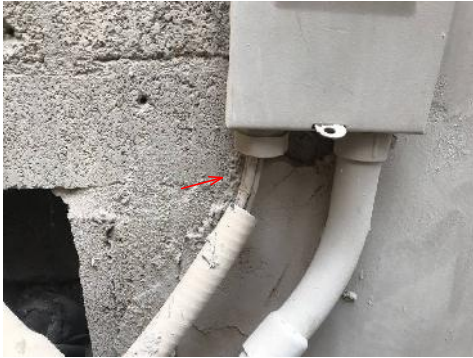
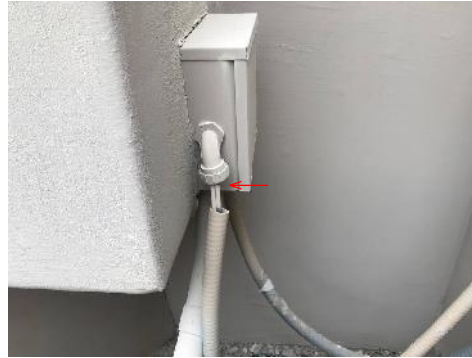
- 42. Conduit Issue** The conduit is not properly connected exposing the wiring at the electrical disconnect for the heat pump on the east and west side of the house.

10. ☐ ☐ ☐ ☒ ☐ ☐ Conduit Issue The conduit is not properly connected exposing the wiring at the electrical disconnect for the heat pump on the east and west side of the house.
11. ☐ ☐ ☐ ☒ ☐ ☐ Junction Boxes Issue There is a junction box missing the cover exposing the wiring below the sink at the outdoor kitchen.

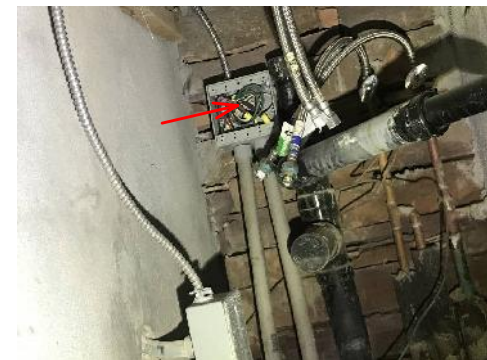
- 43. Junction Boxes Issue** There is a junction box missing the cover exposing the wiring below the sink at the outdoor kitchen.

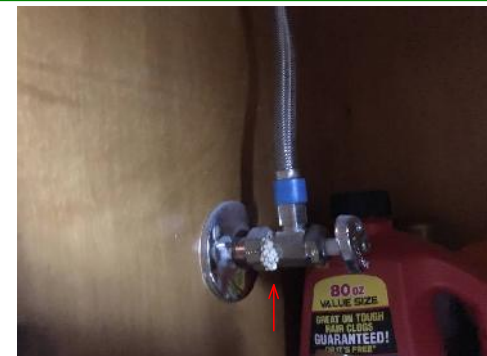
- 44. Supply Line Shut Off Valves .. Issue** There is corrosion on the shut off valves in multiple places throughout the house.

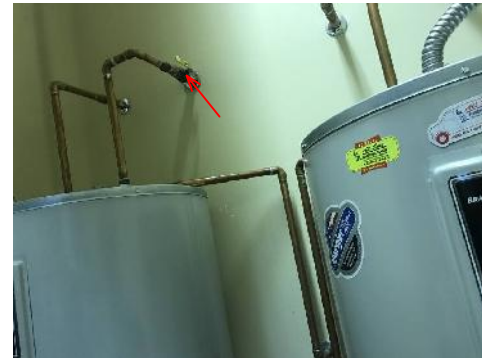
45. Water shut-off valve **Issue** There is corrosion on the shut off valve of the left water heater.

1. Water heater location .. Garage Type .. Electric Gallons .. 50, unable to determine, unable to determine
2. ☐ ☒ ☐ ☐ ☐ ☐ Water shut-off valve Issue There is corrosion on the shut off valve of the left water heater.
3. ☒ ☐ ☐ ☐ ☐ ☐ TPR Valve/Plumbing Visibly Acceptable
4. ☒ ☐ ☐ ☐ ☐ ☐ Tank Visibly Acceptable
5. ☐ ☐ ☐ ☐ ☐ ☒ Catch Pan/Plumbing
6. ☒ ☐ ☐ ☐ ☐ ☐ Produced Hot Water Yes

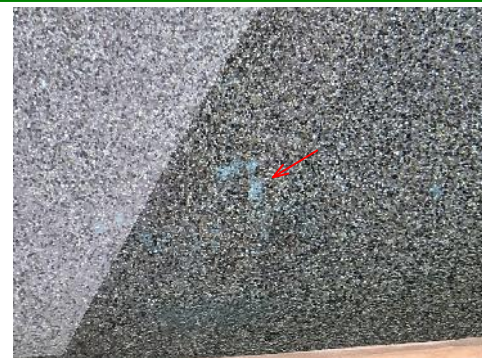
48. Pool/Spa Finish Materials **Pebble Surface** The pebble surface is stained.

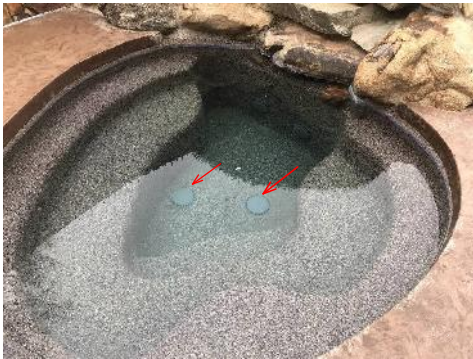
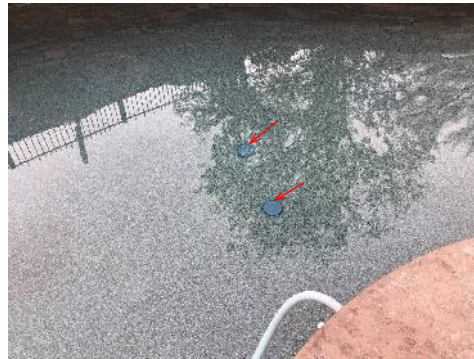
50. Bottom Drain Resistant Strainers Issue I am unable to determine if the main drain covers are child resistant.

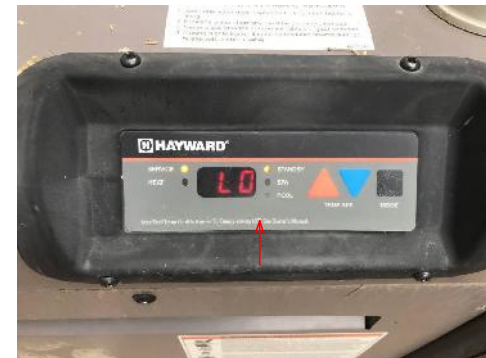
51. Heater Condition Issue Heater functions but there is a service lamp illuminated and an error message L0.

18. ☒ ☐ ☐ ☐ ☐ ☐ Pump/Pumps Operated When Tested
19. ☒ ☐ ☐ ☐ ☐ ☐ Body Bond Visually Acceptable
20. ☒ ☐ ☐ ☐ ☐ ☐ Cleaning System Suction Head
21. ☐ ☐ ☒ ☐ ☐ ☐ Heater Condition Issue Heater functions but there is a service lamp illuminated and an error message L0.

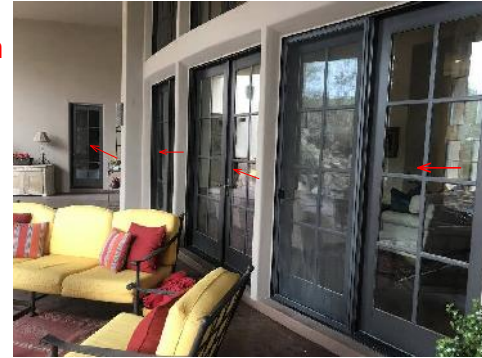
54. Doors with Pool Access **Issue** The doors across the back of the house have pool access and are not self-closing/latching with a latch 54" above the floor..

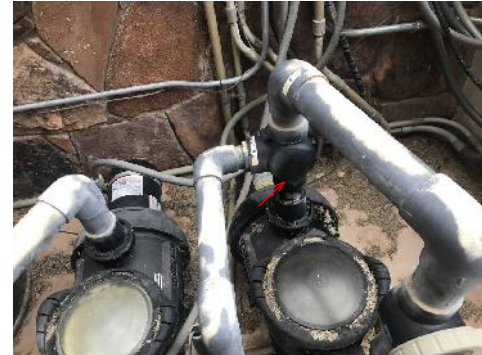
55. Water Feature .. **Issue** The water feature pump plumbing leaks.

29. ☐ ☒ ☐ ☐ ☐ ☐ Water Feature .. Issue The water feature pump plumbing leaks.
