Perfection Home Inspections
1042 E. Fairbrook Circle
Mesa, AZ 85203
602-524-2916
perfectionhomeinspections.com

Client Information: Record Number 7299

Estate, Betty R Wray
4464 E. Cortez Street
Phoenix, AZ 85028

Inspected 6/30/17 8:00 AM
Built 1987
2745 sf

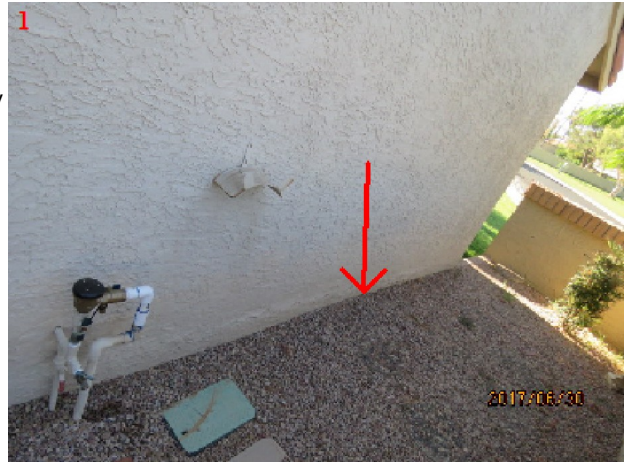
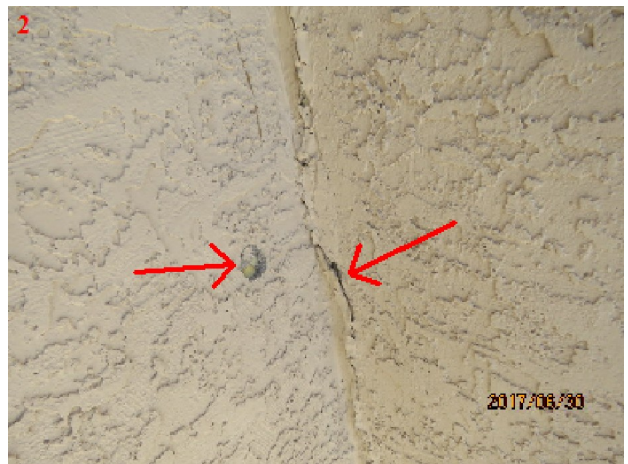
Running stucco to the ground is a common practice for masonry homes in this area.

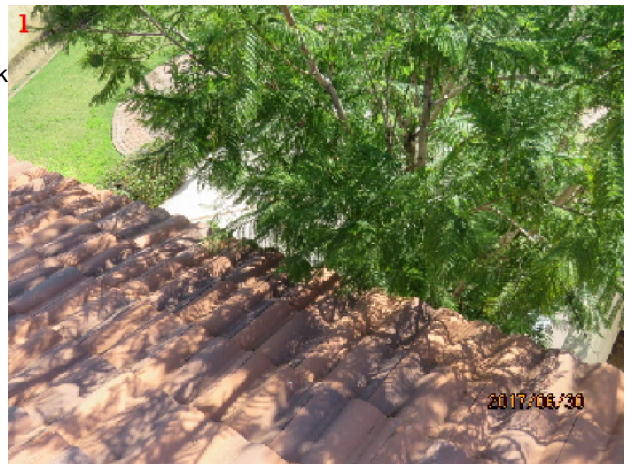
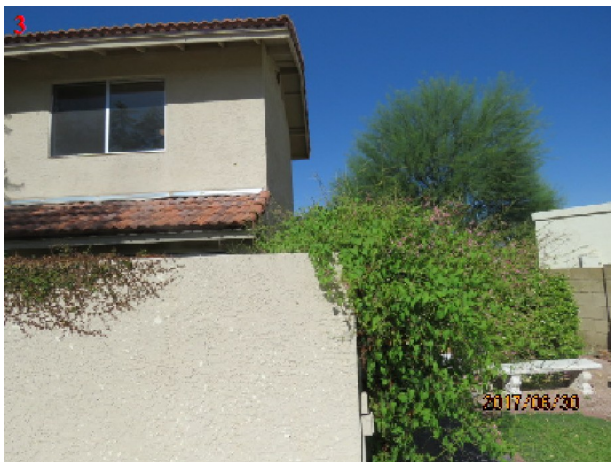
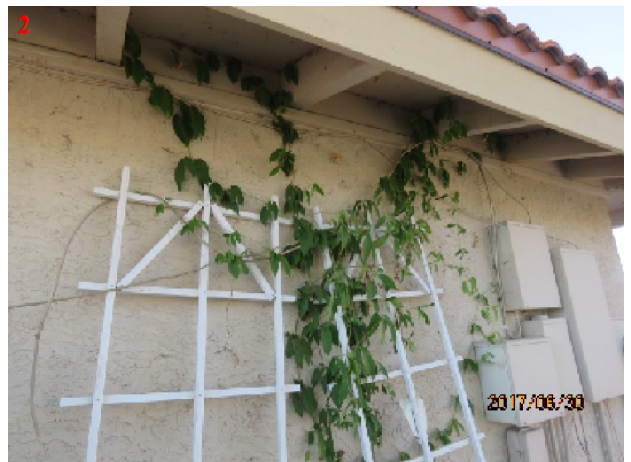
Vines and or other plants on the house are not recommend. Plants and vines hold moisture against the siding and can damage the siding and soffit area. Recommend keeping all vines and plants off the exterior of the house.

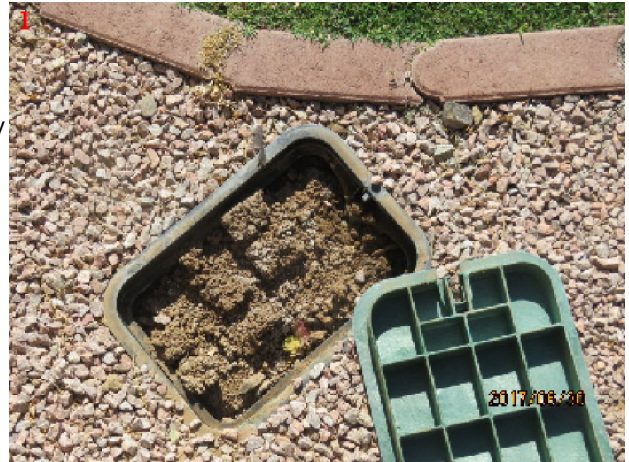
Service/Repair Sprinkler System - Vacuum Breaker

Sprinkler systems are not fully inspected as part of this home inspection. The sprinkler valves in the valve boxes are inspected by turning them on manually and looking for major leaks only. Sometime other items are noted because the system turns on automatically and defects are noticed at that time.

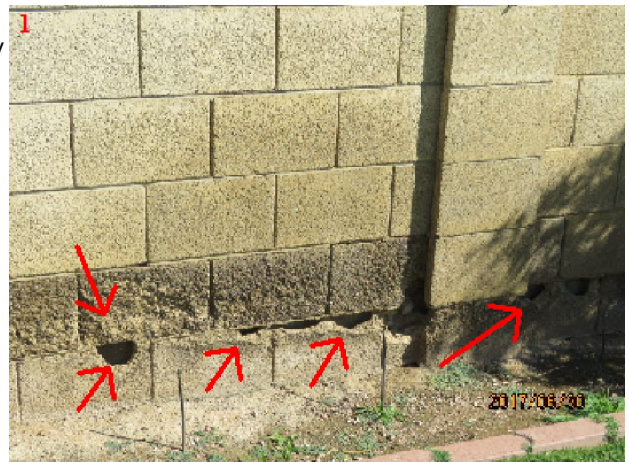
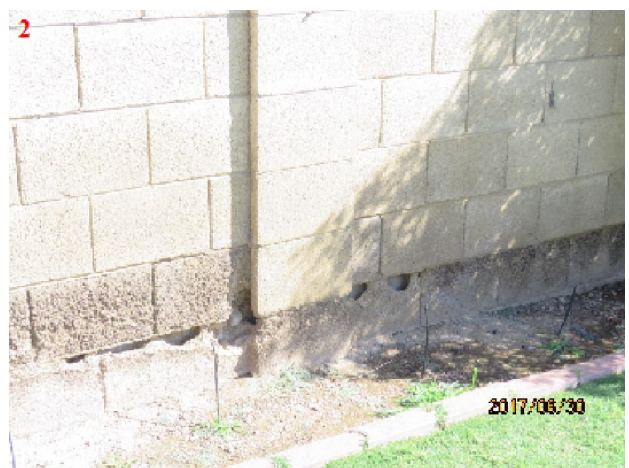
Service/Repair Yard Fences - Masonry, Metal

Damage to the block fencing. See sample picture
Recommend a qualified contractor evaluate and make all necessary repairs.

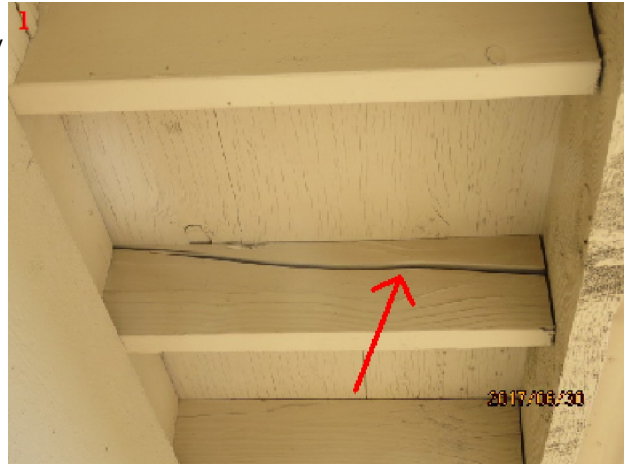
The balcony has a cracked floor joint in the soffit area of the patio. Recommend a qualified contractor evaluate and make all necessary repairs.

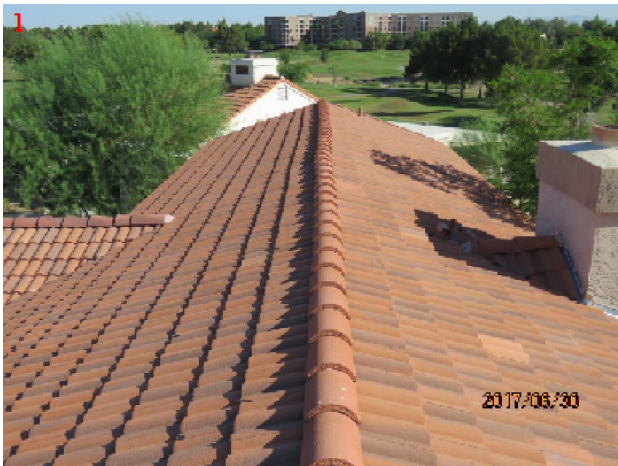
See sample picture of the roof.

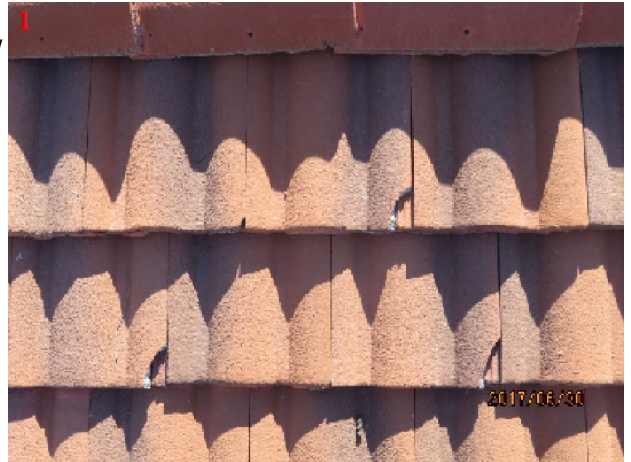
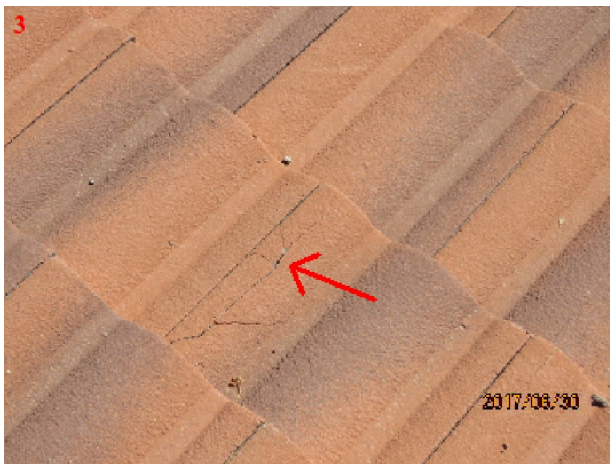
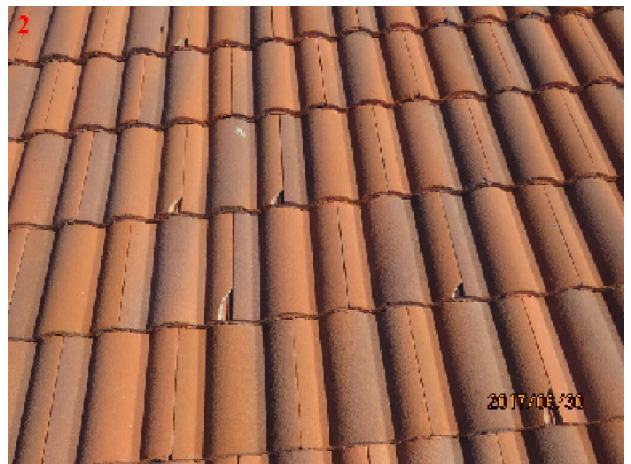
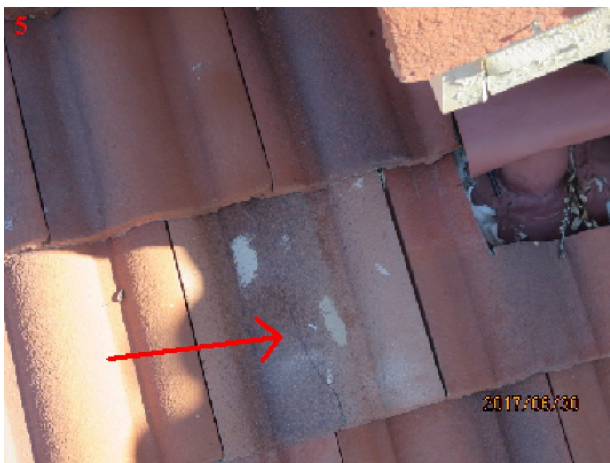
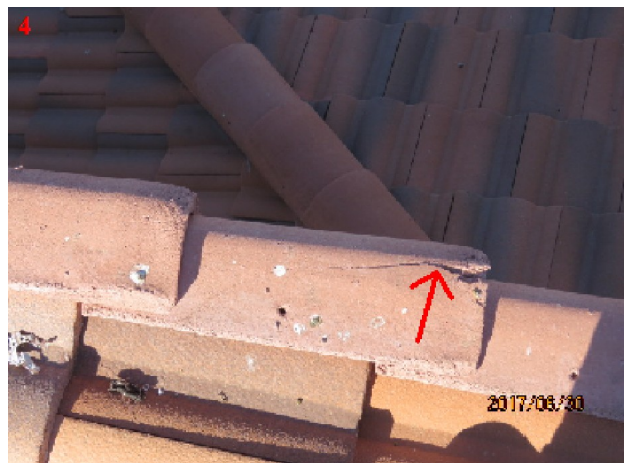
On the back see row 6 in 9' from the north end a cracked roof tile, on the south side see row 13 in 1' from the house cracked roof tile. On the front rake edge row 16 cracked rake tile.

Recommend a qualified roofing contractor evaluate the entire roof system and make all necessary repairs. See sample picture

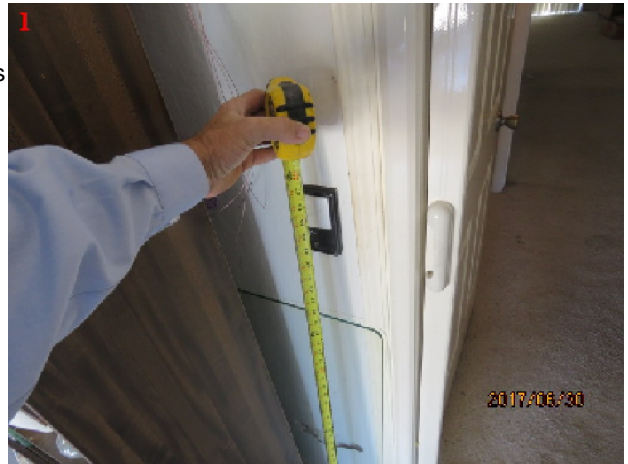
The automatic garage door opener switch is too close to the garage floor. They keep children from using the garage door opener it is recommend the operator switch be installed a minimum of 54 inches above the floor.

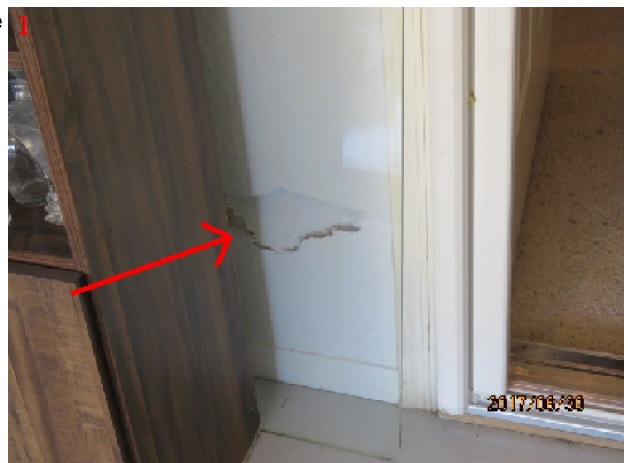
Hole or holes in the drywall on the wall or ceiling between the house and the garage. This drywall is a fire stop and a carbon monoxide stop between the house and the garage. Recommend patching all holes in the wall between the garage and the house. See picture

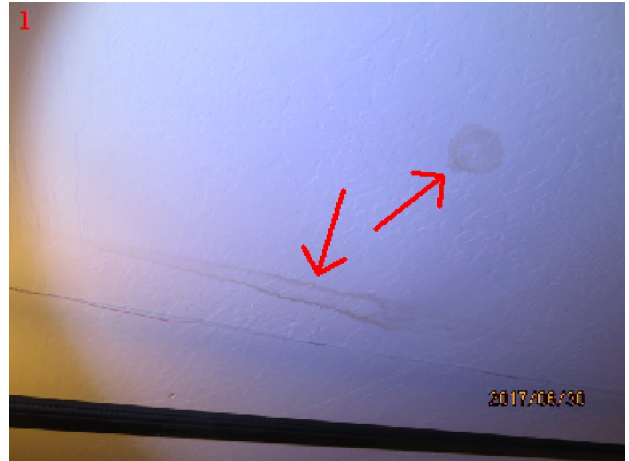
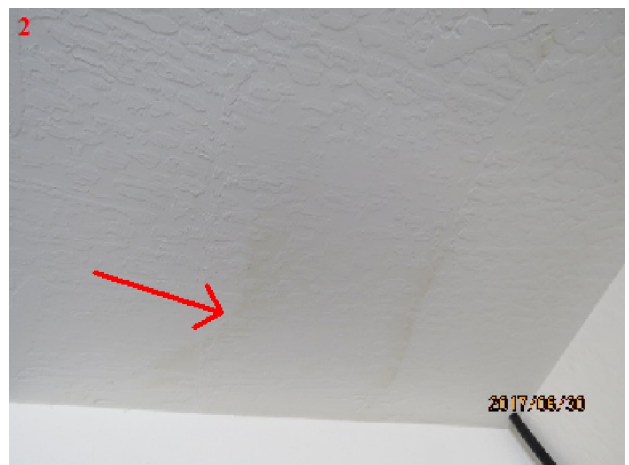
Water stains on the garage ceiling in more than one location. See pictures. Recommend a qualified contractor evaluate and make all necessary repairs.

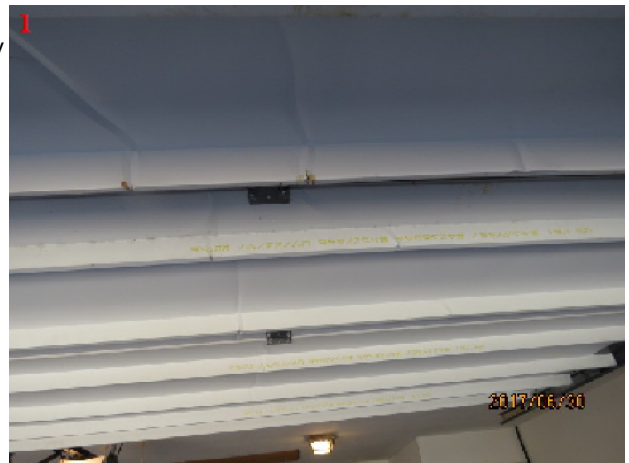
Garage Doors - Overhead

Bent door panels on the overhead garage door. Recommend a qualified contractor evaluate and make all necessary repairs.

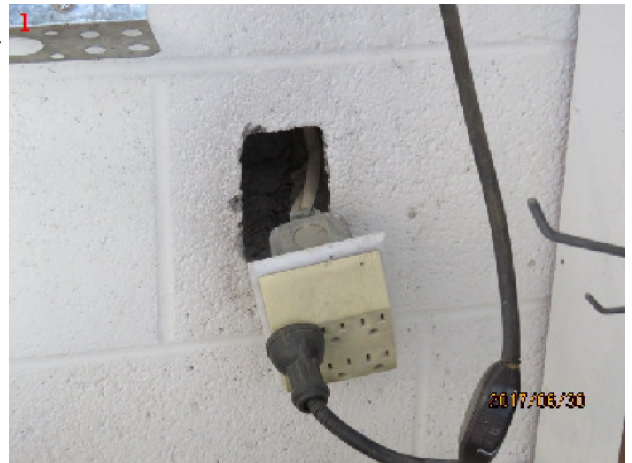
Outlet in the garage is not properly attached to the wall.
This is a shock hazard. Recommend a qualified electrical contractor
evaluate and make all needed repairs.

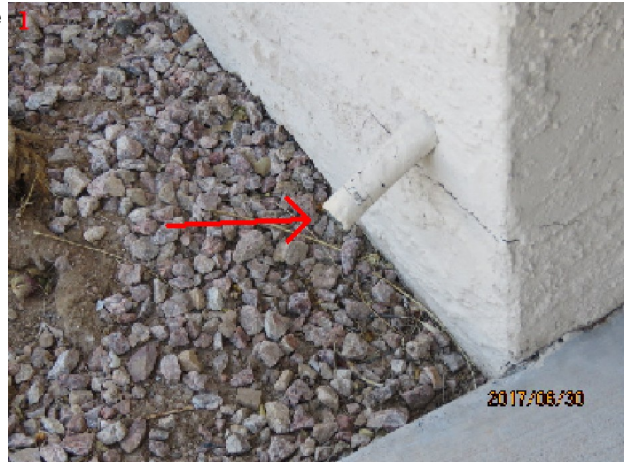
Recommend the water heater temperature and pressure relief valve have a pipe extended from the valve to within 12 inches to the ground and point straight down. The current arrangement is a safety issue. Scalding steam can unexpectedly blow out the end of this pipe and the chances of someone getting burned increases the further the pipe gets above the ground.

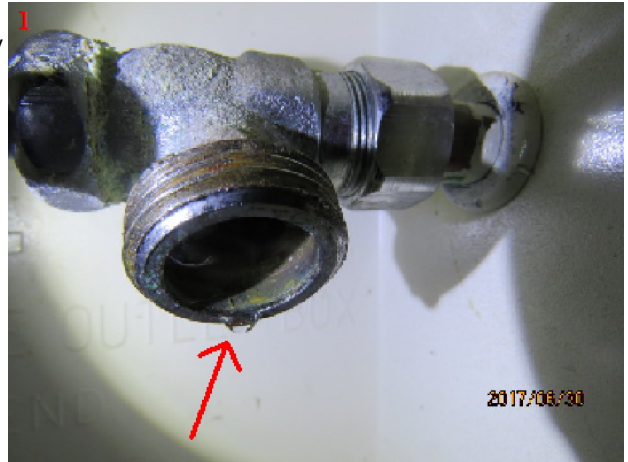
The cold water supply valve in the laundry room is leaking.
Recommend a qualified contractor evaluate and make all necessary repairs.

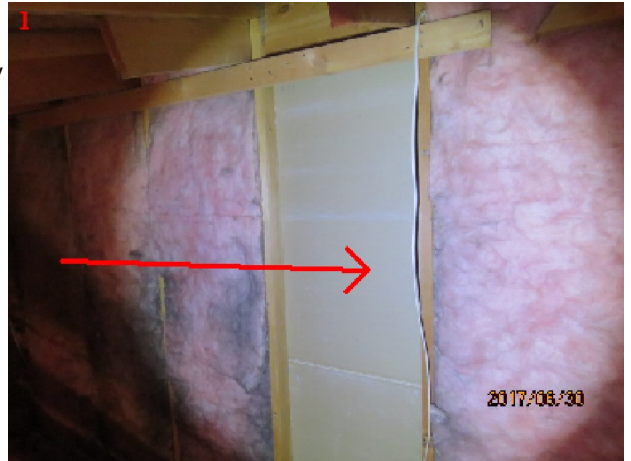
Some insulation in the attic is missing from the wall to livable space. Recommend all walls to living space be insulated from the exterior. Recommend a qualified contractor evaluate and make all necessary repairs.

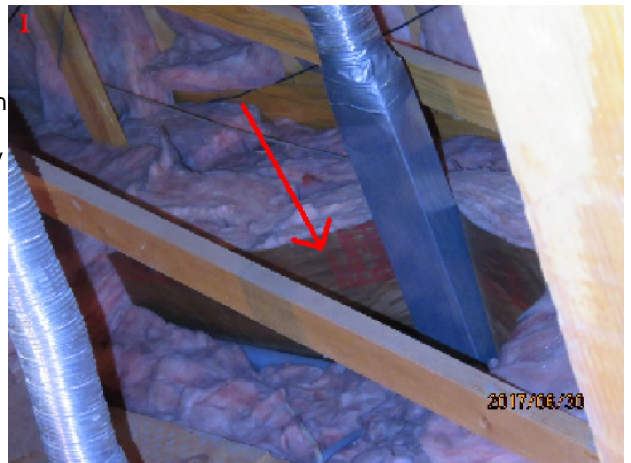
Vapor retarder - Exposed

The Kraft attic insulation vapor barrier on the back of batt insulation is left exposed in the attic. Exposed vapor paper barrier is a fire hazard. Recommend following manufacturers recommendations stamped on the insulation to help avoid a fire hazard. Recommend a qualified contractor evaluate and make all necessary repairs. See picture

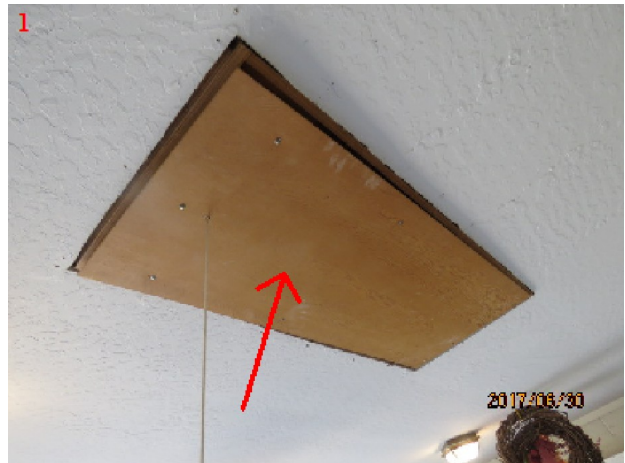
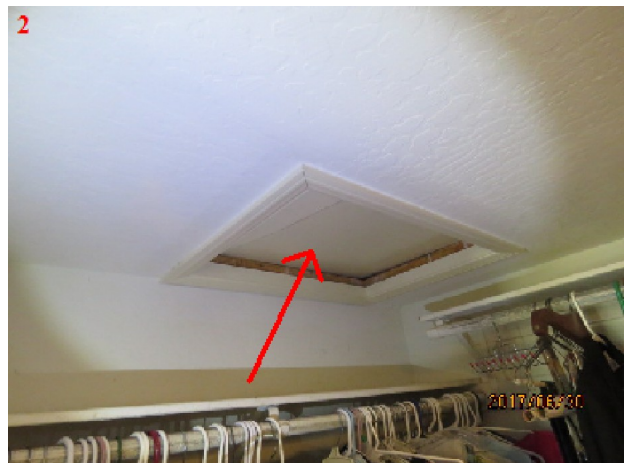
Attic hatch in garage is not properly fire rated. Recommend installing fire resistant hatch as needed. Recommend a 5/8 inch thick type x drywall be used as an attic hatch cover. Some area no longer require this to be fire rated if there is no habitable space above the garage.

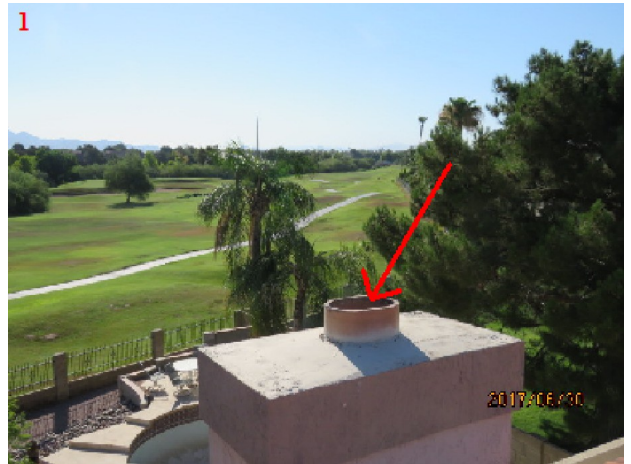
No screen to cap fireplace which could allow hot sparks to fly out of chimney and may allow pests to enter the chimney. Recommend installing screen on top of chimney.

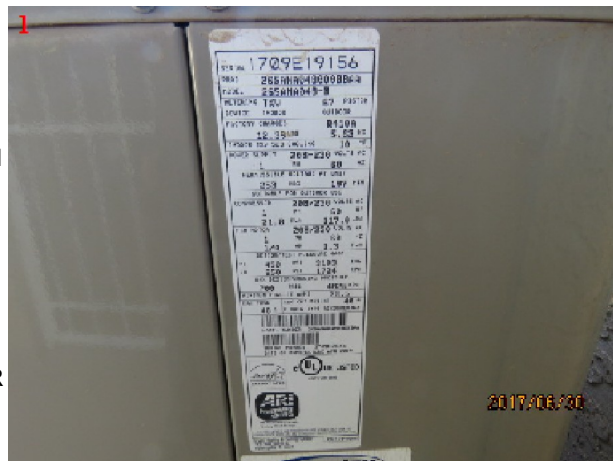
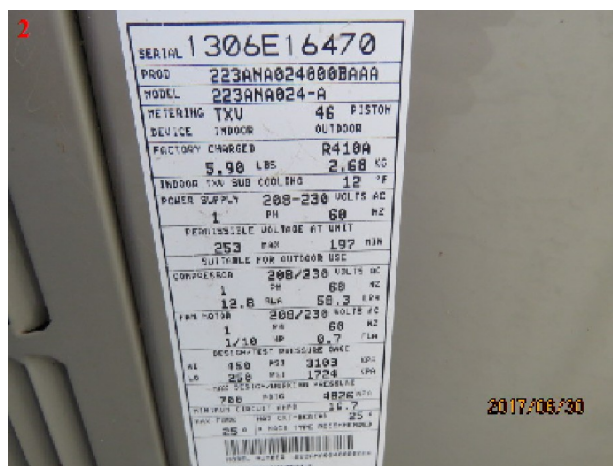
AC units have an average life of 12 to 15 years in the Phoenix area. One was manufactured in 2009 and the other in 2006.

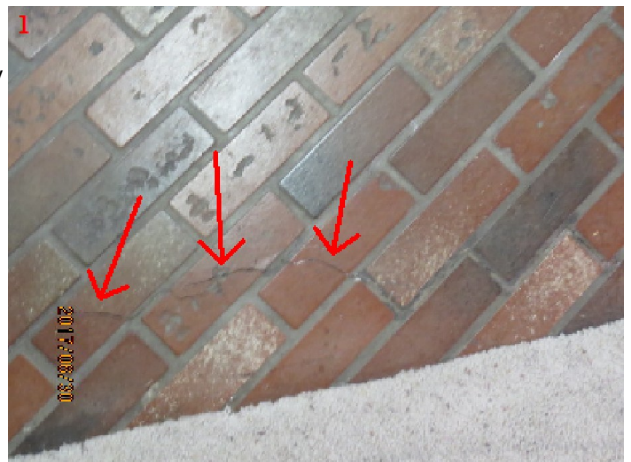
There is a crack in the kitchen floor running through multiple floor bricks.
Recommend a qualified contractor evaluate and make all necessary repairs.

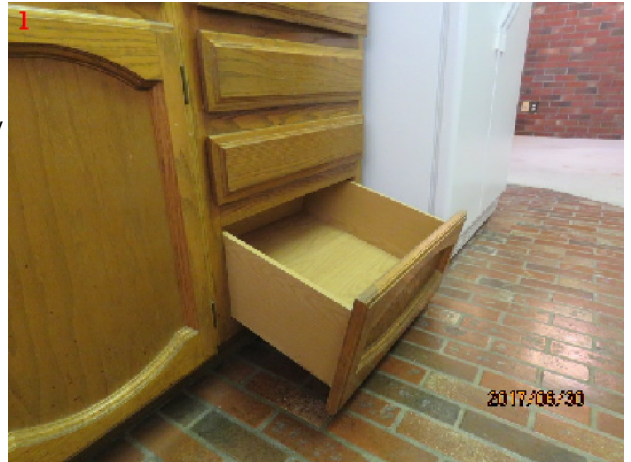
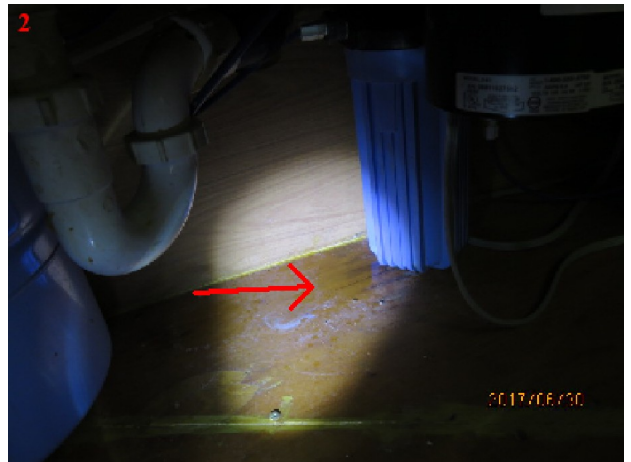
Some drawers in the kitchen cabinets have missing or defective guide hardware. Recommend repair.
Water leaking onto the base of the kitchen sink when the faucet is on.
Recommend a qualified contractor evaluate and make all necessary repairs.

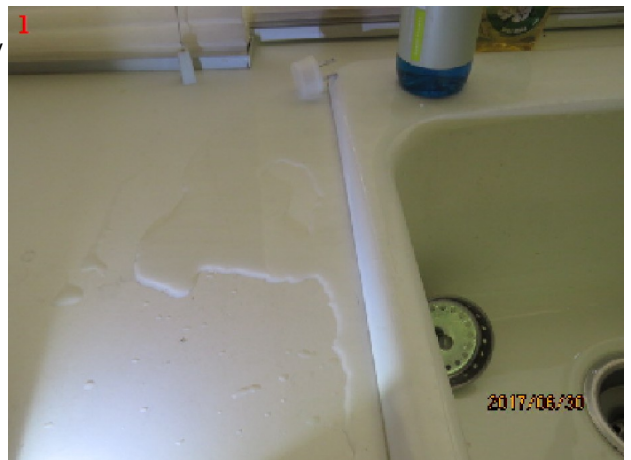
Water leaking form the kitchen sink faucet to the counter top.
Recommend a qualified contractor evaluate and make all necessary repairs.

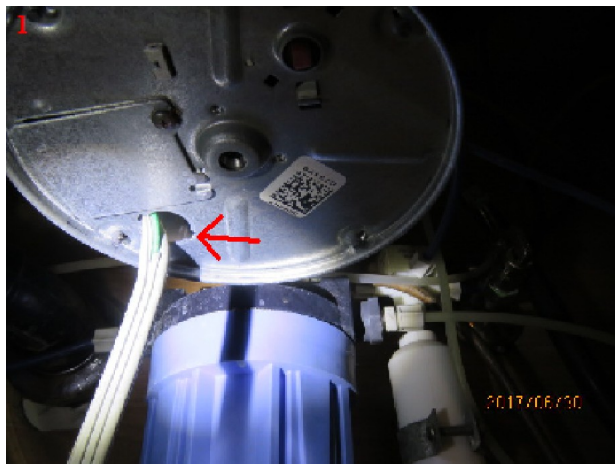
Electrical cable not properly attached to disposal. Recommend properly attaching cord to disposal. Possible shock hazard. See picture

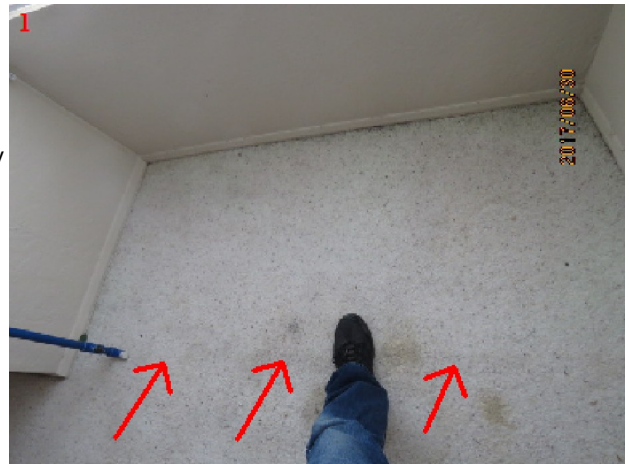
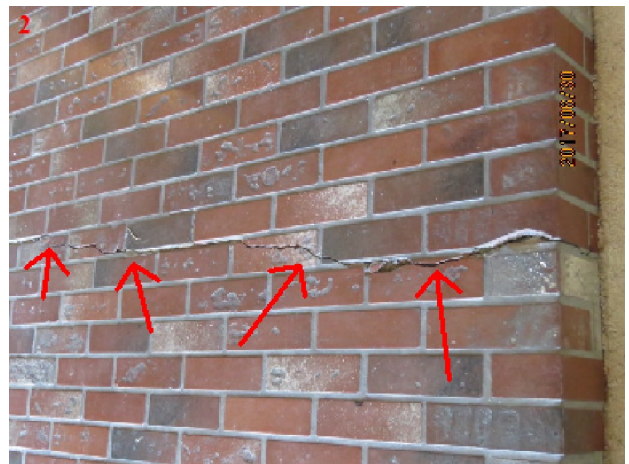
The slab inspection is visual only and carpets are not lifted to inspect slabs. Slabs may have cracks and other problem not detectable by a visual home inspection.
Crack in the entryway slab brick and slab below. There is a lump in the living room floor at the bay window area.
Recommend a qualified contractor evaluate and make all necessary repairs.
The upper floor structure is not visible but no signs of defects were found at the time of the home inspection.

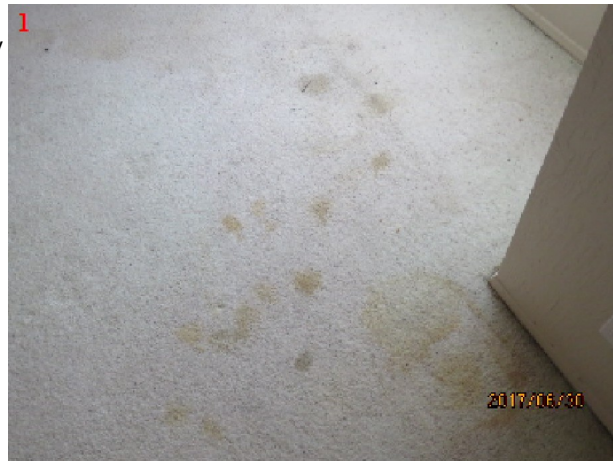
The carpet is stained throughout the home.
Recommend a qualified contractor evaluate and make all necessary repairs.

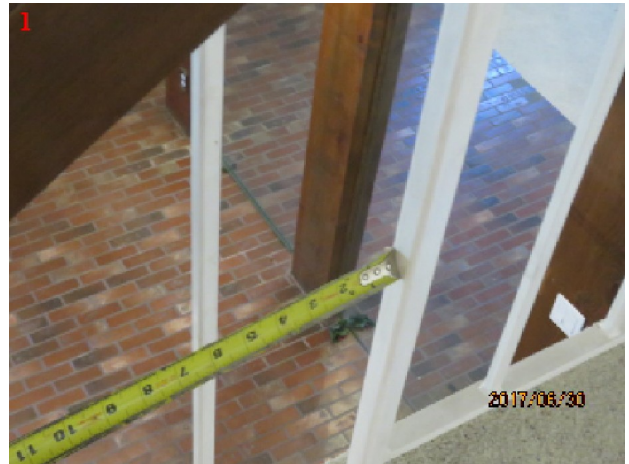
Railing spacing of more than 4" is considered unsafe for small children. This may have been acceptable when it was built.

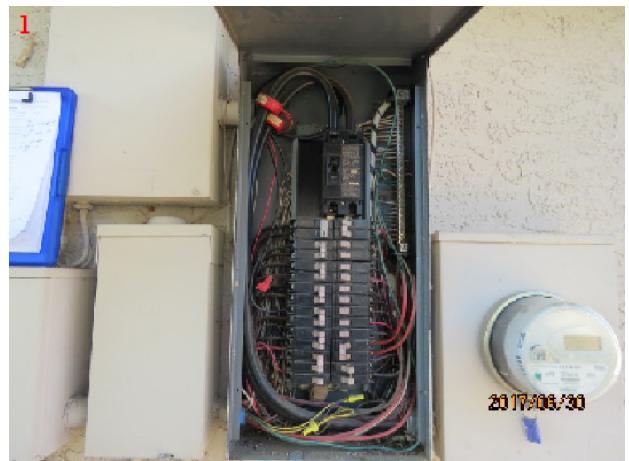
Sample picture of the main electric panel.

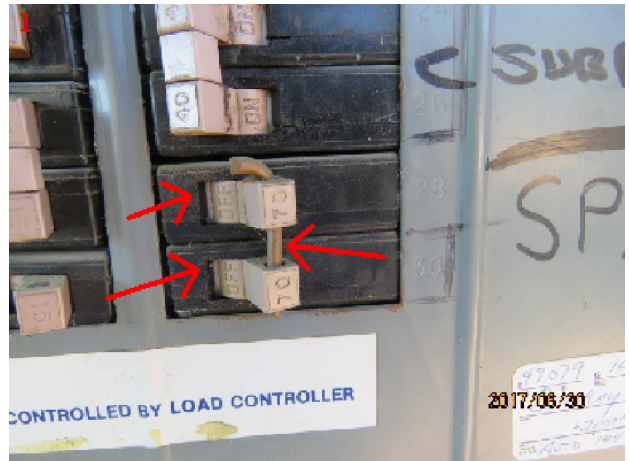
A double breaker in the main electric panel is tied with a wire. Recommend replacing this breaker.

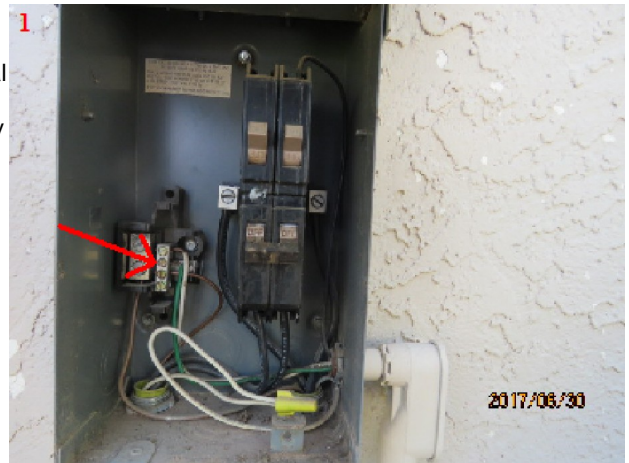
The sub electric panel at the spa equipment area has the neutral and ground wires on the same terminal. This is not allowed for sub electric panels and the panel is not bonded however there is a metal conduit to the panel which may bond the panel. Recommend a qualified contractor evaluate and make all necessary repairs.

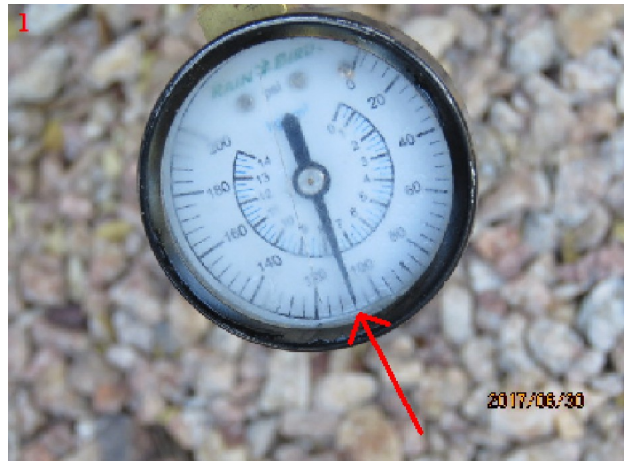
A water pressure regulator is recommended for homes with water pressure in excess of 80 psi. if the water supply company does not lower it below 80 psi.

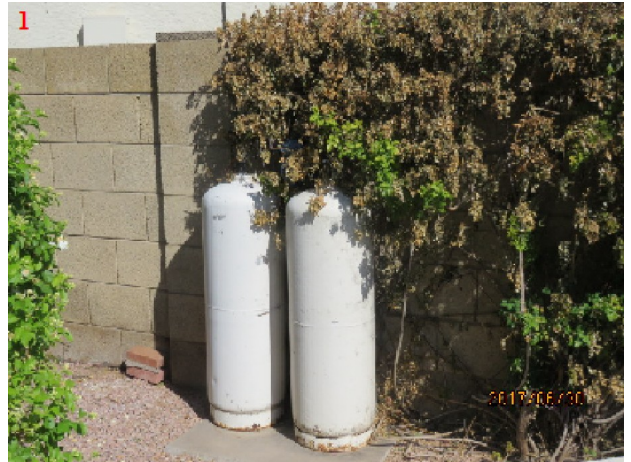
The propane tanks for the pool /spa heater are not strapped.
Recommend properly strapping both gas tanks to help keep them from falling over.

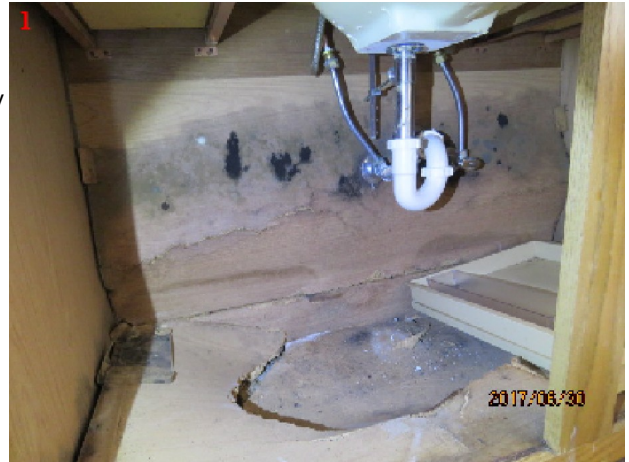
The bottom of the right side sink cabinet has caved in from water damage and there walls are damaged with a black substance that looks like mold. Recommend a qualified contractor evaluate and make all necessary repairs.

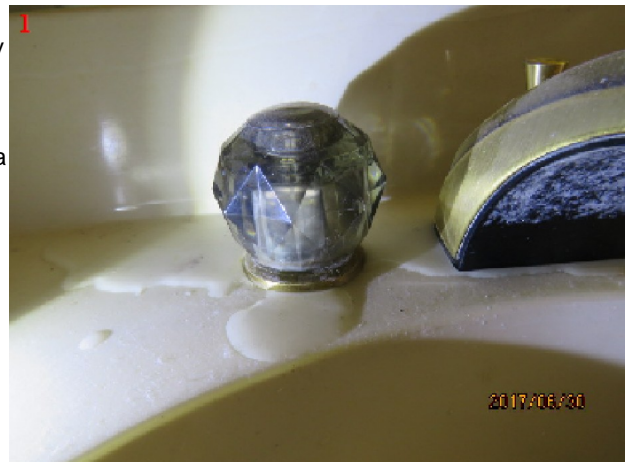
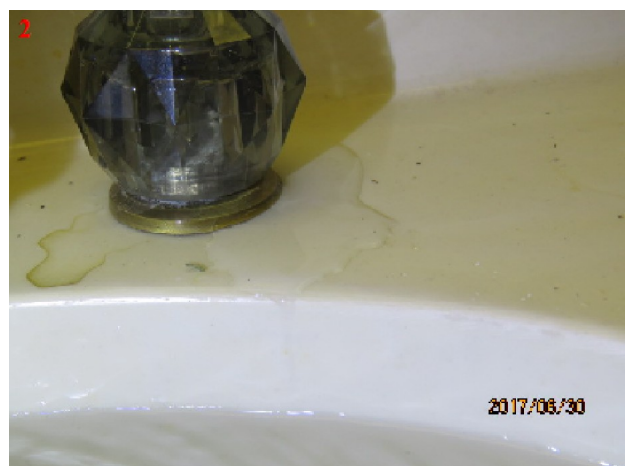
The master bath sink angle stops or water supply valves under the sink cabinet are stuck or they are difficult to operate. Recommend a qualified contractor evaluate and make all necessary repairs.

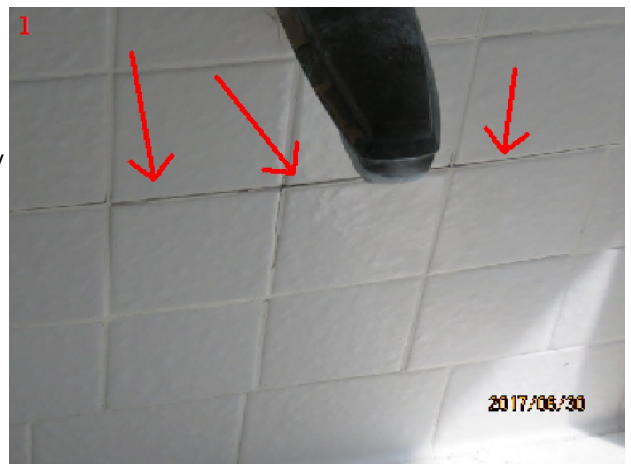
Tiles are bulging away from the wall with gaps in the grout. Periodic re-caulking and or grouting of ceramic wall and floor tile in tub and shower area is an ongoing maintenance task which should not be neglected. The shower door does not latch. Recommend a qualified contractor evaluate and make all necessary repairs.

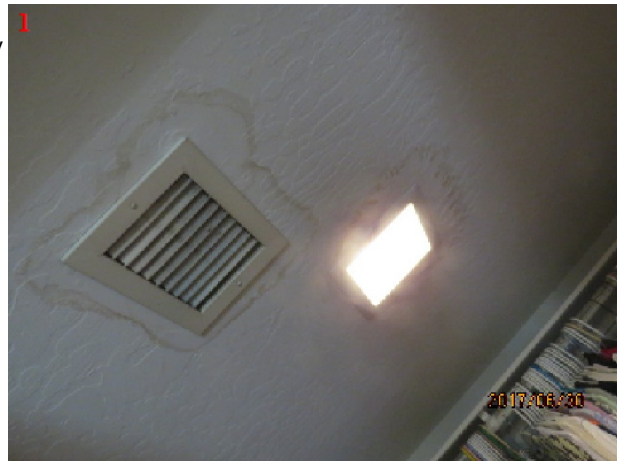
Water stains on the ceiling in the master bedroom closet.
Recommend a qualified contractor evaluate and make all necessary repairs.

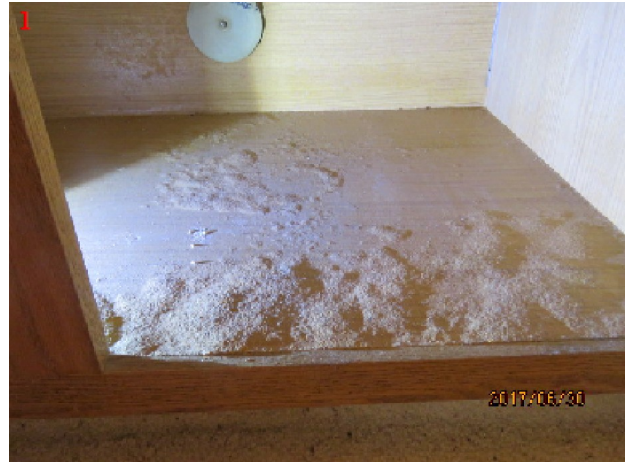
Some water stains found on the base of the sink cabinet in this bathroom. Recommend monitoring for leaks.

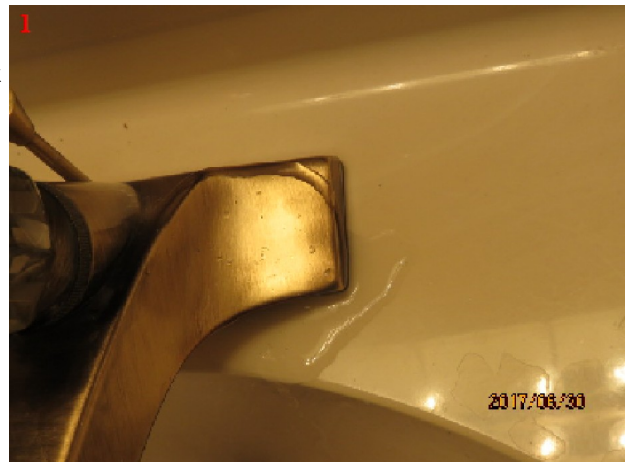
The hall bath sink angle stops or water supply valves under the sink cabinet are stuck or they are difficult to operate. Recommend a qualified contractor evaluate and make all necessary repairs.

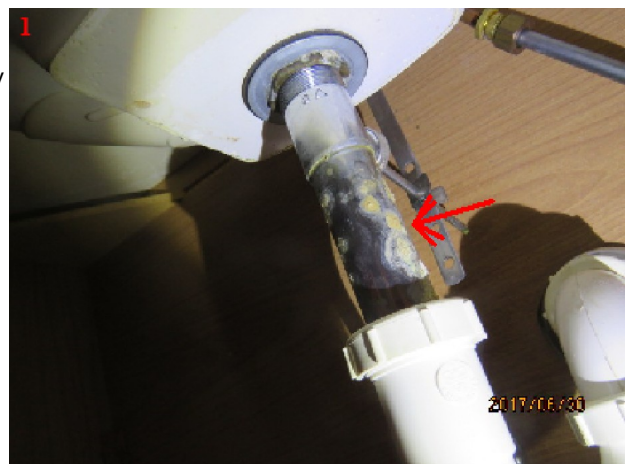
Service/Repair Drain, Trap, Waste and Vent Piping - Tested, Corrosion

Corrosion on the drain pipe for the sink drain in the hall bathroom. This is an indication of past leaking. Recommend a qualified contractor evaluate and make all necessary repairs.

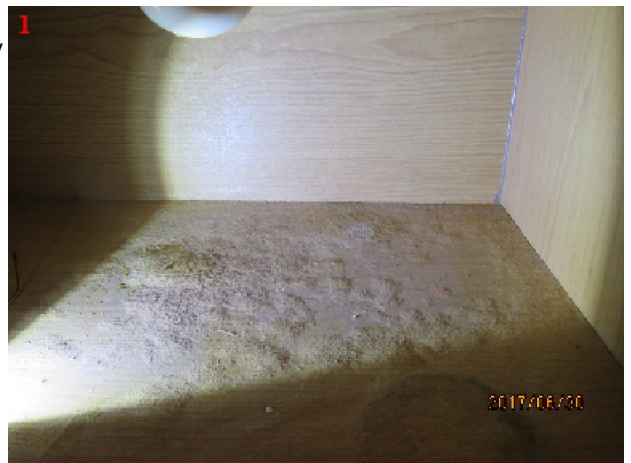
Water stains and water damage to the base of the sink cabinet.
Recommend a qualified contractor evaluate and make all necessary repairs.

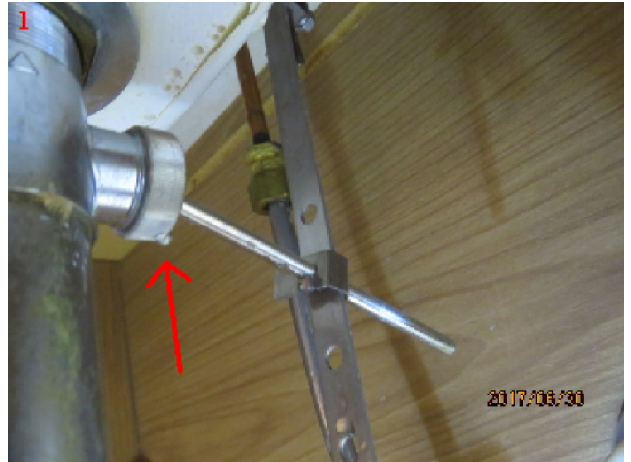
The sink drain is leaking from the stopper arm nut under the sink.
Recommend immediate repair.

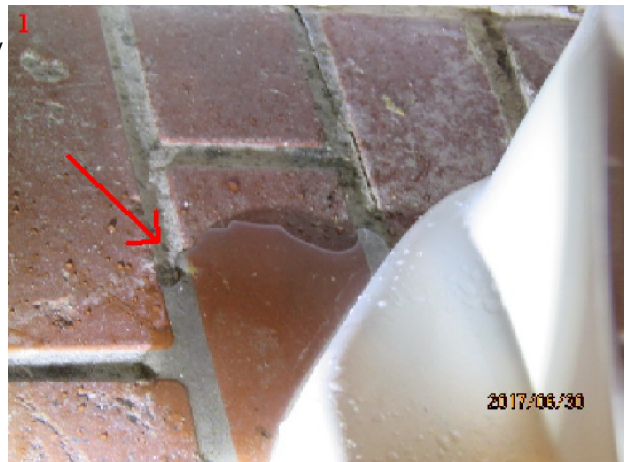
Toilet leaks between the tank and the bowl.
Recommend a qualified contractor evaluate and make all necessary repairs. See picture

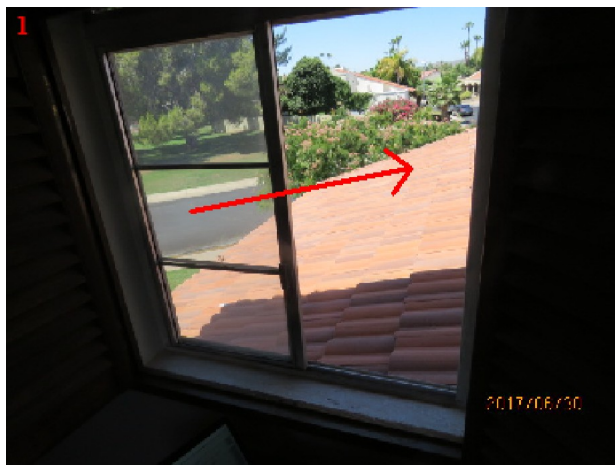
Screen missing. Recommend installing screen to help avoid having small children fall out of 2nd story window.

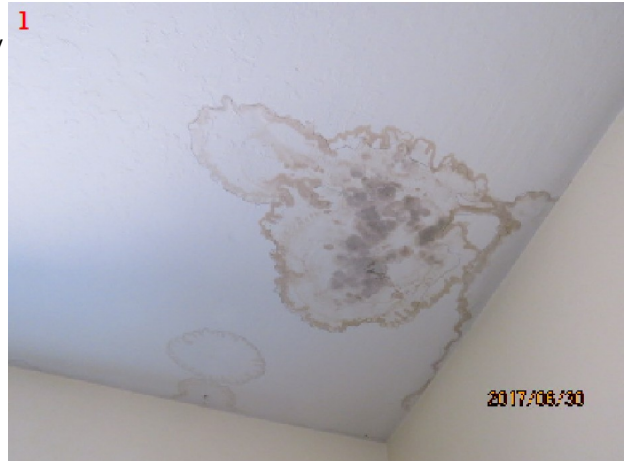
Water stains on the ceiling.
Recommend a qualified contractor evaluate and make all necessary repairs.

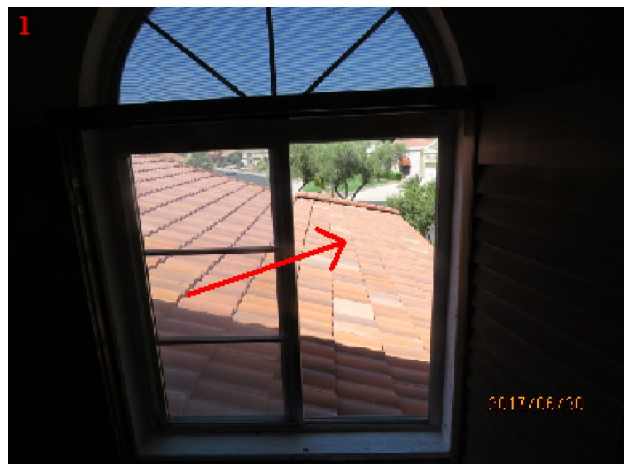
Screen missing. Recommend installing screen to help avoid having small children fall out of 2nd story window.

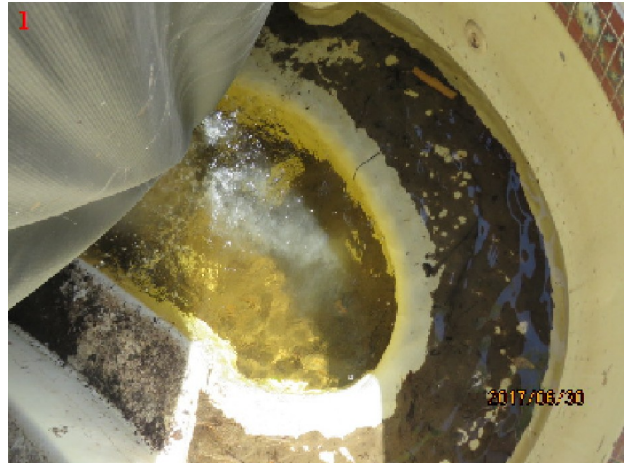
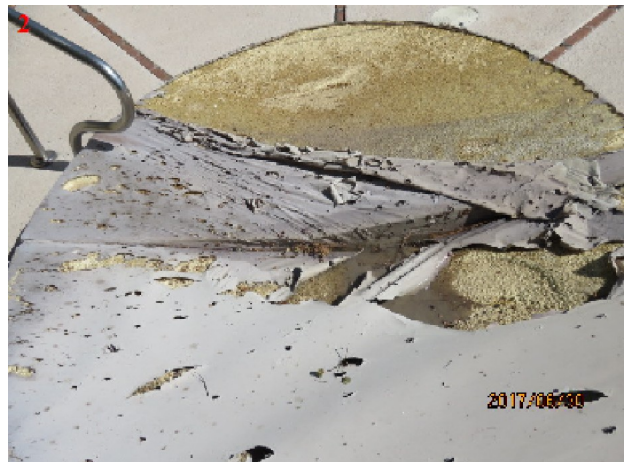
The pool is empty and the spa is mostly empty so none of the pool or spa equipment could be tested. See picture of the spa

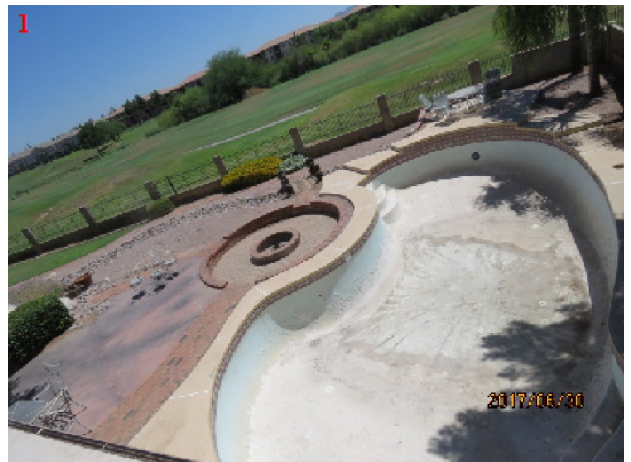
The swimming pool has no water. Recommend testing after the pool water level is at the proper level.

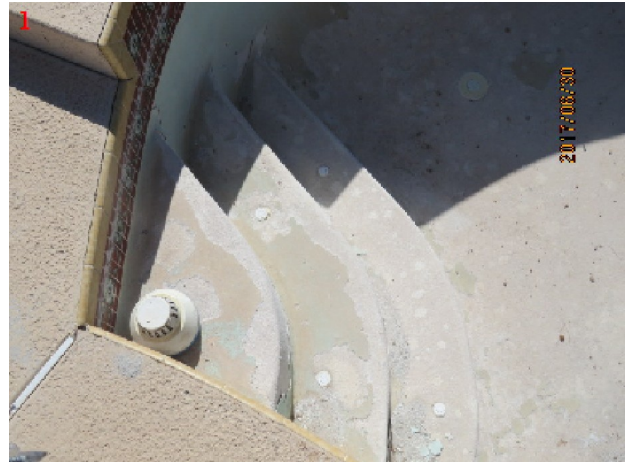
The pool plaster is no good.
Recommend a qualified swimming pool contractor evaluate and make all necessary repairs.

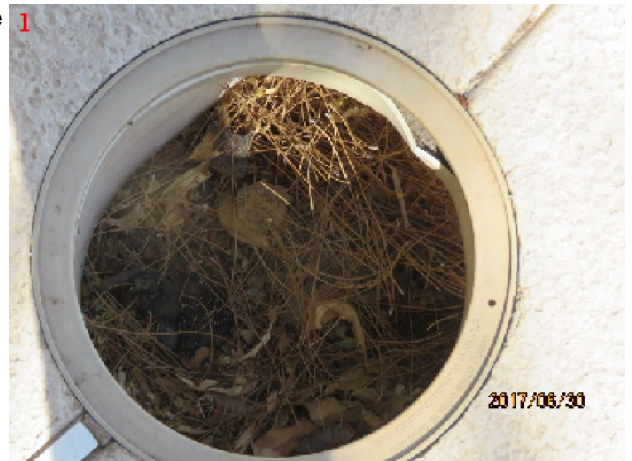
Recommend installing a skimmer basket and removing debris in the basket hole.

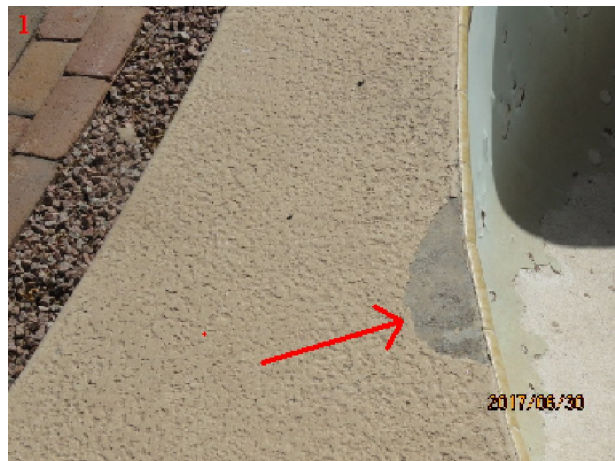
Some of the pool cool decking is peeling off the concrete. Recommend a qualified contractor evaluate and make all necessary repairs.

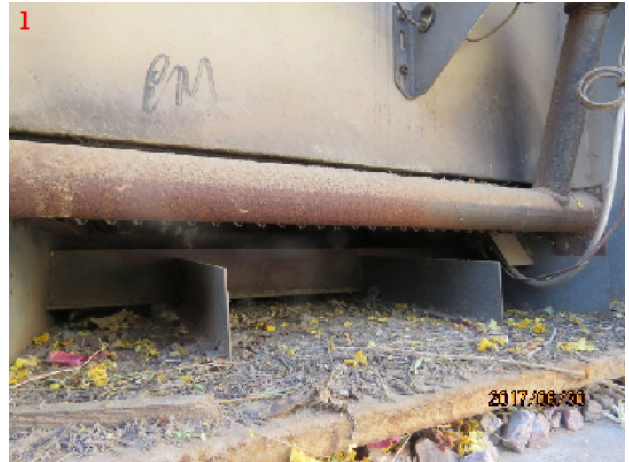
The propane spa heater is dirty and rusty. Recommend this heater be cleaned and serviced before use.

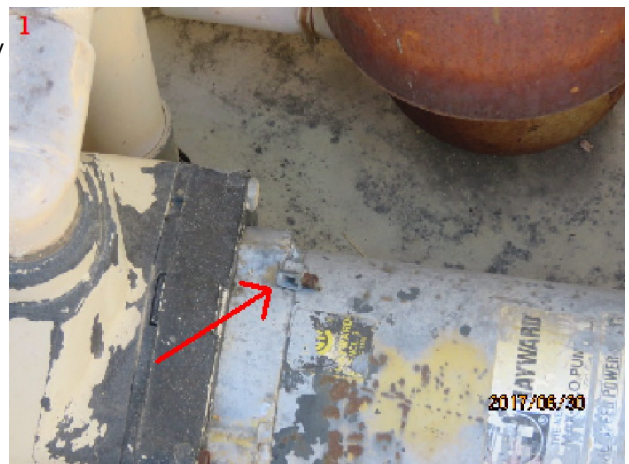
The spa pump is not properly bonded. This is a shock hazard. Recommend a qualified contractor evaluate and make all necessary repairs.

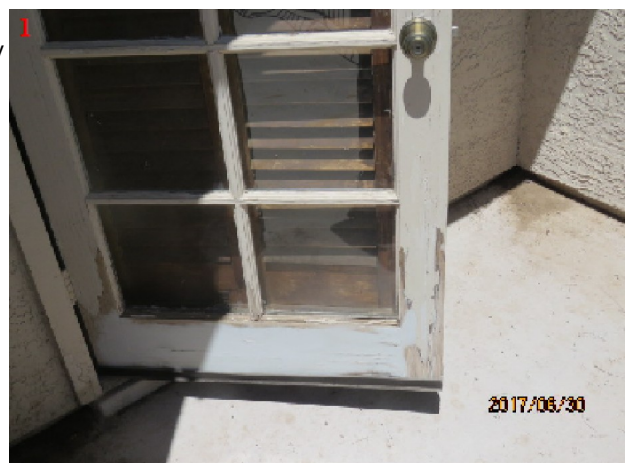
The door and door trim to the balcony are weathered. Recommend a qualified contractor evaluate and make all necessary repairs.

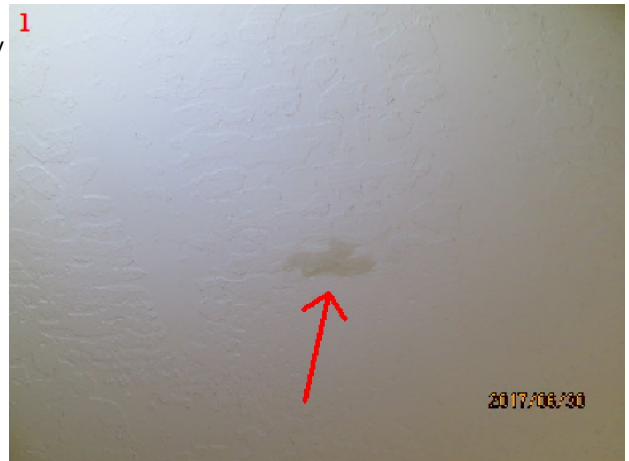
Water stain on the ceiling in this area.
Recommend a qualified contractor evaluate and make all necessary repairs.
