**Perfection Home Inspections**  
**1042 E. Fairbrook Circle**  
**Mesa, AZ 85203**  
**602-524-2916**  
**perfectionhomeinspections.com**

Client Information: Record Number 7556

**Manley, Deborah**  
**8707 E. San Felipe Drivw**  
**Scottsdale, AZ 85258**

Inspected 3/27/18 3:00 PM  
Built 1993  
2976 sf

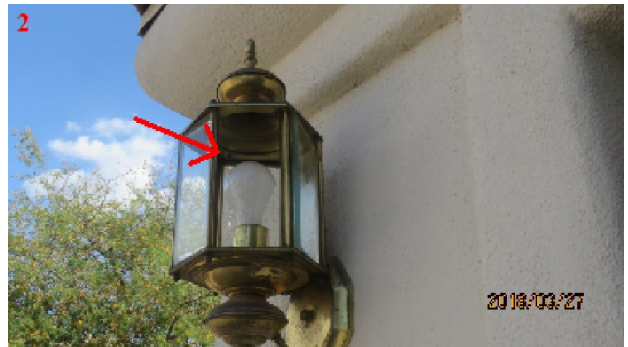
### **Service/Repair** Exterior Electrical Fixtures - Inspected

Glass pane missing in the garage light fixture on the front of the garage. Recommend installing missing pane.

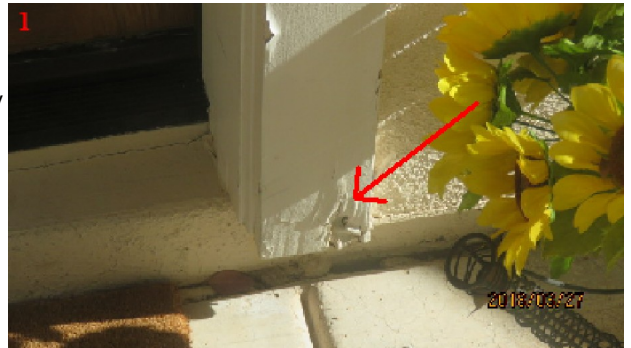
Exterior entrance door tested and found to be in proper working order.  
The front door jamb has wood rot.  
Recommend a qualified contractor evaluate and make all necessary repairs.

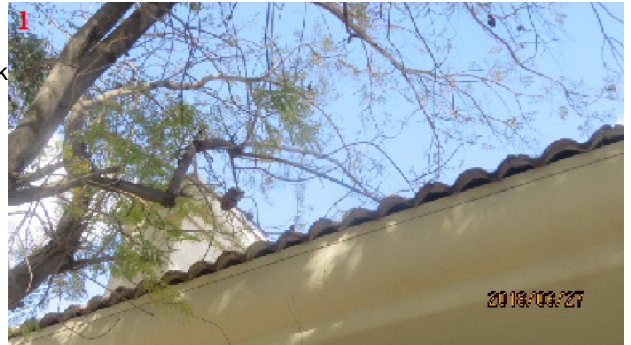
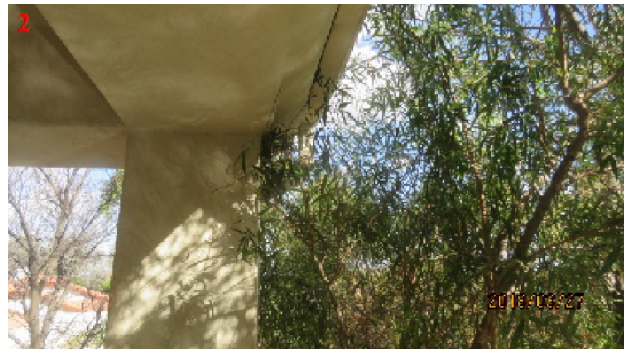
Vines and or other plants on the house are not recommend. Plants and vines hold moisture against the siding and can damage the siding and soffit area. Recommend keeping all vines and plants off the exterior of the house.

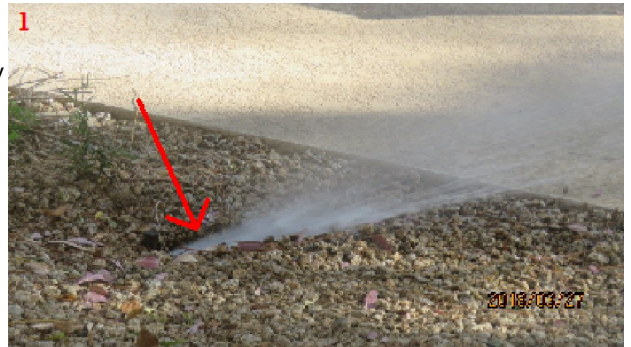
### **Service/Repair** Sprinkler System - Vacuum Breaker

Broken sprinkler head or pipe in the back. Recommend repair. Sprinkler systems are not fully inspected as part of this home inspection. The sprinkler valves in the valve boxes are inspected by turning them on manually and looking for major leaks only. Sometime other items are noted because the system turns on automatically and defects are noticed at that time.

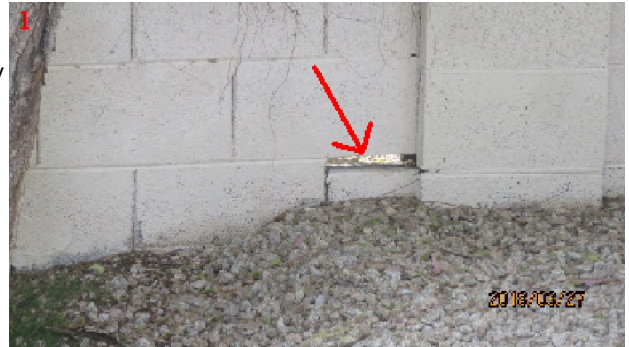
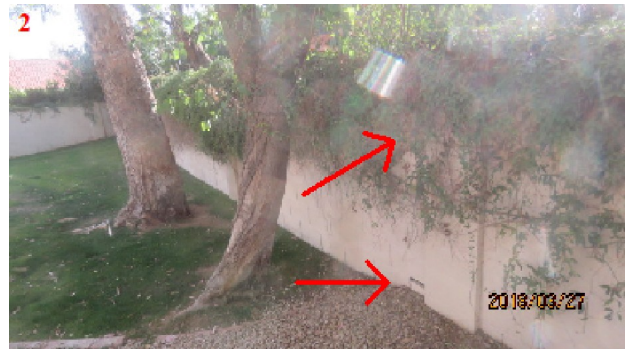
### **Service/Repair** Yard Fences - Masonry

There is a hole in the fence block wall in the back and some loose or displaced upper bricks.  
Recommend a qualified contractor evaluate and make all necessary repairs.

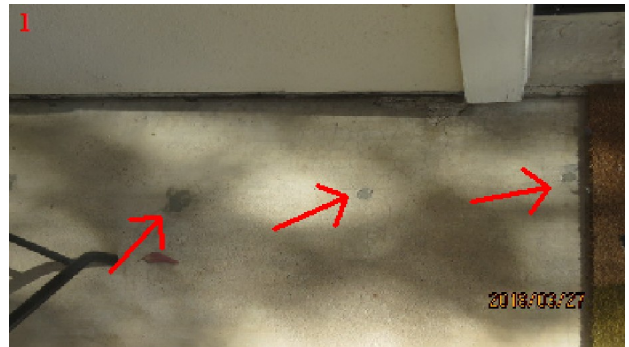
Drill marks in the slab are signs of past termite treatment. Recommend asking seller for more information on past termite treatment and what caused the treatment and if there a warranty on this treatment?

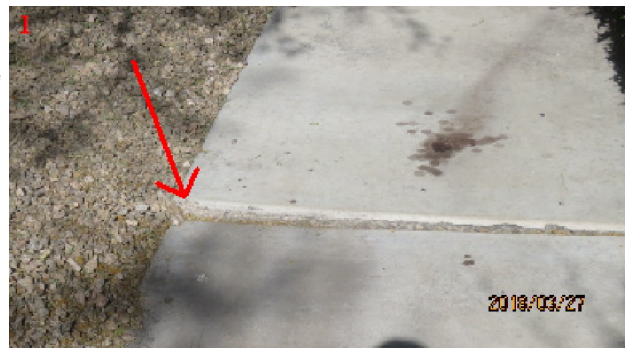
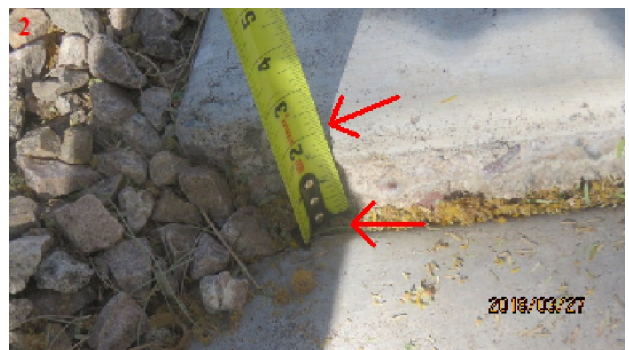
Trip hazard due to uneven areas in the sidewalk. Recommend finding out what has caused this problem and solving it to avoid the problem getting worse. Recommend a qualified contractor evaluate and make all necessary repairs. See sample picture

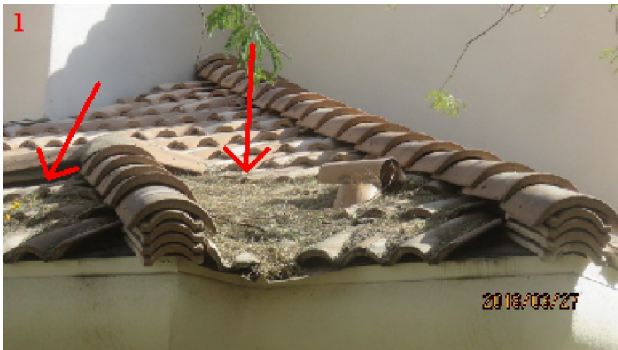
Debris on the roof should be removed. Debris can cause water to backup on the roof and create a roof leak. See sample picture

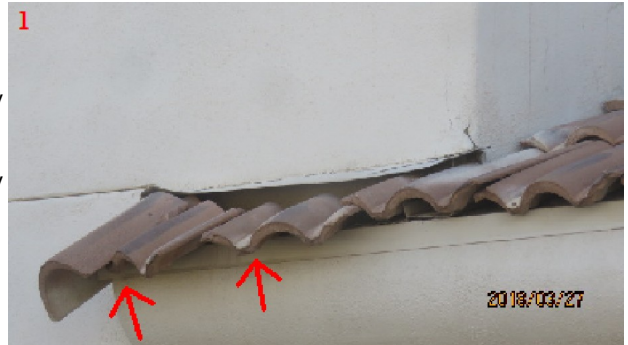
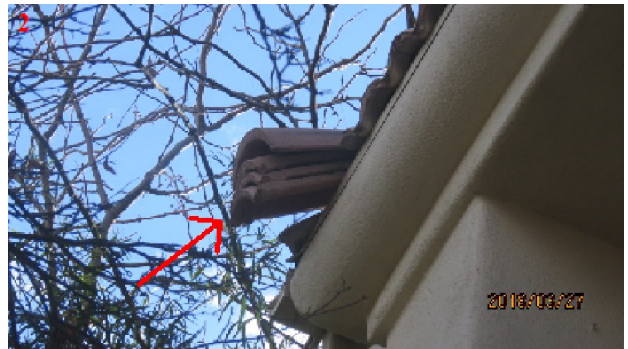
W style concrete roof tiles installed.  
Missing roof tiles on the front of the house and garage see row one.  
Loose and out of place roof tiles on the east side of the home.  
Recommend a qualified contractor evaluate and make all necessary repairs.  
Cement caps on the roof are cracked.  
Recommend a qualified contractor evaluate and make all necessary repairs.

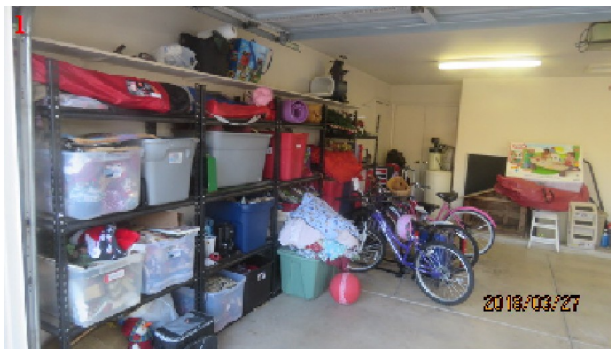
#### GARAGE - Garage Stuff

Stuff in the garage blocks view of the interior of the garage. Recommend inspecting garage area after the stuff is removed.

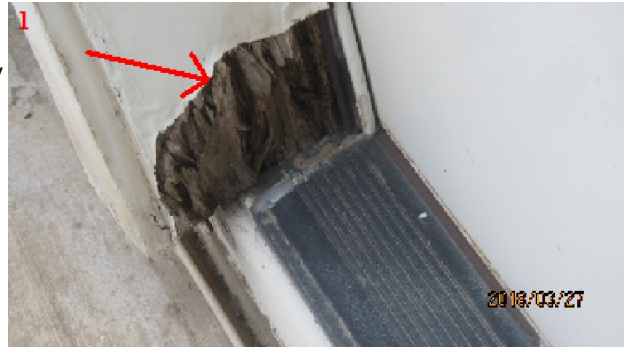
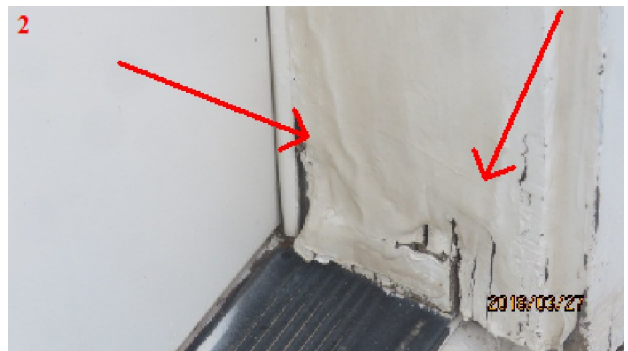
The garage door to the side yard is screwed shut and there is wood rot in the door jamb.  
Recommend a qualified contractor evaluate and make all necessary repairs.

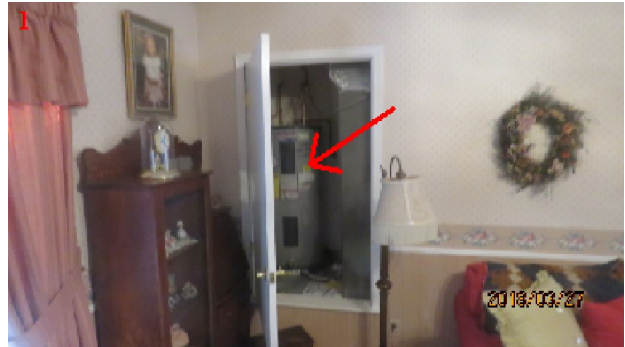
**Satisfactory** **WATER HEATER - Tested**

Two water heaters in this home one in the upstairs closet and the other in the garage.

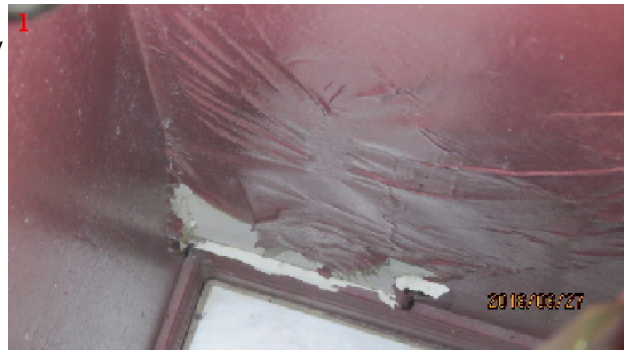
Water damage to the laundry wall below the valve box.  
Recommend a qualified contractor evaluate and make all necessary repairs.

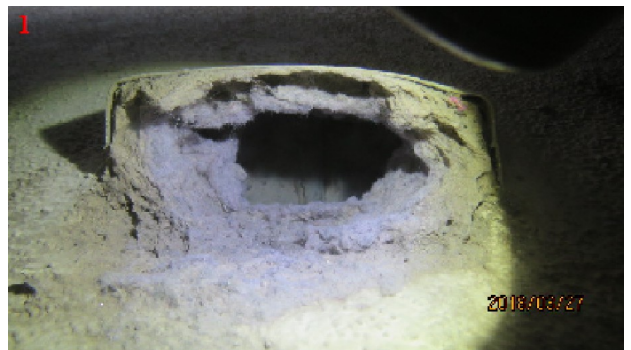
Lots of lent in the dryer vent on the side of the home. Lent blocks airflow an can cause fires. Recommend cleaning the dryer vent.

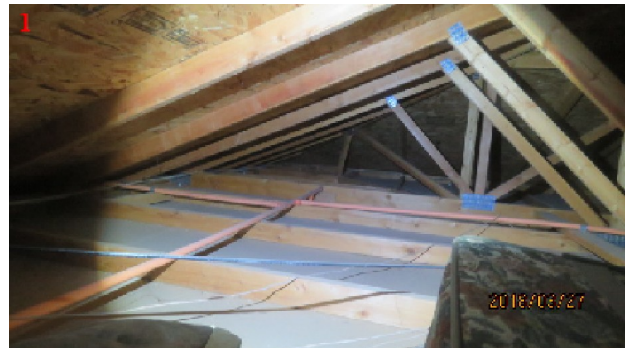
**Satisfactory** ATTIC - Sample picture

Sample attic picture.

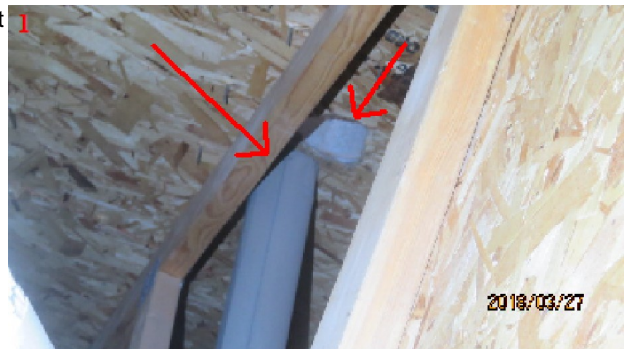
Vent pipes not properly connected to roof vent. Recommend all vent pipes be directed outside. See picture

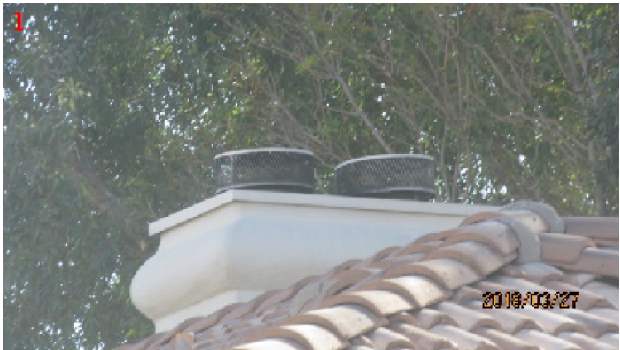
**Satisfactory** Spark Arrestor - Installled

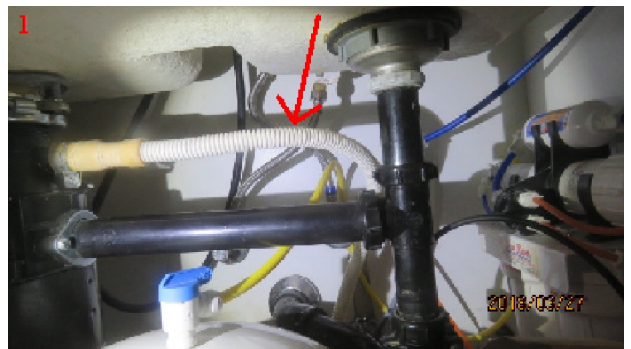
The drain hose from the dishwasher to the disposal needs a loop above the disposal drain and most of the sink or a sink air gap to prevent disposal water from flowing into the dishwasher. See picture

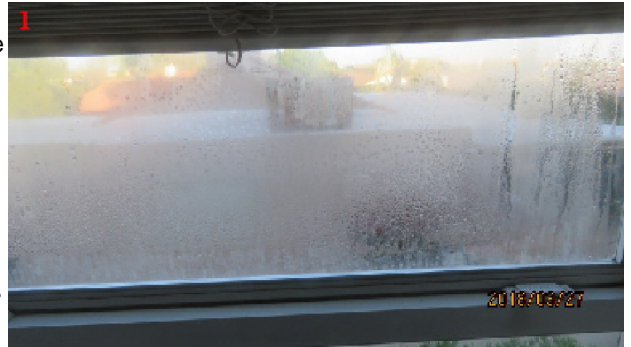
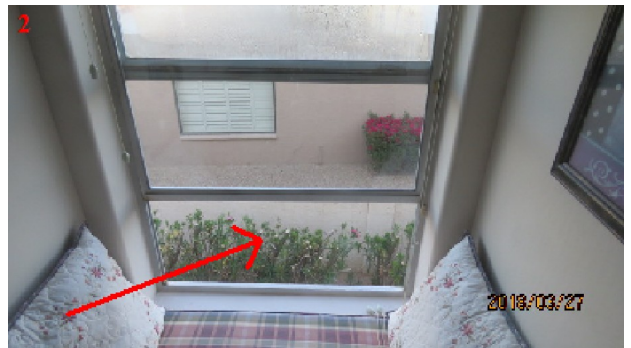
When a window seal between the window panes is found to leak all the windows should be suspect of having a seal problem. Since all windows are normally purchased at the same time from the same batch when one goes the others may be soon to follow. Sometimes it is difficult to see the moisture between the panes. Recommend a qualified window contractor evaluate all sealed windows and make all necessary repairs.

Most window manufacturers warranty sealed windows for a minimum of 10 years and some for life.

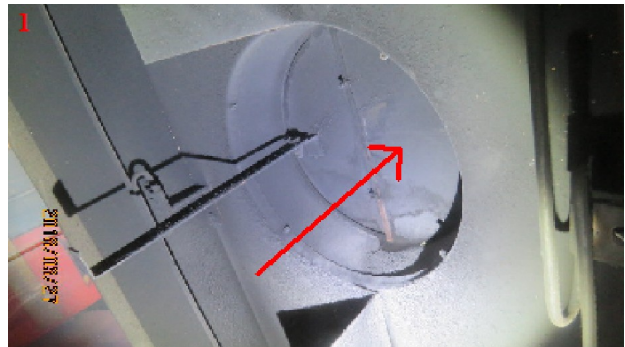
Gas fireplace so the damper should not close completely. When converted to gas this damper should have been made so it would not close.  
If natural gas leaks it needs to escape out the chimney and not go into the home.  
Propane used in both fireplace so this may not apply.  
Recommend further investigation.

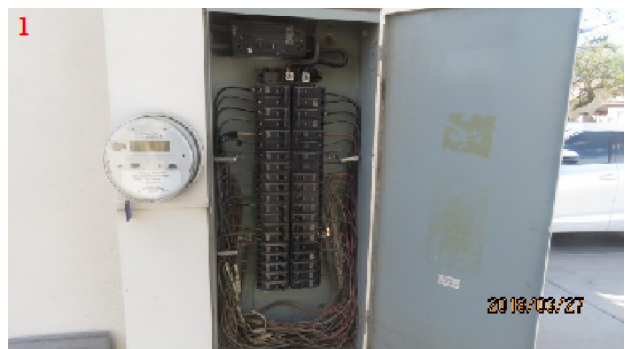
#### Main Electric Panel - Inspected, Sample Picture

Sample picture of the main electric panel.

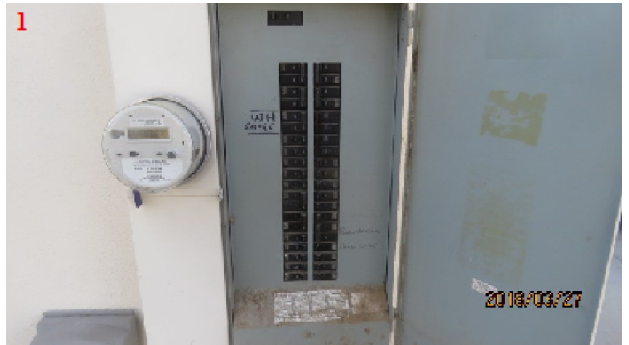
One breaker is double tapped this may create a loose connection and loose connections can cause electrical fires. Recommend only one wire per breaker. Recommend a qualified electrical contractor evaluate and make all necessary repairs. See picture

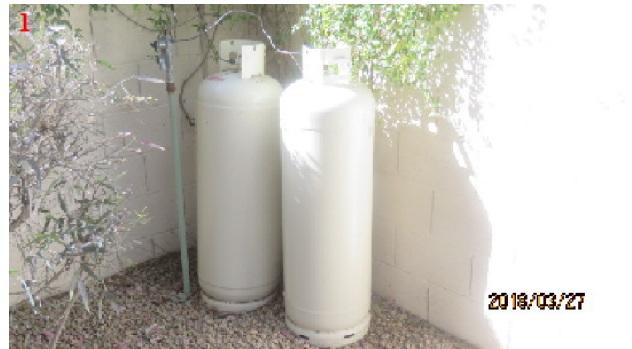
The west side propane tanks are not strapped. Recommend properly strapping both gas tanks to help keep them from falling over.

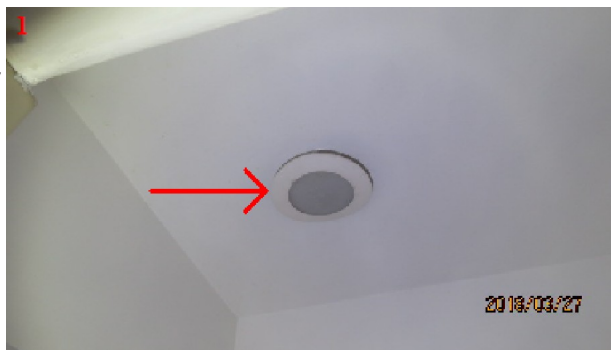
The master bath ceiling fixture cover on the shower ceiling is warped and does not seal properly. Recommend a qualified contractor evaluate and make all necessary repairs.

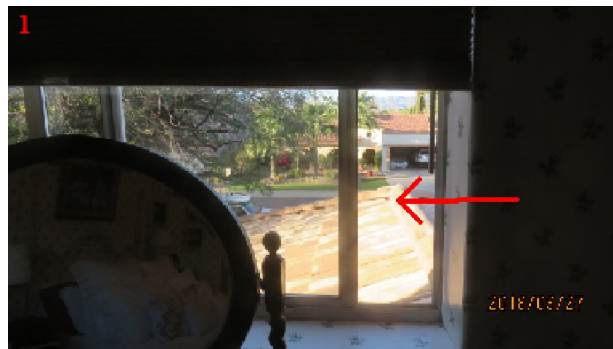
Screen missing on master bedroom window(s). Recommend installing screen to help avoid having small children fall out of 2nd story window.

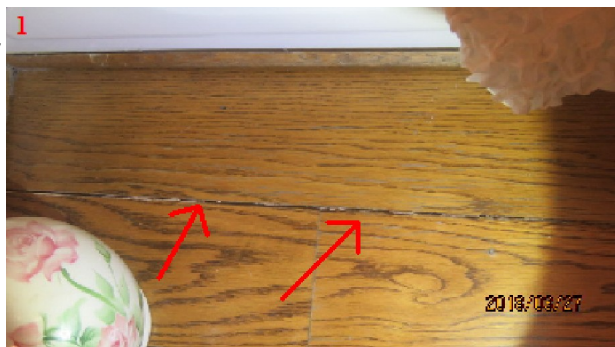
There is a gap in the wood flooring along the shower.  
Recommend a qualified contractor evaluate and make all necessary repairs.

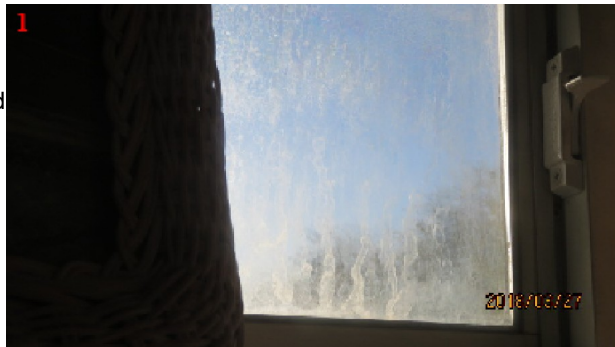
Seal in the hall bathroom window is bad. Recommend replacing window. When one window seal goes bad others may also be bad but sometimes it is difficult to see the moisture between the panes. Recommend a qualified window contractor evaluate all windows and make all necessary repairs.

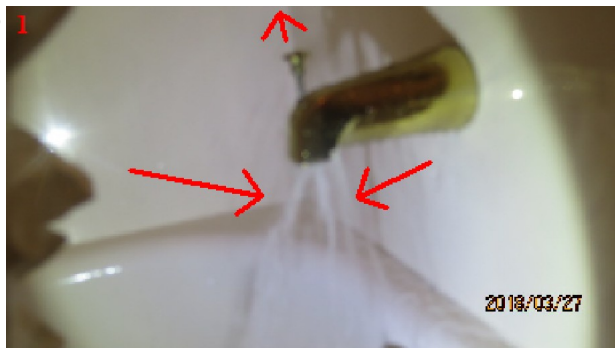
The diverter valve in shower is defective. Water does not shut off to tub when the shower is running. Recommend replacing shower diverter valve.

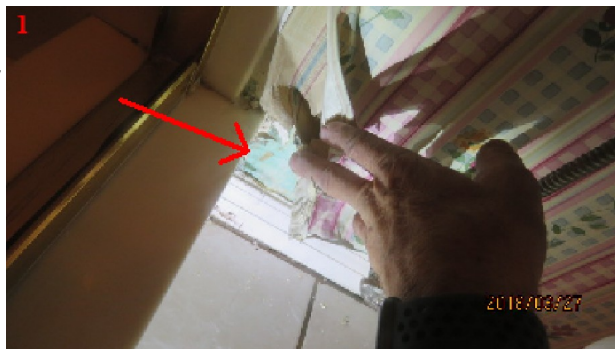
Some minor water damage to the drywall between the toilet and the shower.  
Recommend a qualified contractor evaluate and make all necessary repairs.

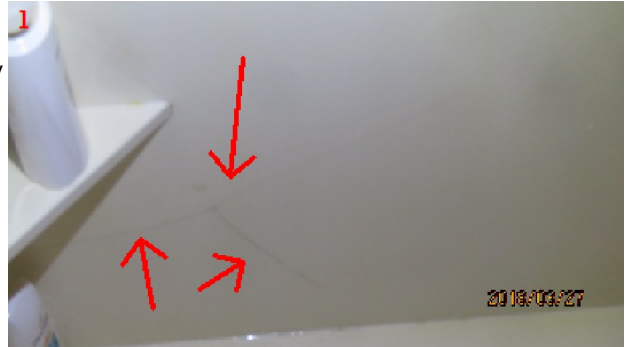
There is a crack in the manufactured stone on the back wall of this shower enclosure.

Recommend a qualified contractor evaluate and make all necessary repairs.

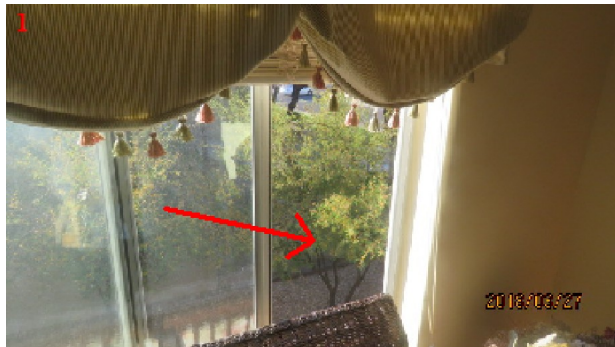
Screen missing. Recommend installing screen to help avoid having small children fall out of 2nd story window.

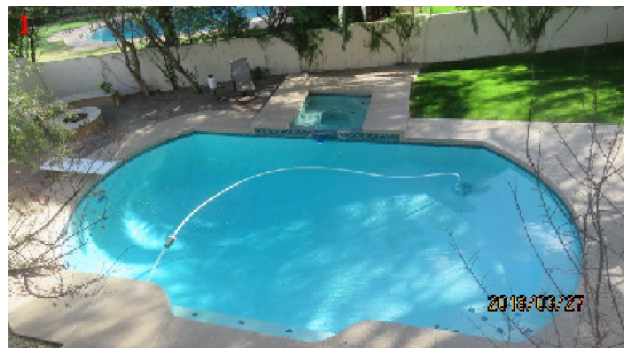
### **Satisfactory** Type of Pool /Spa - In ground

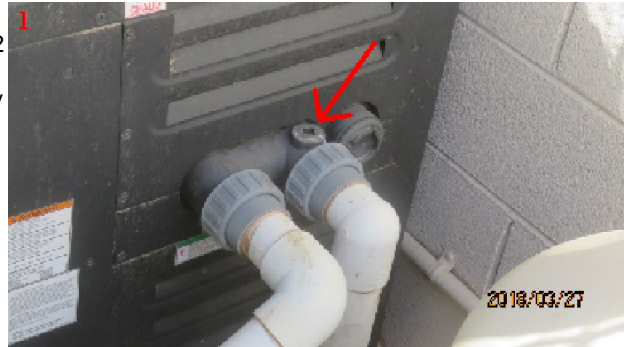
No temperature pressure relief valve pipe found for the pool heater. Recommend all temperature pressure relief valve pipes be within 12 inches of the ground and pointed straight down. Recommend a qualified contractor evaluate and make all necessary repairs

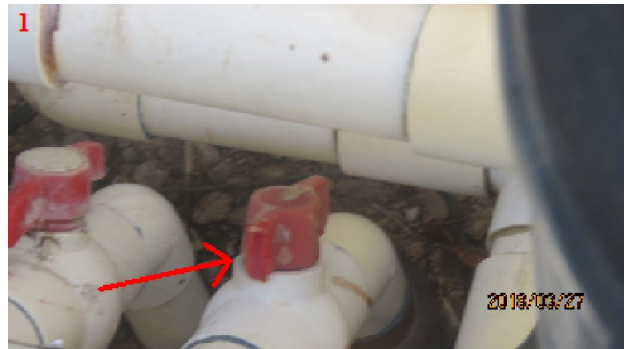
A pool valve with a red handle has a broken handle. Recommend a qualified swimming pool contractor evaluate and make all necessary repairs.

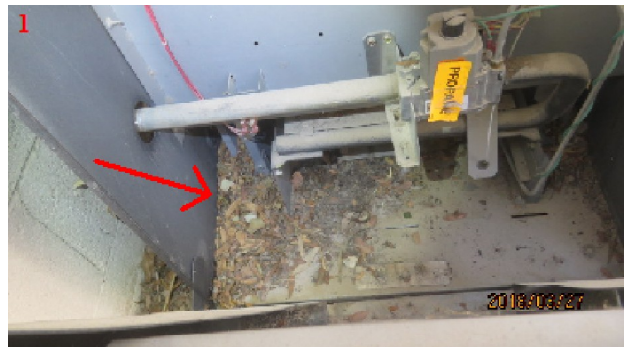
### **Service/Repair** Heater - Gas

Debris inside the pool heater burner area. Recommend removing all debris inside this cover.

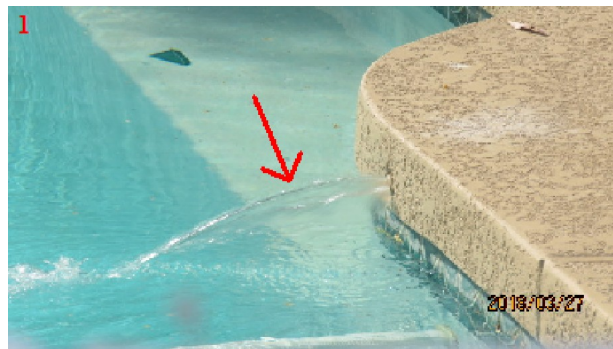
The pool aerator did not work properly when tested. Recommend a qualified pool contractor evaluate and make all necessary repairs.

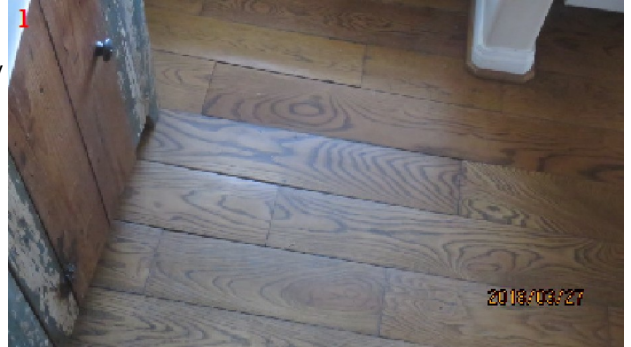
Wood flooring in the upstairs kitchen area is bowed and has gaps between the planks.  
Recommend a qualified contractor evaluate and make all necessary repairs.
