INSPECTION REPORT
31546 W Grant St
Buckeye AZ 85326

INSPECTED BY
David Drown
Vannier Home
Inspections
73226

INSPECTION DATE
📅 11/9/2021
🕒 08:00 AM

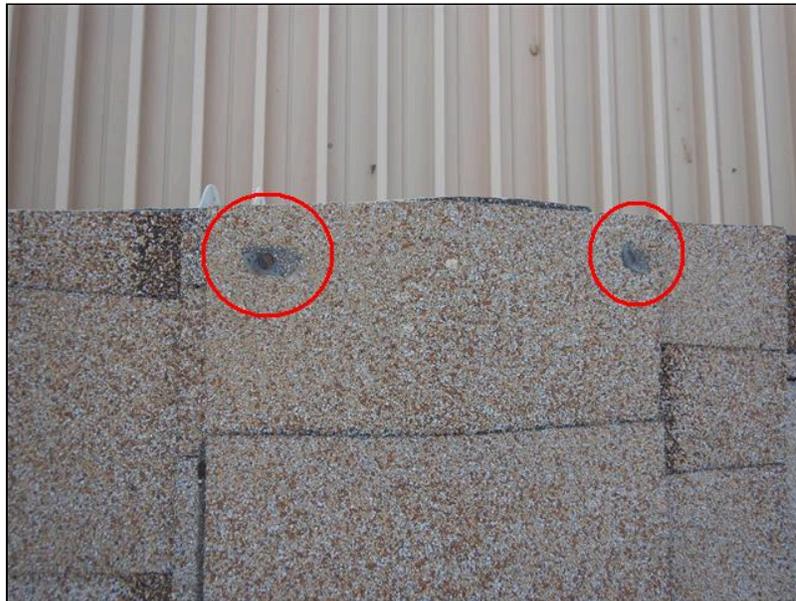
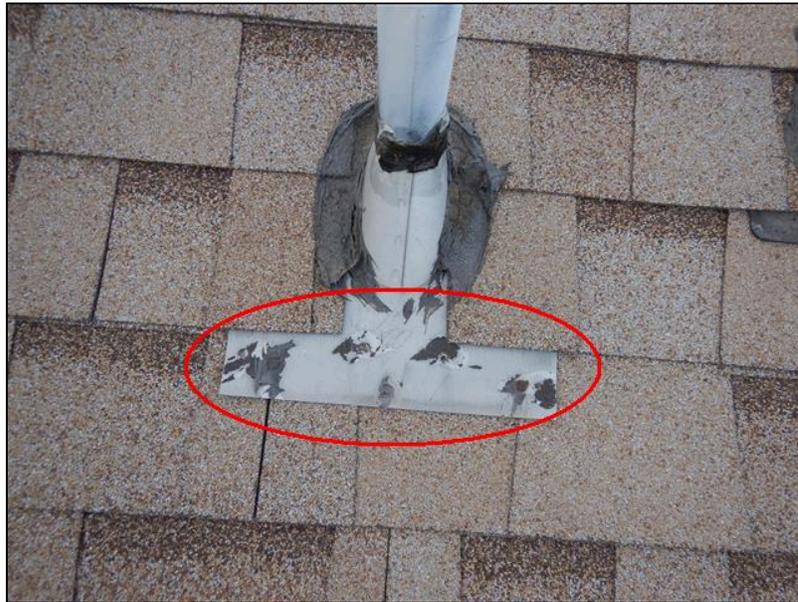
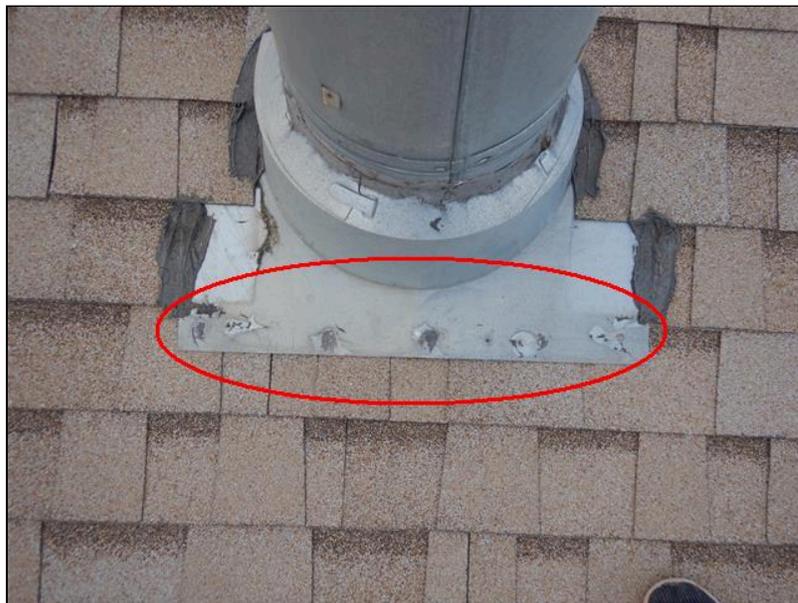
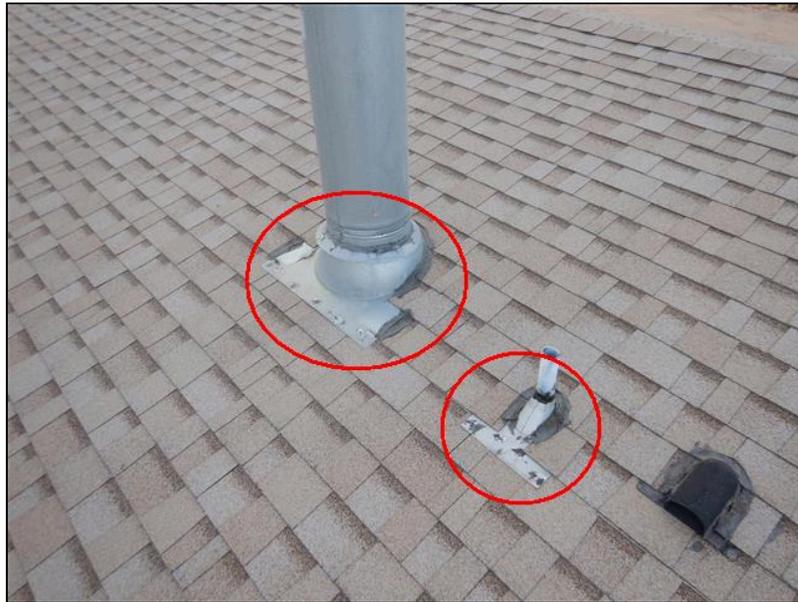
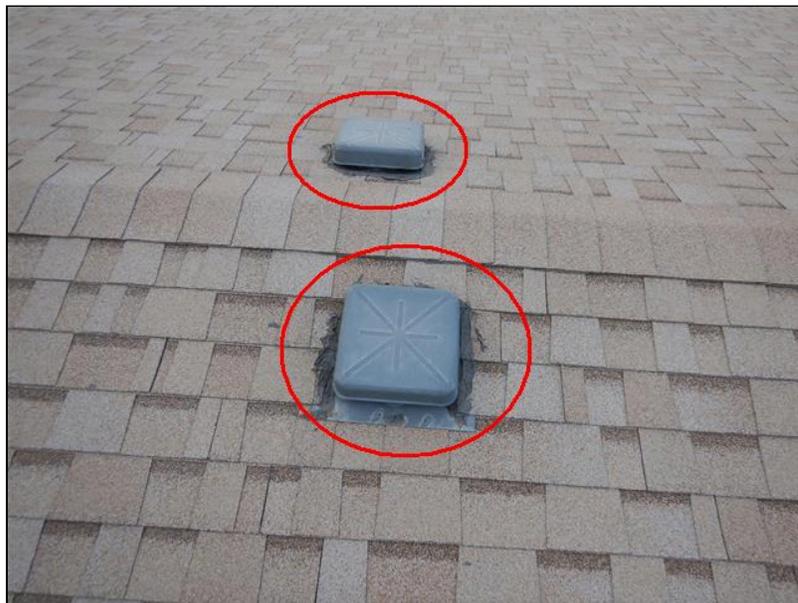
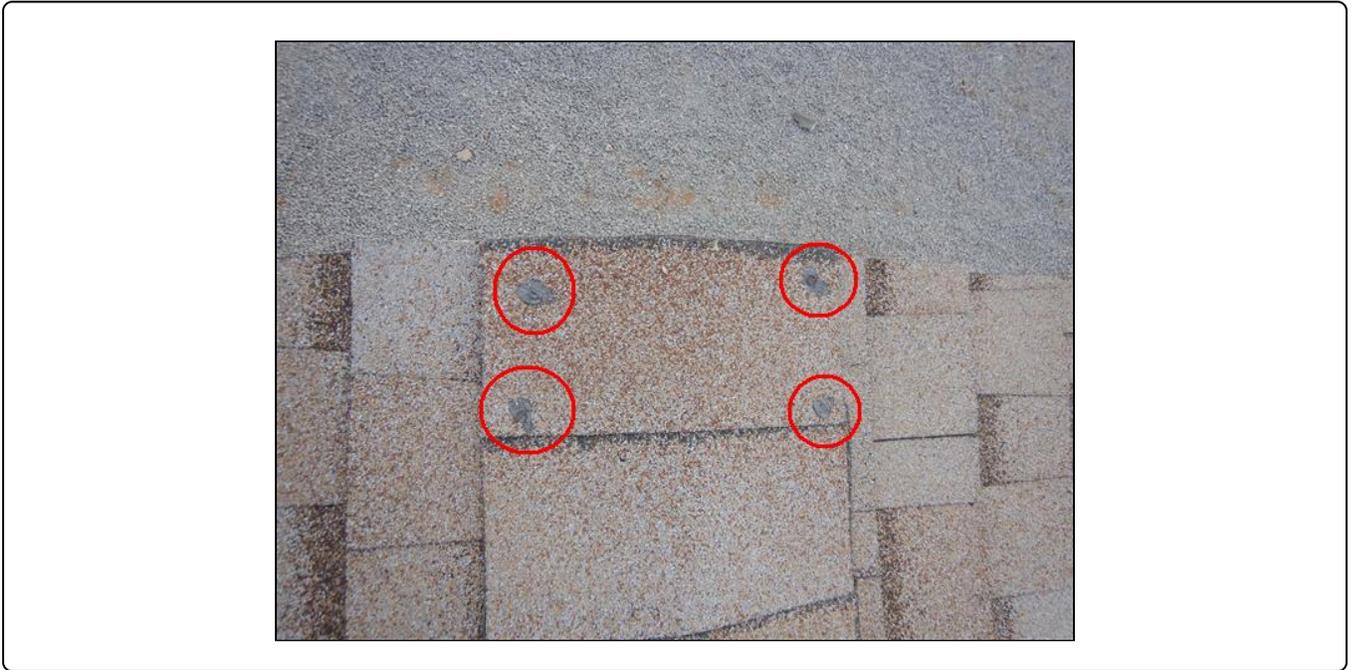
2.0 ROOF COVERINGS

Worn/missing mastic tar. The nail heads and flashing joints on the roof need to have mastic tar re-applied as it is worn/absent at multiple locations. This is a regular maintenance item. Recommend correction by a qualified contractor.

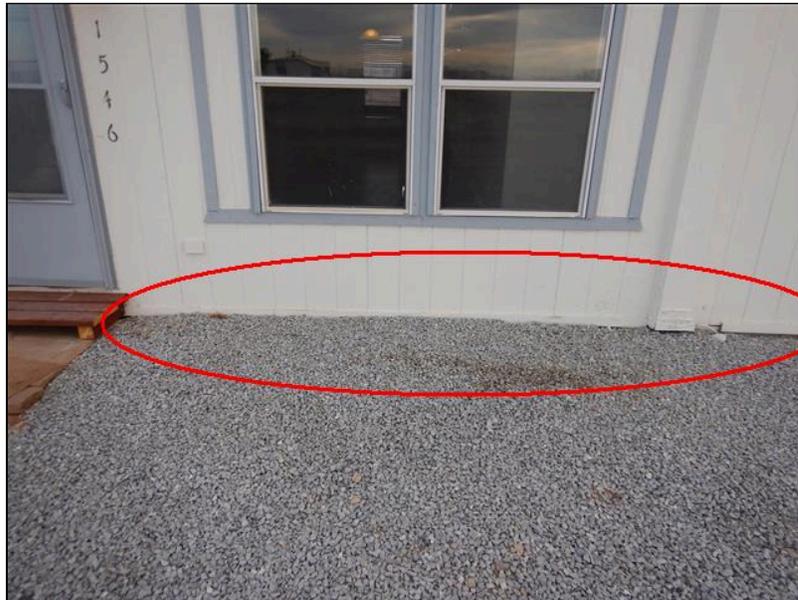
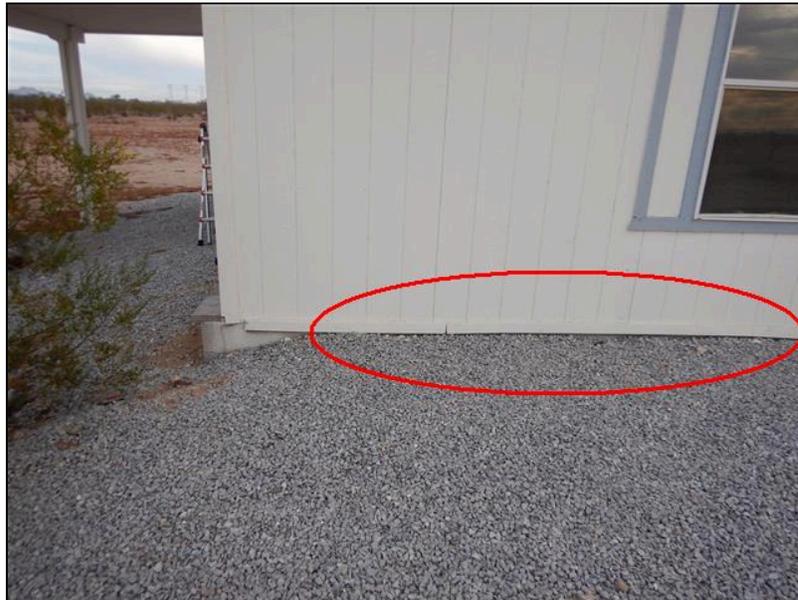
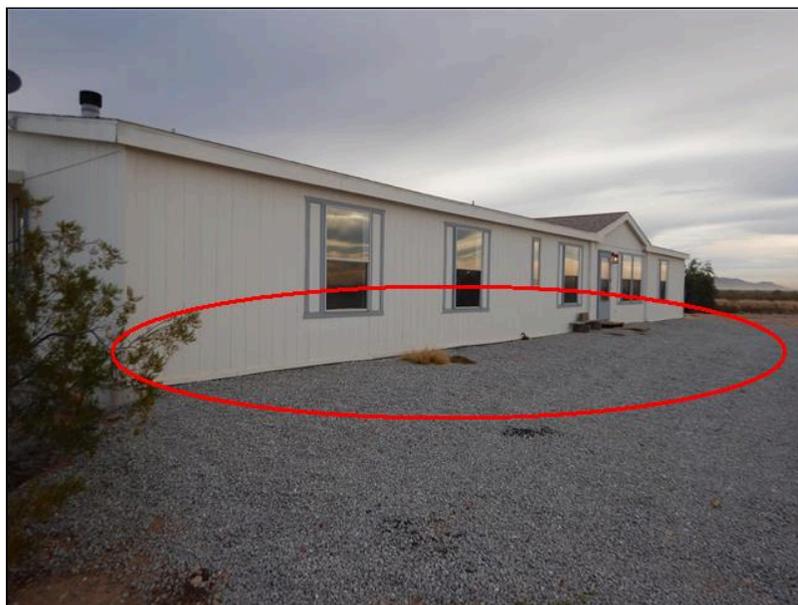
3.0 WALL CLADDING and TRIM

Wood siding in contact with ground. This can lead to water damage and offer a path for termites or other pests to enter the structure. Recommend correction by a qualified contractor.

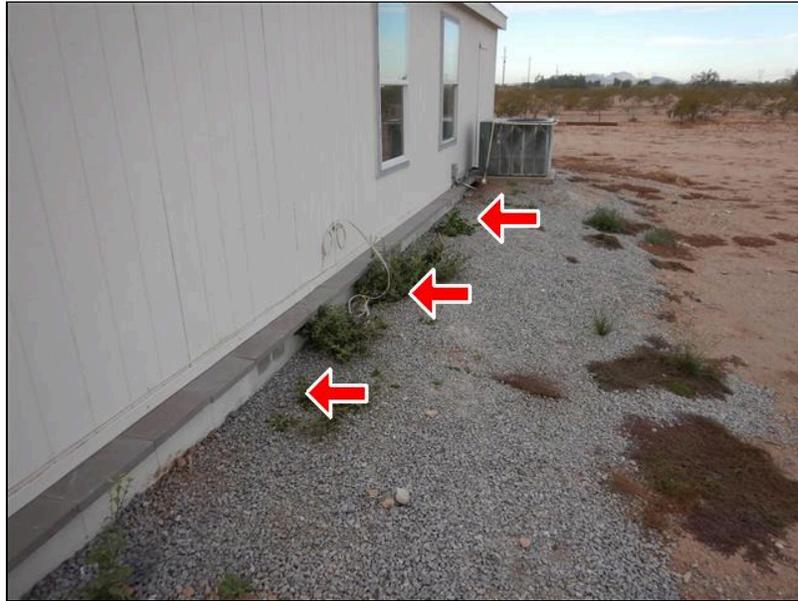
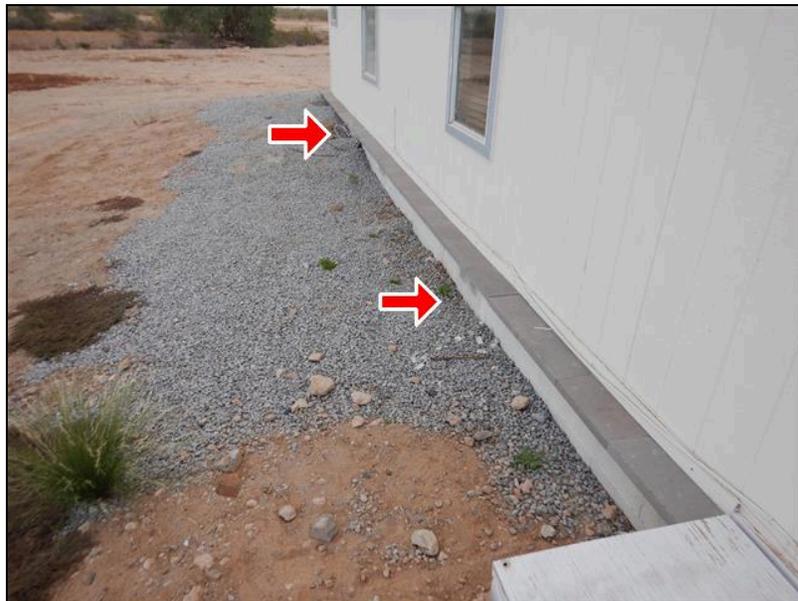
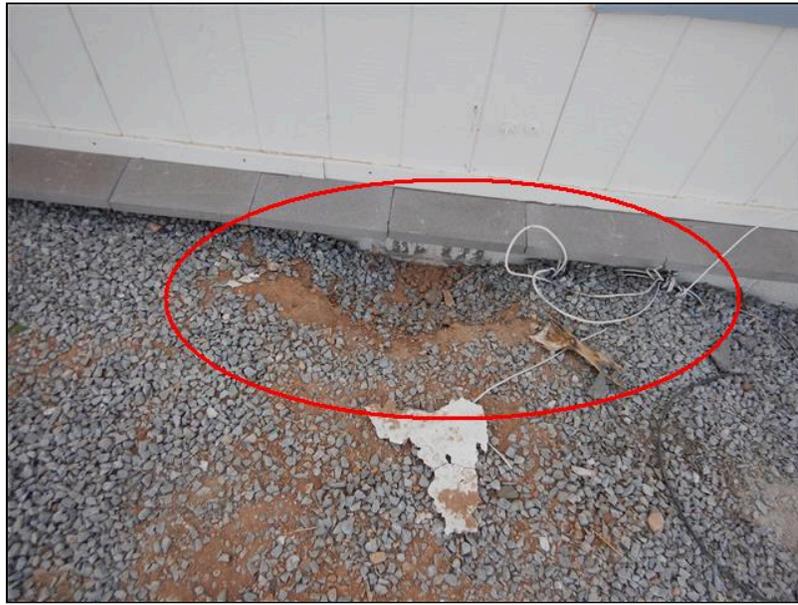
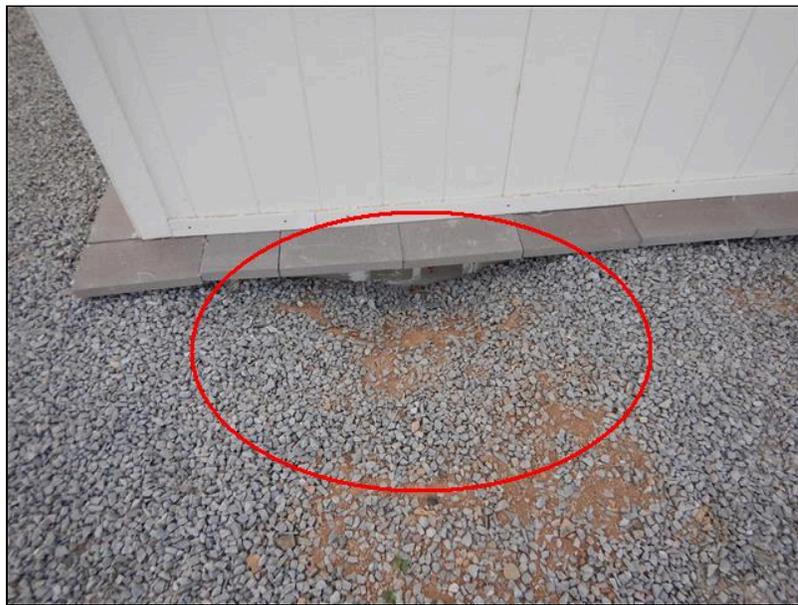
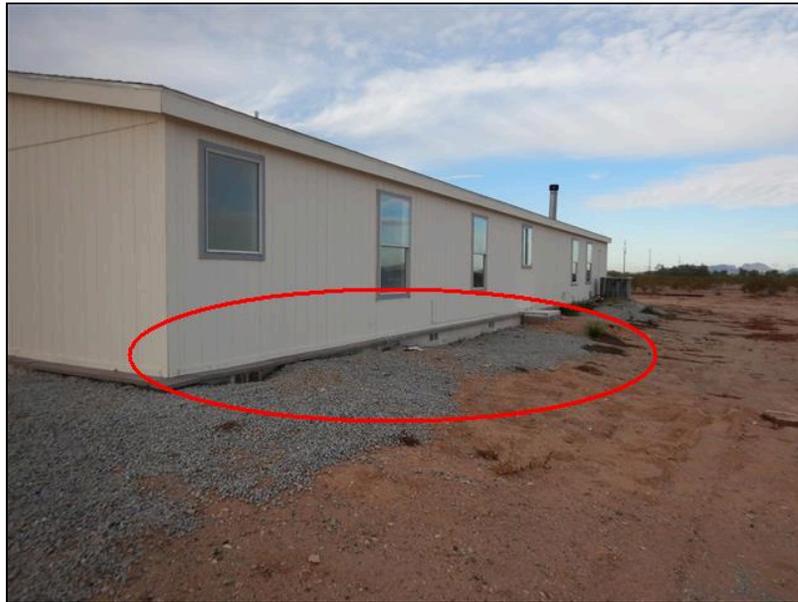
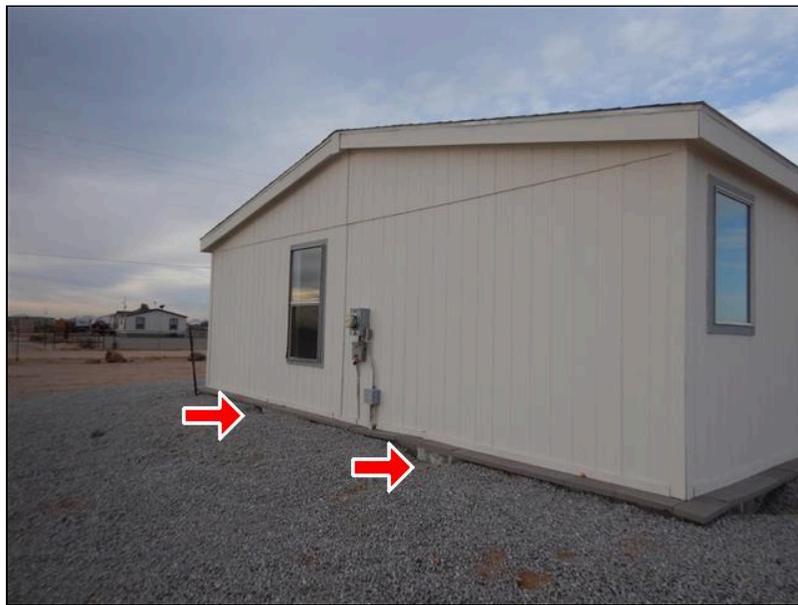
3.6 GRADING, DRAINAGE, and RETAINING WALL(S)

Faulty grade. It is important that all grading around the home is sloped to drain water away from the structure as water pooling against the structure or water running into the crawl space can cause damage. Recommend correction by a qualified contractor. Noted mainly at back and right walls of the home.

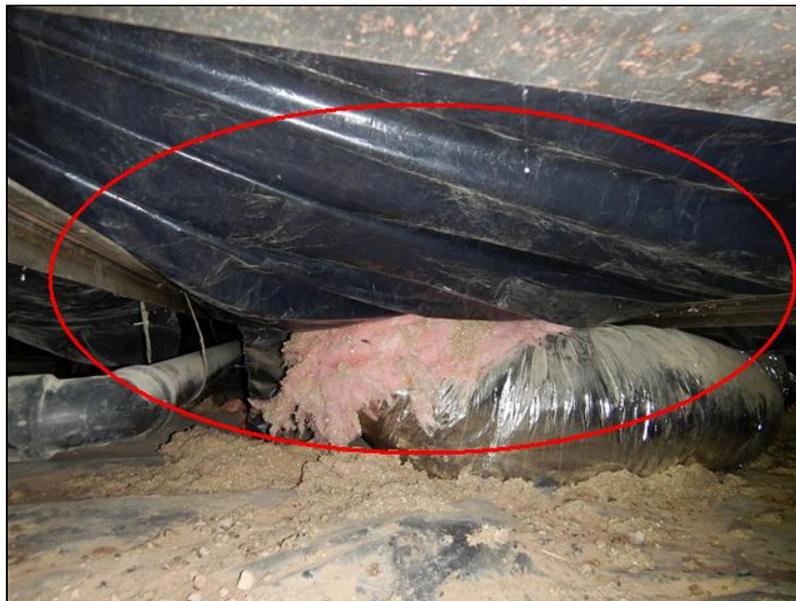
4.3 CRAWL SPACE

Some of the insulation under the home is hanging down. Vapor barrier is not secured and is not protecting insulation. Recommend correction.

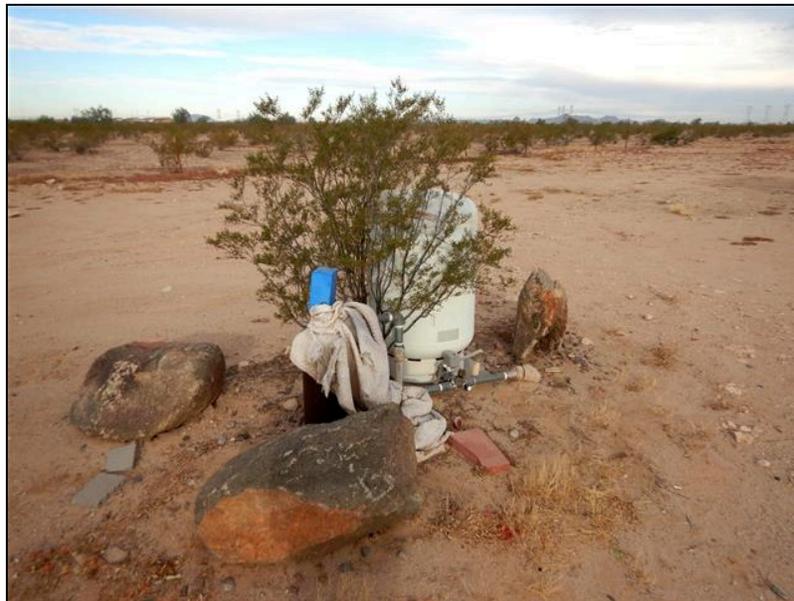
6.0 IMPORTANT CLIENT INFORMATION

Water off to home during inspection. The water for the home is supplied by a well. The water shut-offs at the well and the side of the appear to be in the on position but no water was being supplied to the home. This may be due to a faulty well pump or operator error. Inspecting wells is beyond the scope of a home inspection. The lack of water severely limited the inspection. Inspector could not test plumbing, fixtures, or appliances that use water (water heater, dishwasher, etc.). Recommend complete review and correction as needed of well and all plumbing, fixtures, and related appliances by a qualified contractor.

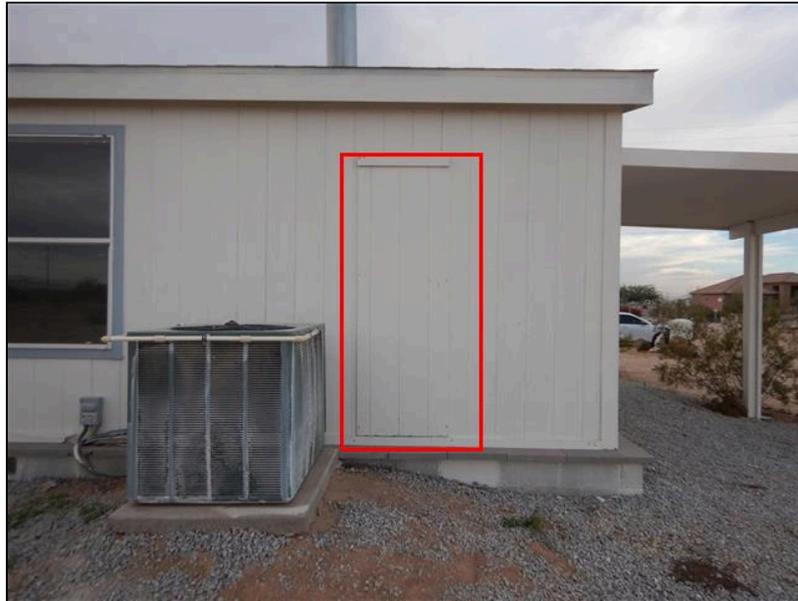
(1) No access to water heater. Access panel is screwed shut. Inspector did not inspect water heater. Recommend review and correction as needed by a qualified plumber.

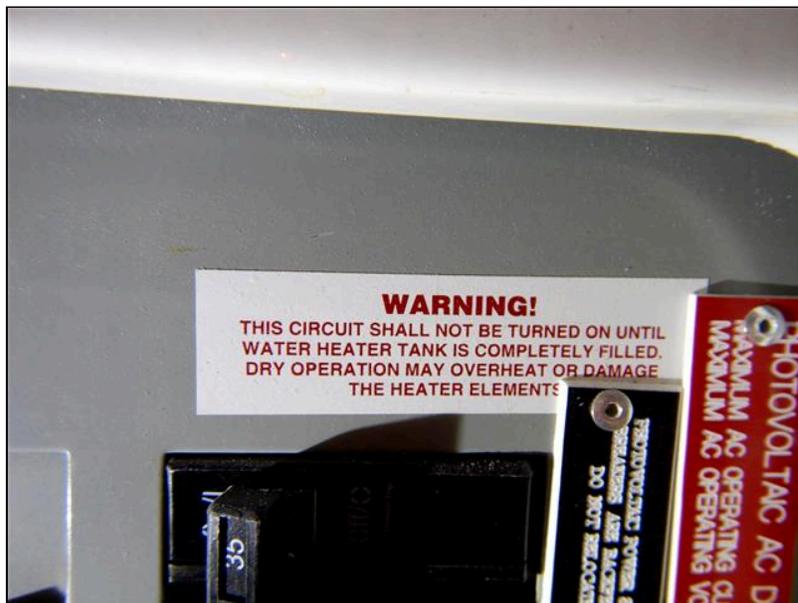
(2) Power on to empty water heater. No water was supplied to the home at time of inspection but the breaker for the water heater was in the on position. This can damage the water heater. Recommend review and correction as needed by a qualified plumber.

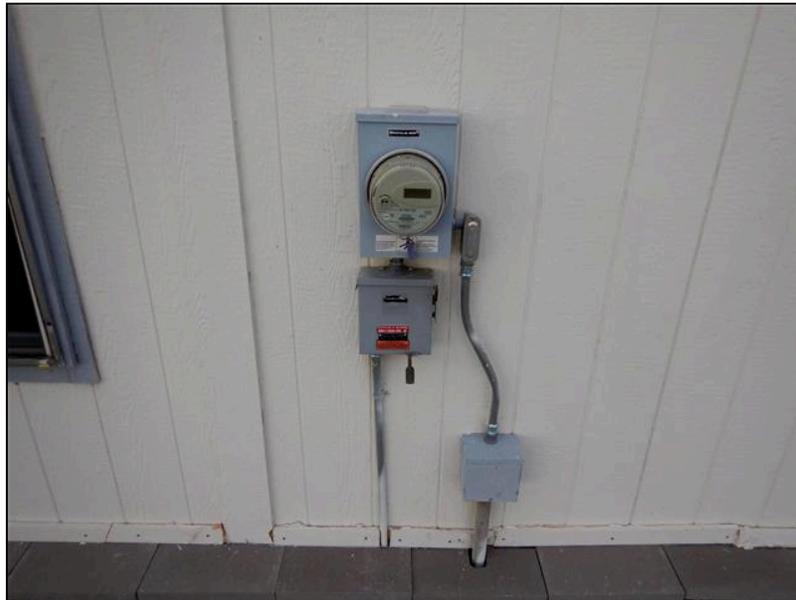
7.0 SERVICE ENTRANCE CONDUCTORS and EQUIPMENT

Inspection of solar equipment is not within the scope of a home inspection. Recommend review and correction as needed by a qualified contractor.

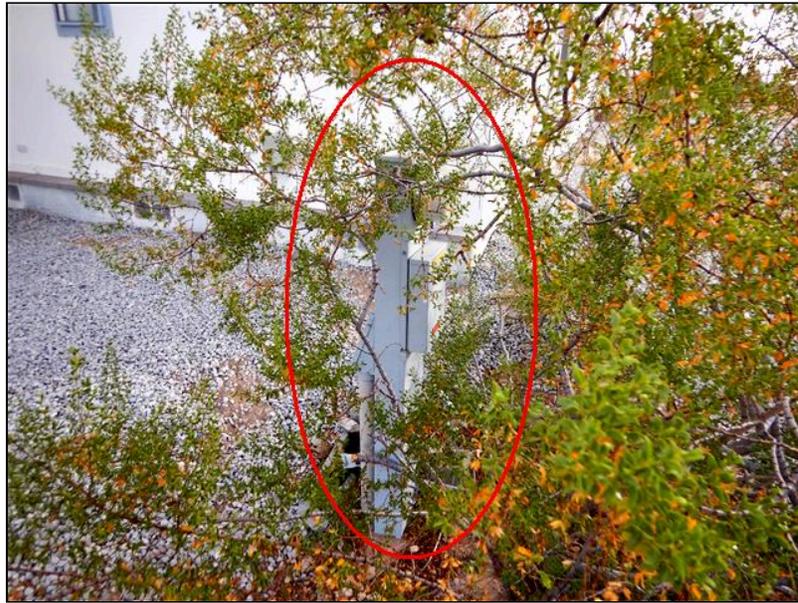
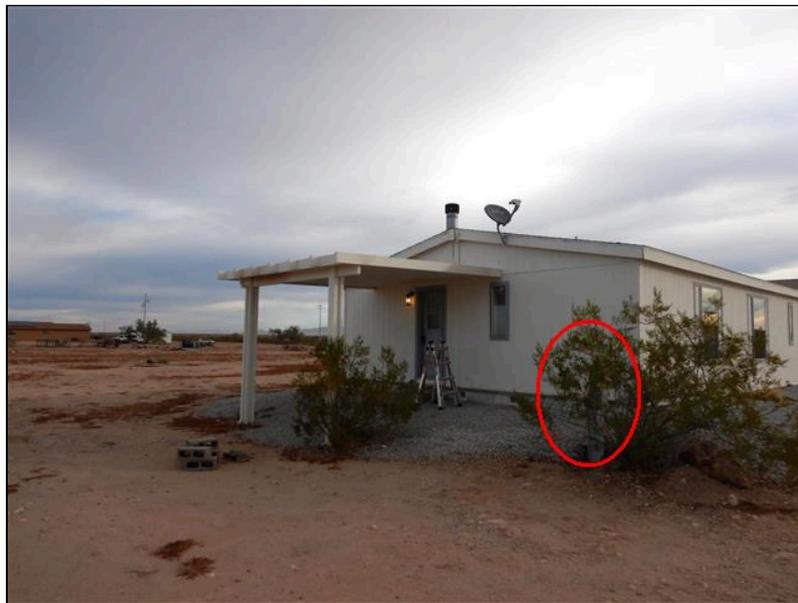
7.1 MAIN DISTRIBUTION PANEL and CIRCUIT BREAKERS

Insufficient clearance in front of main electrical panel/meter. Meter is overgrown by plant/bush. Recommend to trim plant back 36 inches for ease of access.

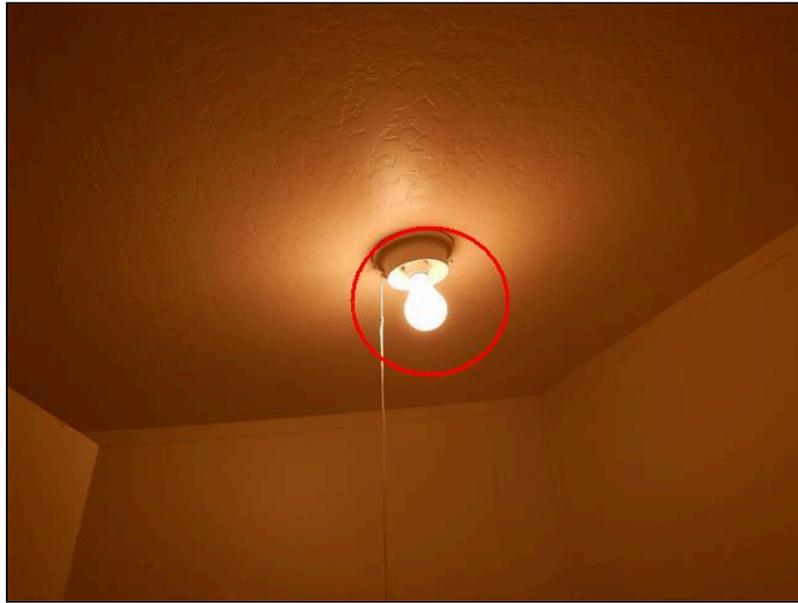
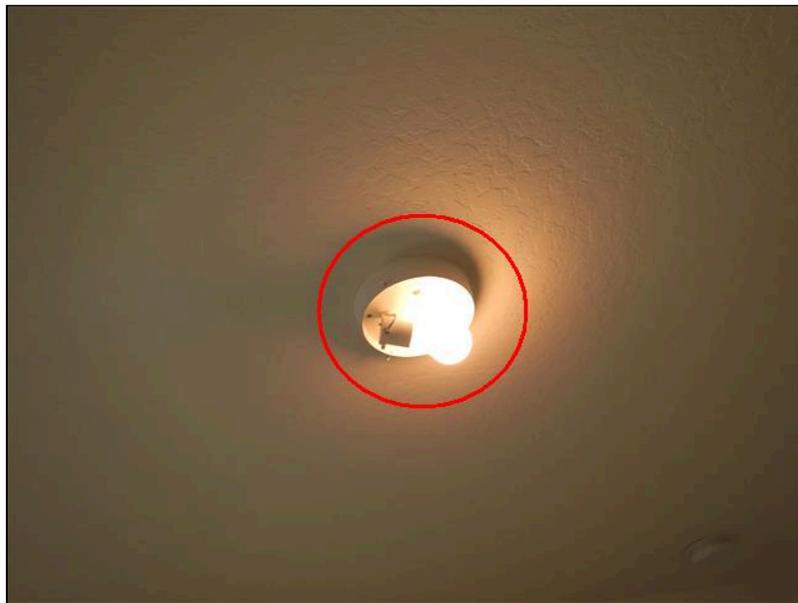
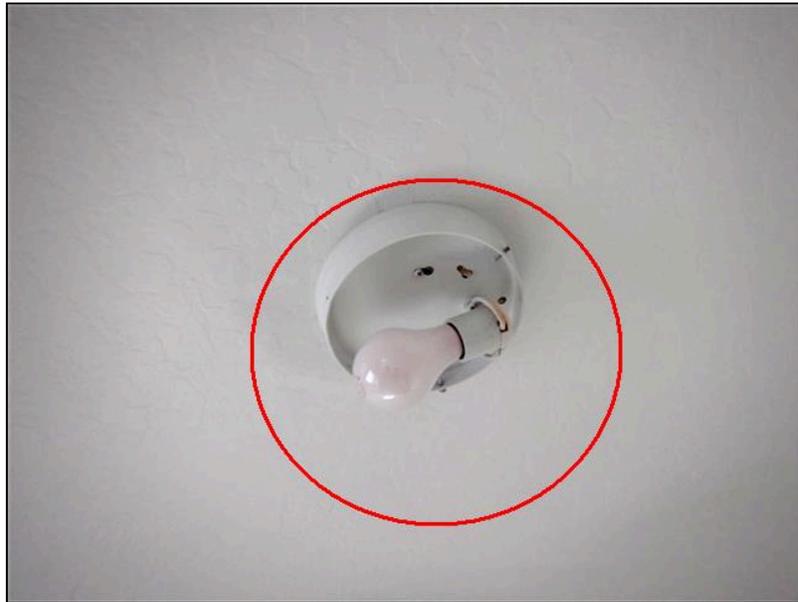
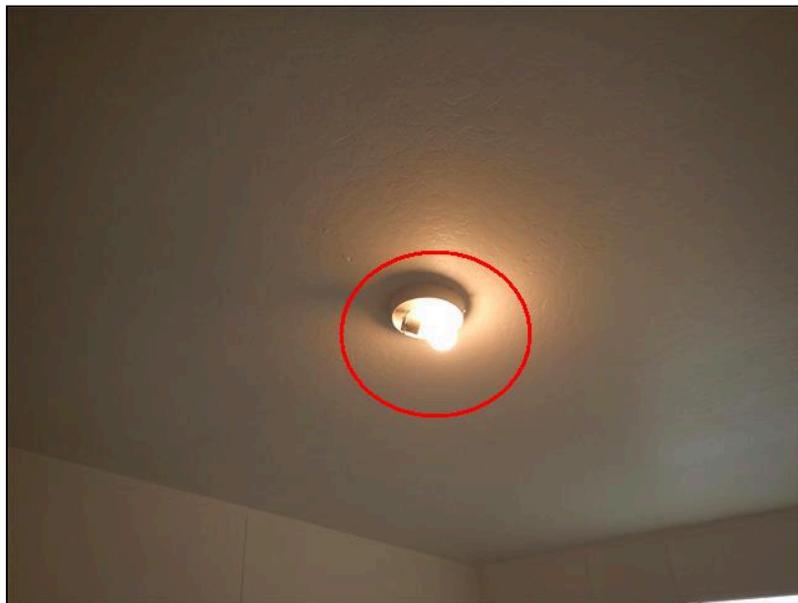
(1) Missing covers/globes. Recommend correction. Noted in multiple locations including second, third, and fourth bedrooms and attached closets.

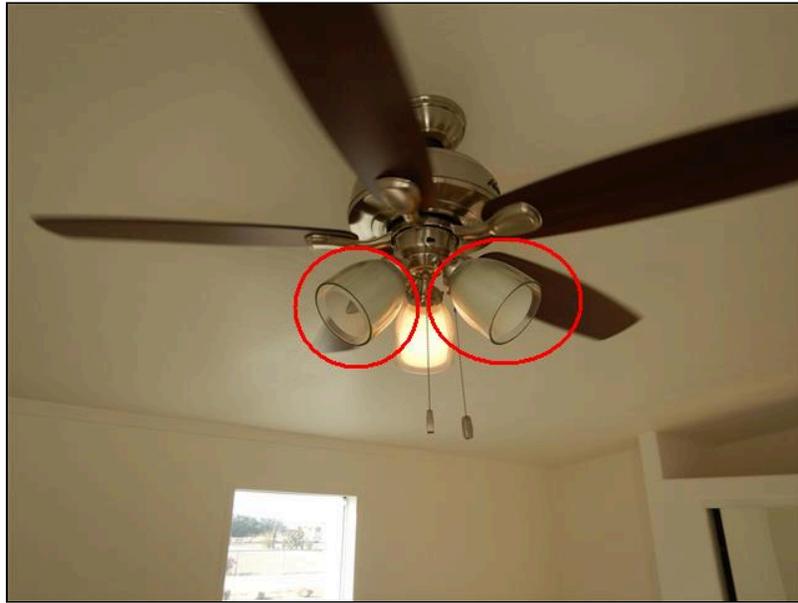
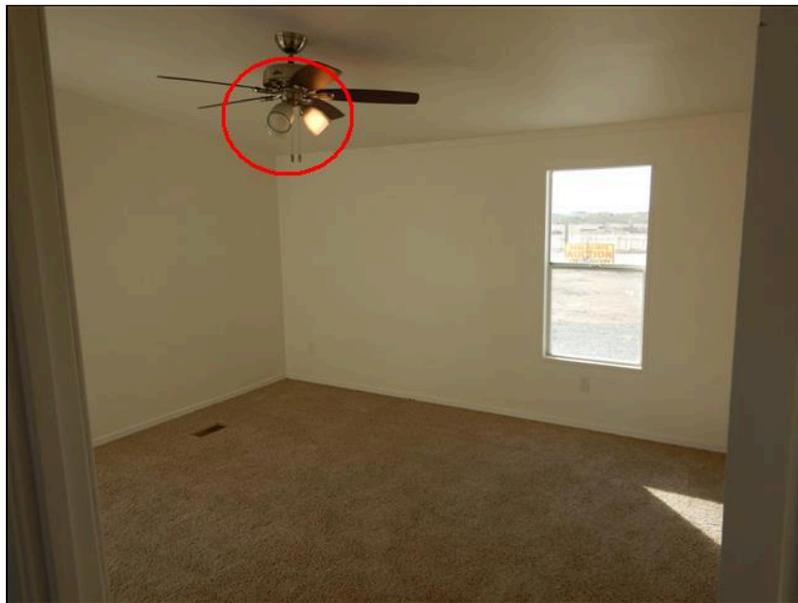
(2) Lights not operating. Possible failed/missing bulbs. Recommend correction. Noted at master bedroom.

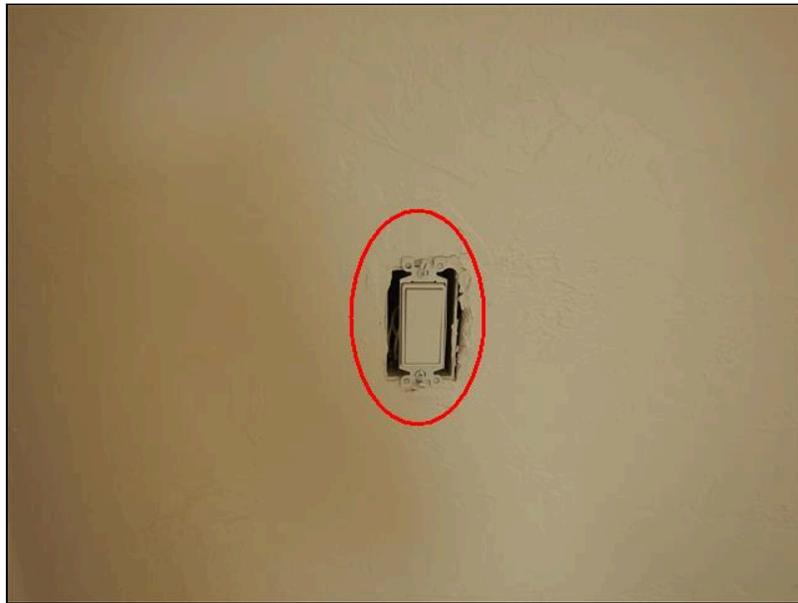
(3) Missing cover plate. Recommend correction. Noted in master bedroom.

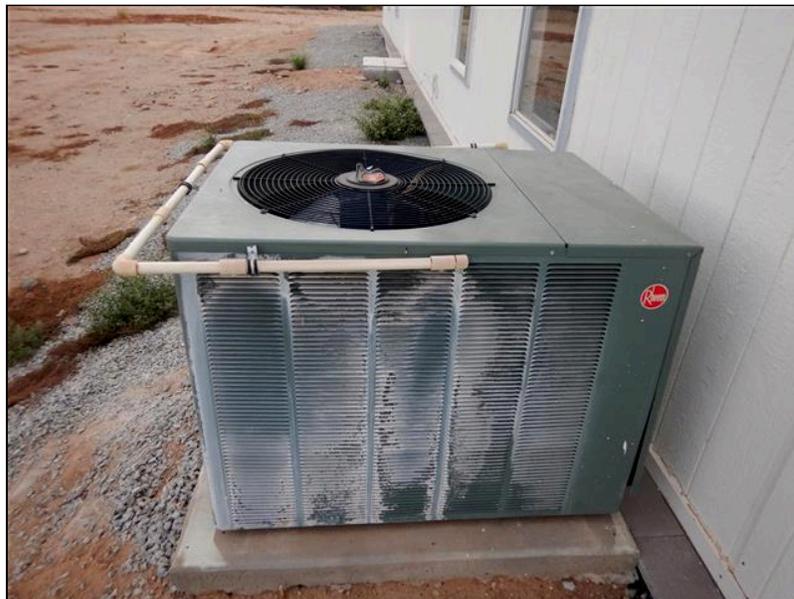
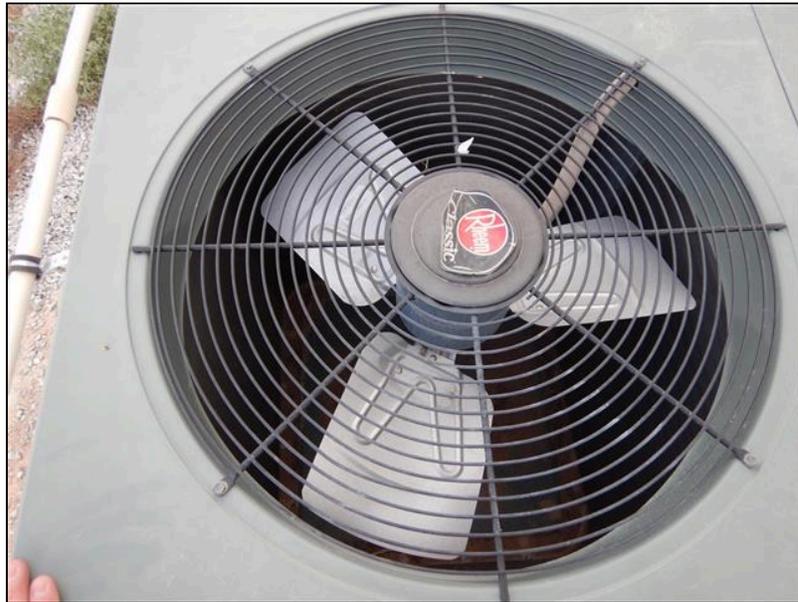
(1) The HVAC condenser fan does not turn on. The HVAC system does turn on and heats/cools the air but due motor for the condenser fan does not operate. This will severely reduce the performance of the HVAC system. Recommend review and correction by a qualified HVAC contractor.

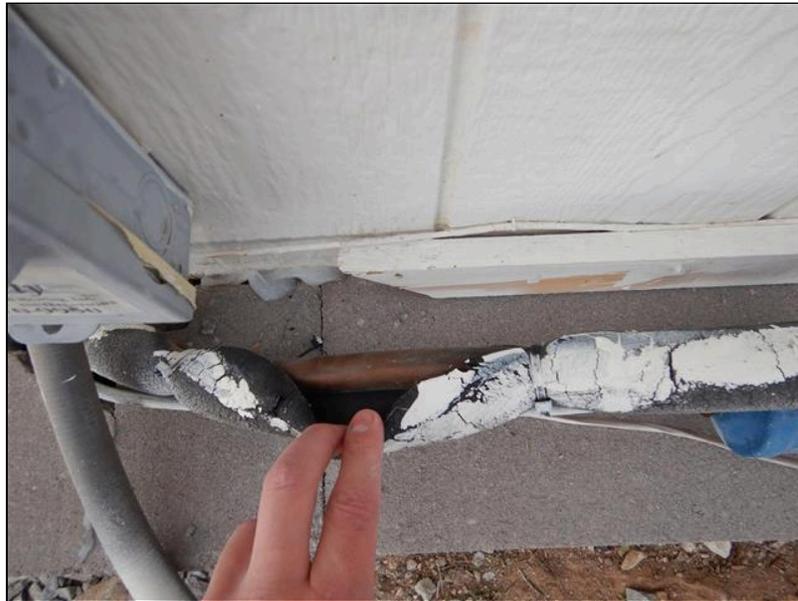
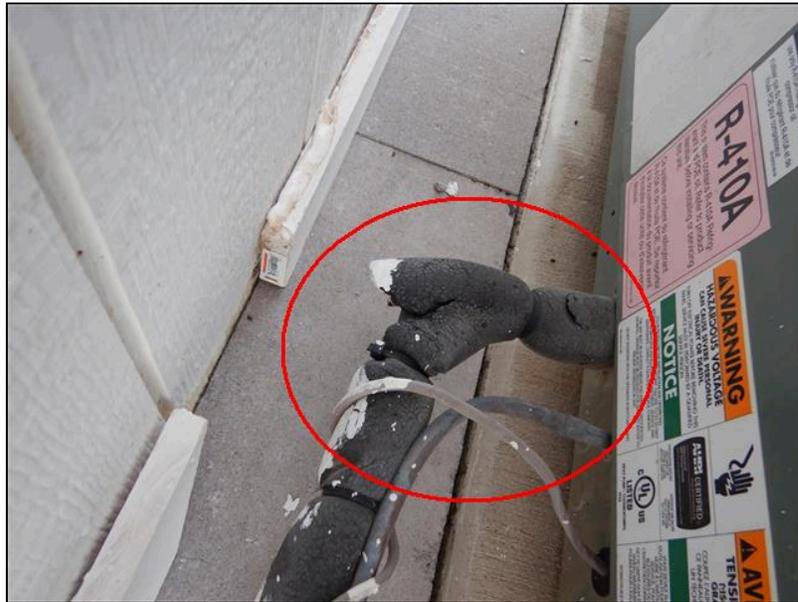
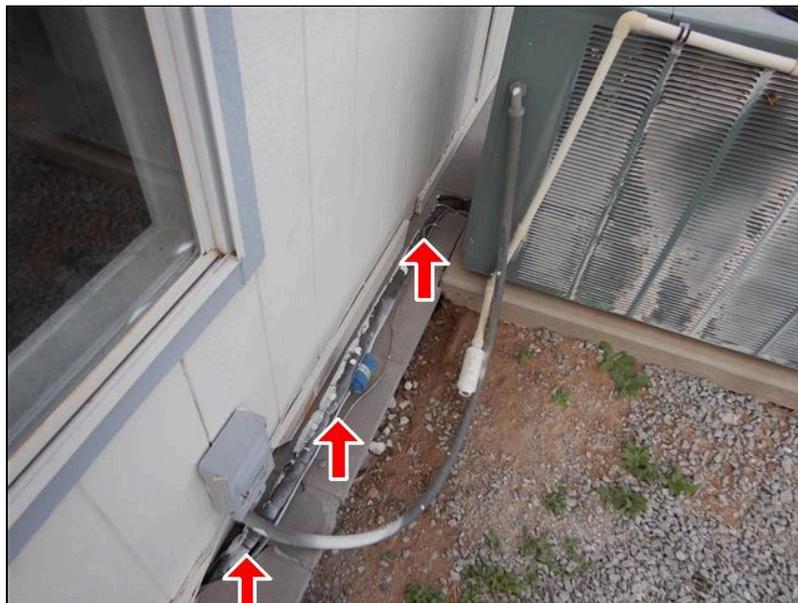
(2) Damaged insulation on refrigerant lines. This can reduce the efficiency of the HVAC system. Recommend correction.

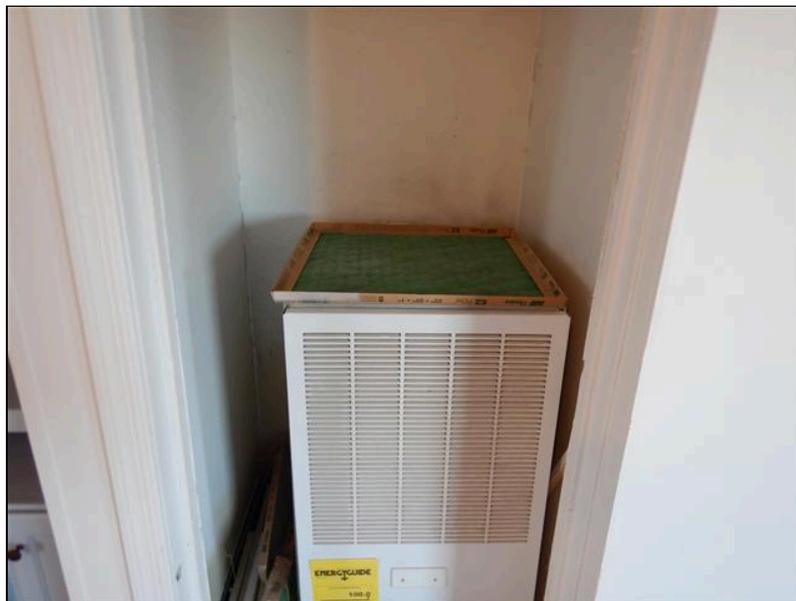
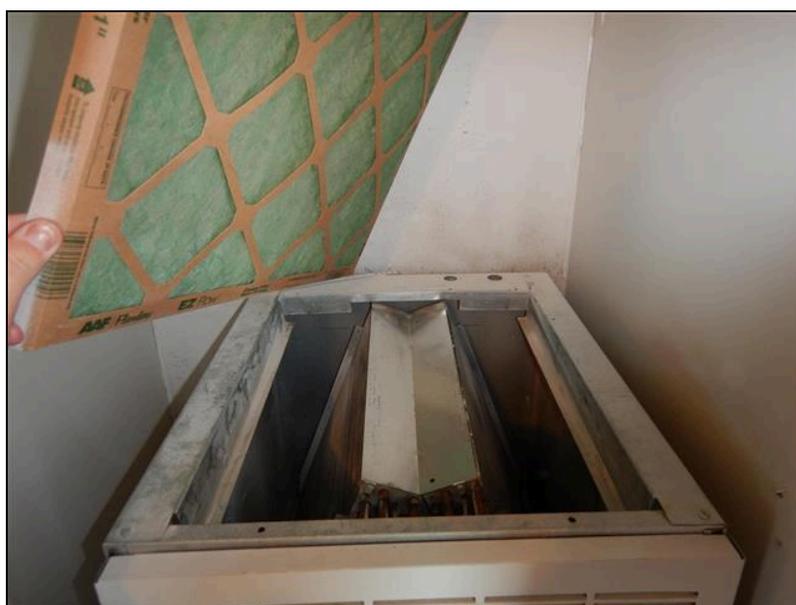
(4) The HVAC air filter does not have a slot or secured location to be installed. Air filter is sitting on top of air handler. This could allow dust to bypass the filter and contaminate the coils. Recommend correction by a qualified contractor.

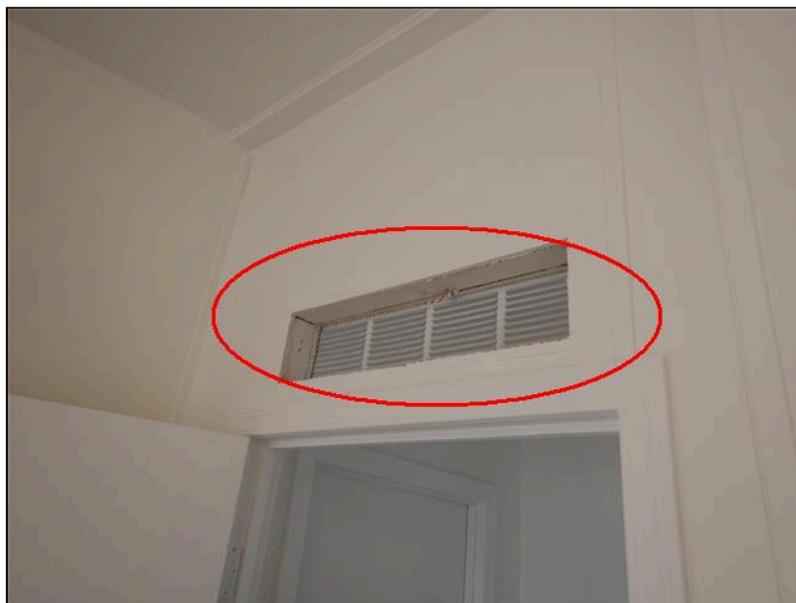
(1) Missing vent grill. Recommend correction as needed. Noted in bedroom closest to laundry room.

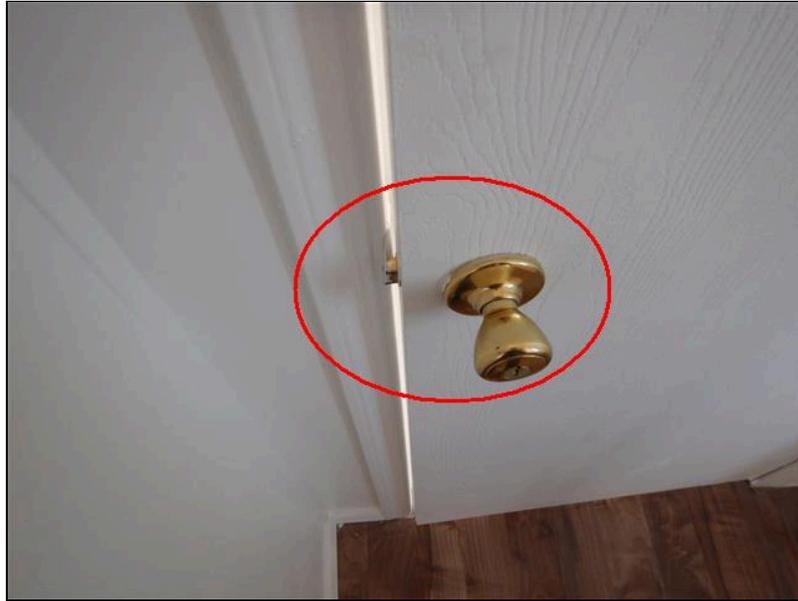
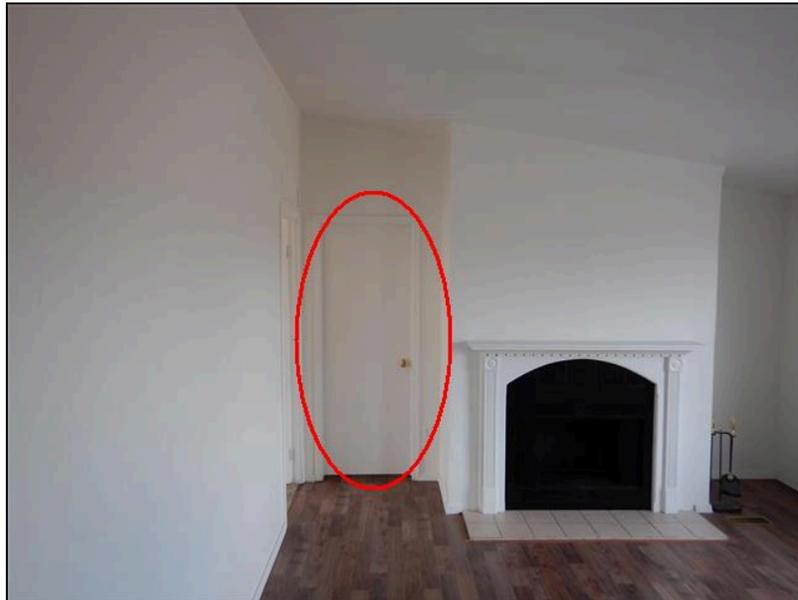
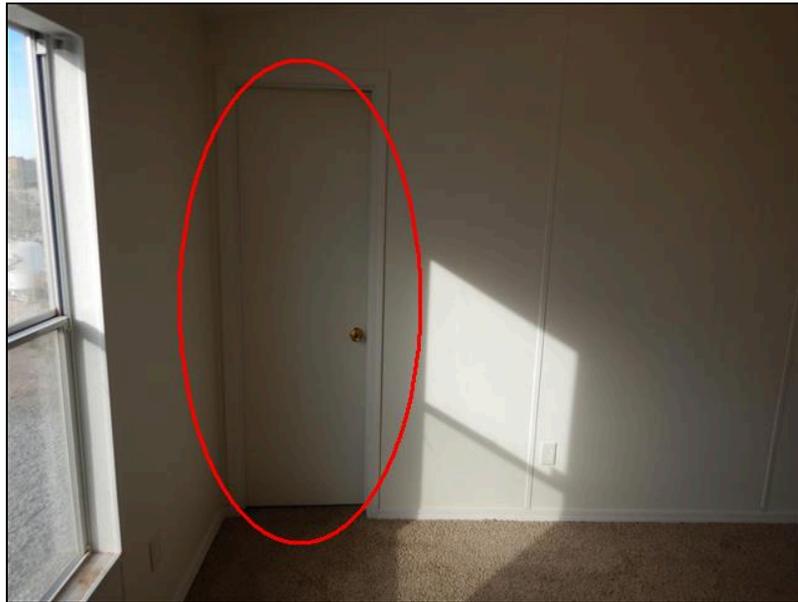
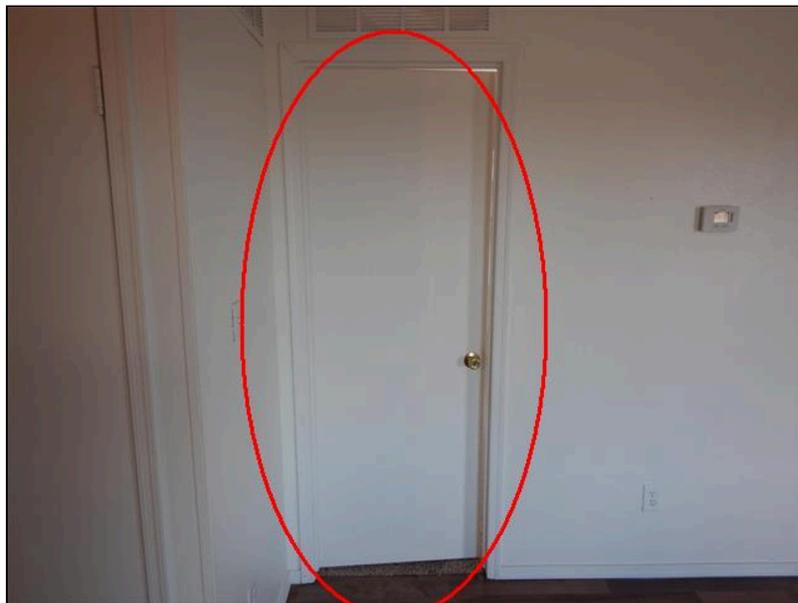
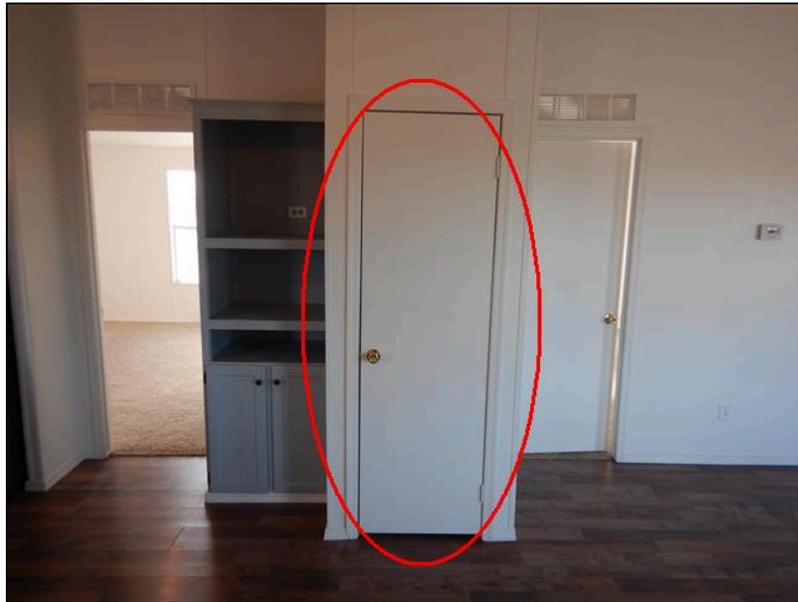
9.3 DOORS

Striker/striker plates misaligned. Doors do not latch. Recommend adjustments. Noted at multiple

locations including laundry room, closet in bedroom closest to laundry room, bedroom closest to kitchen, and air handler closet.

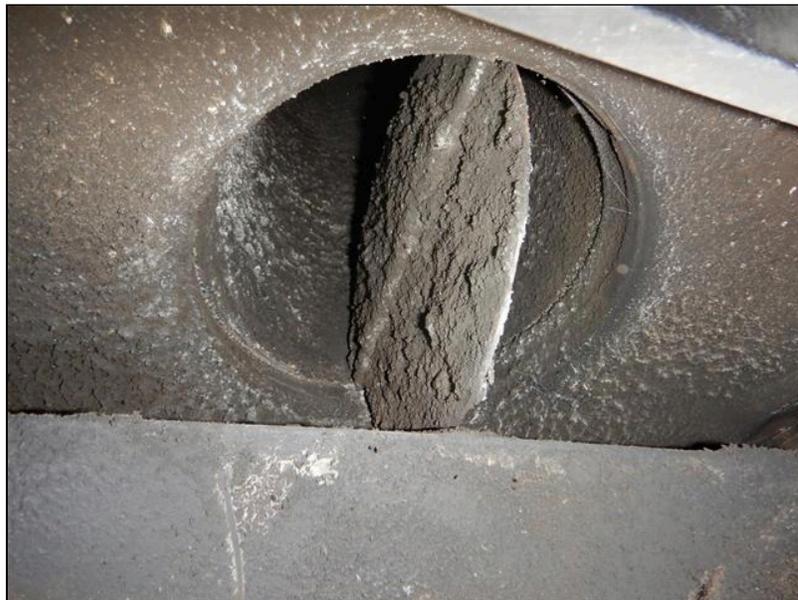
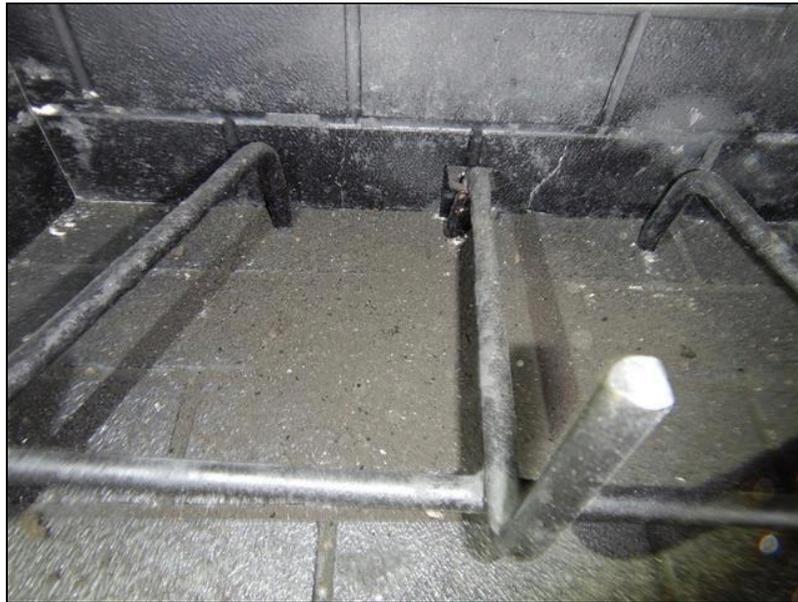
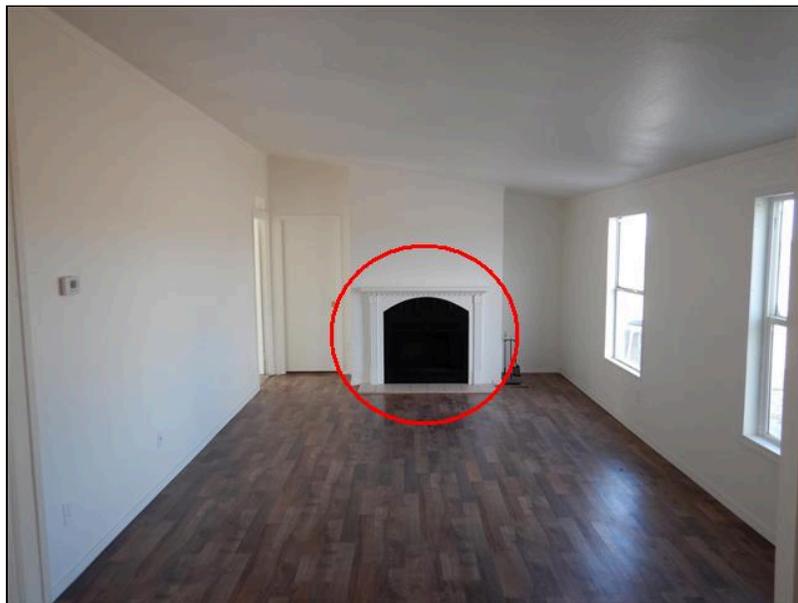
9.6 FIREPLACE & CHIMNEY

Fireplace chimney dirty. Recommend cleaning before use.
