INSPECTION REPORT
31546 W Grant St
Buckeye AZ 85326

INSPECTED BY
David Drown
Vannier Home
Inspections
73226

INSPECTION DATE
📅 11/9/2021
🕒 08:00 AM

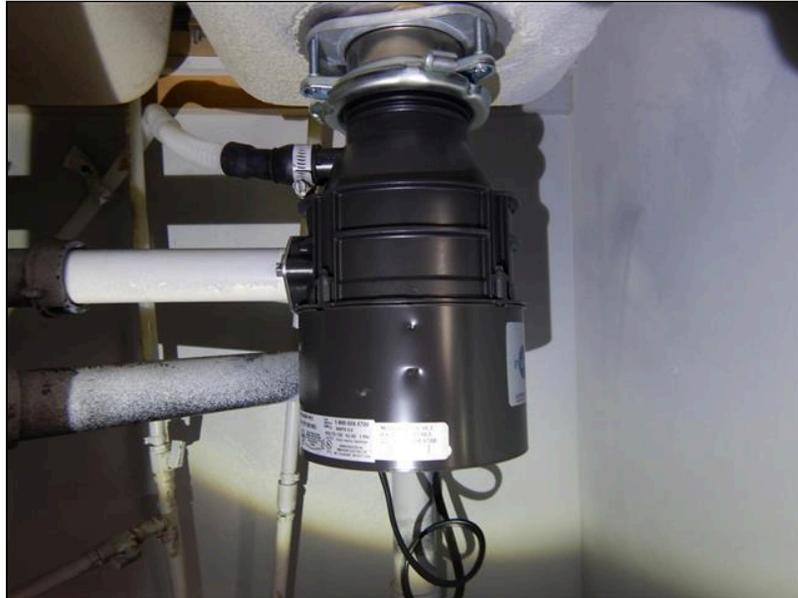
10.1 DISPOSAL

Garbage disposal is very loud during operation. Recommend correction.
