## Special Buyers Report

Buyers Report : 1/28/2017

# XPERT Home Inspections

1222 Main St West, Hartselle, Alabama

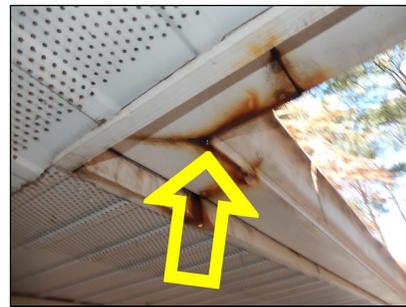
2.0 Item 8(Picture)

2. Fascia needs a little adjustment as it has become loose and the edges of the soffits are exposed. Item 6(Picture)
3. The gutter leaks at the center joint just over the front steps and this should be sealed and repainted or fully replaced. Item 8(Picture)

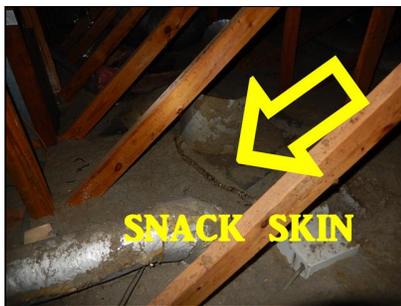
2.0 Item 13(Picture)

4. Insulation is aprox R30 in the attic
5. I found a snake skin wrapped around an exhaust vent near the air handler. Item 13(Picture)
6. The exhaust vents at the bathrooms exhaust to the attic and there are no ducts to direct the exhaust up and away from the insulation.

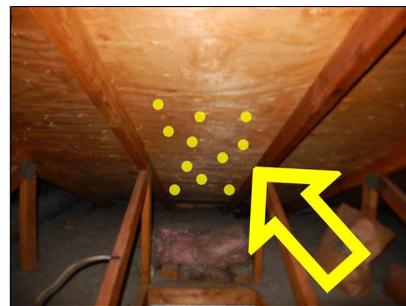
2.0 Item 14(Picture)

7. When entering the attic, please take care not to scrape your head on the bottom side of the roof where roofing nails are protruding and are a hazard. Item 14(Picture)

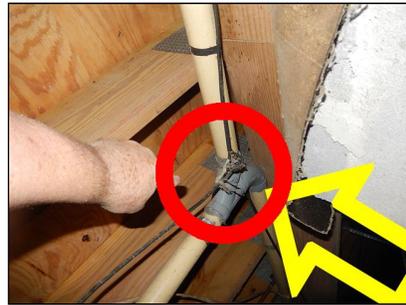
3.0 Item 18(Picture)

10. GFCI outlets are missing at outlets in the kitchen, outside the home and in the garage area, please improve them.
11. A small electrical issues exists ONLY if the old house vac is used. The wiring for the switches is strapped to the vacuum pipes and spliced with tape. The vacuum was not active at the time of the inspection and unless the system is used, there is no reason to make these upgrades. Item 21(Picture) Item 18(Picture)

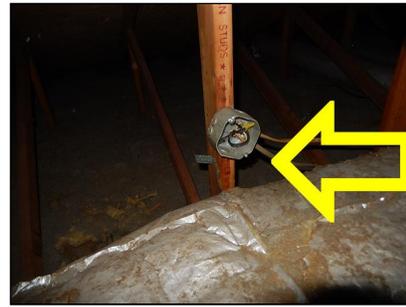
3.0 Item 24(Picture)

8. I found a small number of uncovered junction boxes in the crawlspace and attic, they are simple improvements. Item 24(Picture)
9. ONE loose lighting fixture is lying on its side with a bulb in it at the entrance to the attic, please secure the bulb to a rafter or support. Item 23(Picture)

Junction boxes should be covered, there is NEVER a reason to leave one open. Open junction boxes are prime contributors to house fires. Covers are inexpensive, easy to apply there is no excuse not to add the covers especially in the attic, under cabinets or in the crawlspace. This is a building code and fire safety issue.

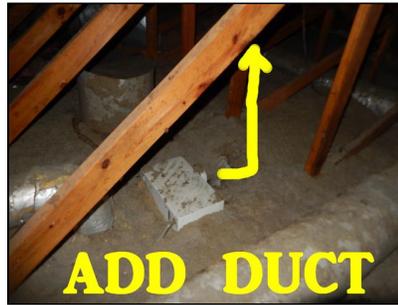
3.0 Item 25(Picture)

12. The exhaust ducts for the bath fans are missing at the fans. Item 25(Picture)

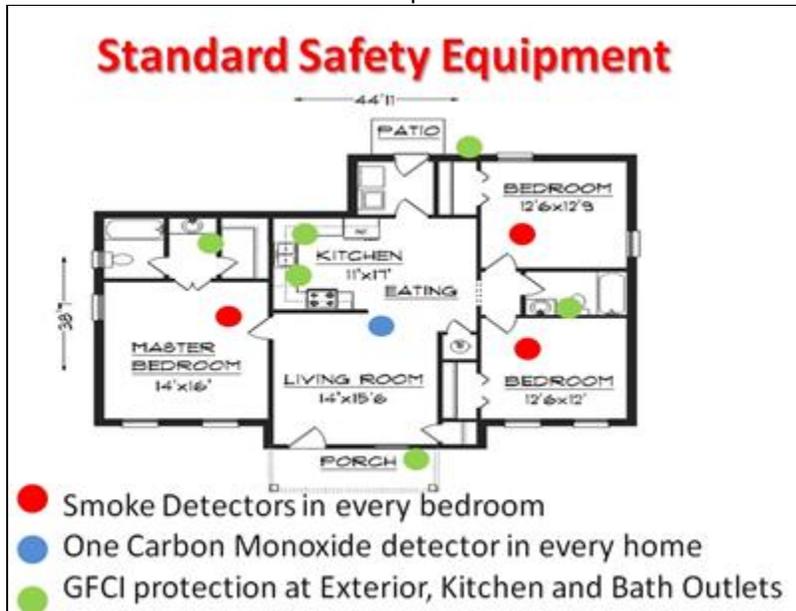
3.7 Item 1(Picture)

A proper home inspection includes determining if the safety equipment is in place such as smoke detectors, carbon monoxide detectors and GFCI protection for outlets near water or moisture.

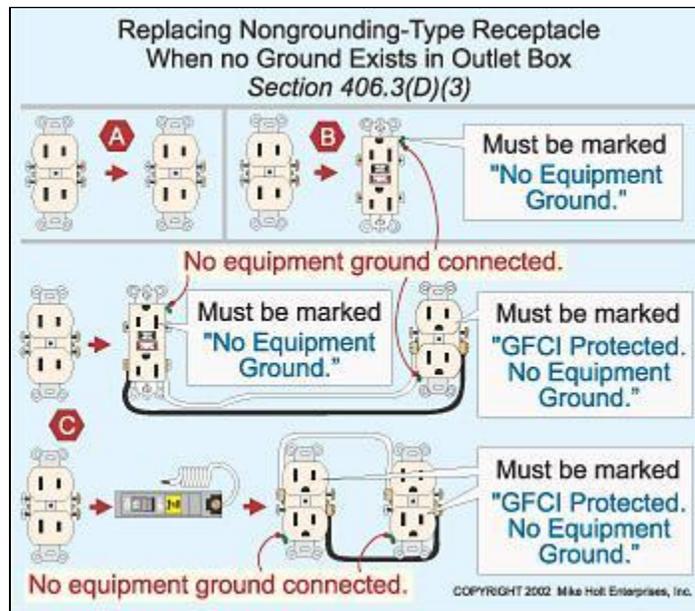
3.9 Item 1(Picture)

A grounding-type receptacle that is GFCI protected without an equipment grounding conductor is a safer installation than a grounding-type receptacle with an equipment grounding conductor (if GFCI protection is not provided). This is because the GFCI protection device will clear a ground-fault when the fault-current is 5 milliamperes (+ or - 1 milliampere), which is less than the current level necessary to cause serious electric shock or electrocution,

A grounding-type receptacle without a ground is a safe installation as long as the GFCI protection circuitry within the device has not failed from shorts and voltage transients. To insure proper GFCI protection, test the GFCI monthly in accordance with the manufactures instructions and if the GFCI test does not operate properly, replace the GFCI protection device.

- (a) Replace the 2-wire receptacle with another 2-wire receptacle.
- (b) Replace the 2-wire receptacle with a GFCI-type receptacle and marked the receptacle with the words "No Equipment Ground."
- (c) Replace the 2-wire receptacle with a grounding-type receptacle where protected by a GFCI protection device (circuit breaker or receptacle). Since the grounding terminals for the receptacles are not grounded, the receptacles must be marked with the words "GFCI Protected" and "No Equipment Ground."

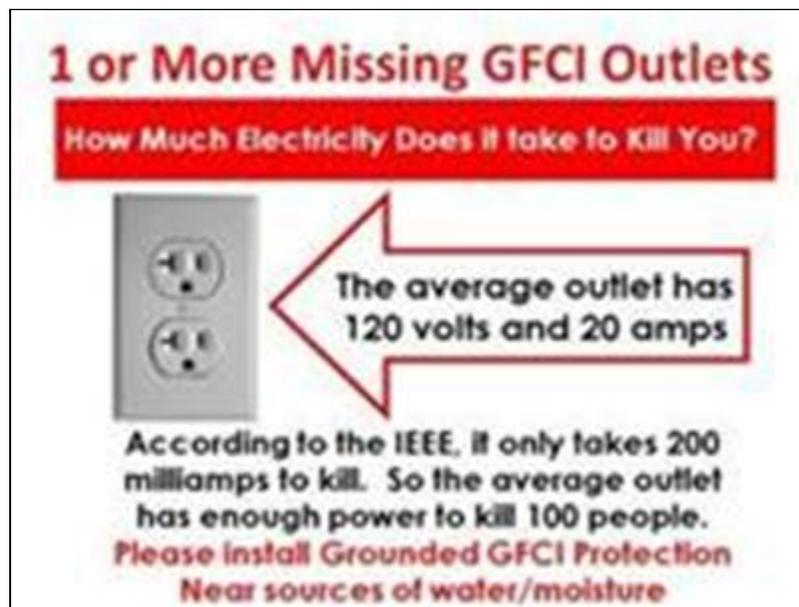
3.11 Item 1(Picture)

6. The kitchen, outside, and garage outlets are missing GFCI protection and it should be added.
7. Smoke detectors are required inside each bedroom and at least one carbon monoxide detector should be put into place

The National Electrical Code requires GFCI protection of receptacles located outdoors and in bathrooms, garages, and spa areas. This GFCI circuit breaker provides protection against overloads, short circuits, and ground faults. It detects very low levels of electrical current leaks (ground faults), and acts quickly to shut off power, preventing serious shock.

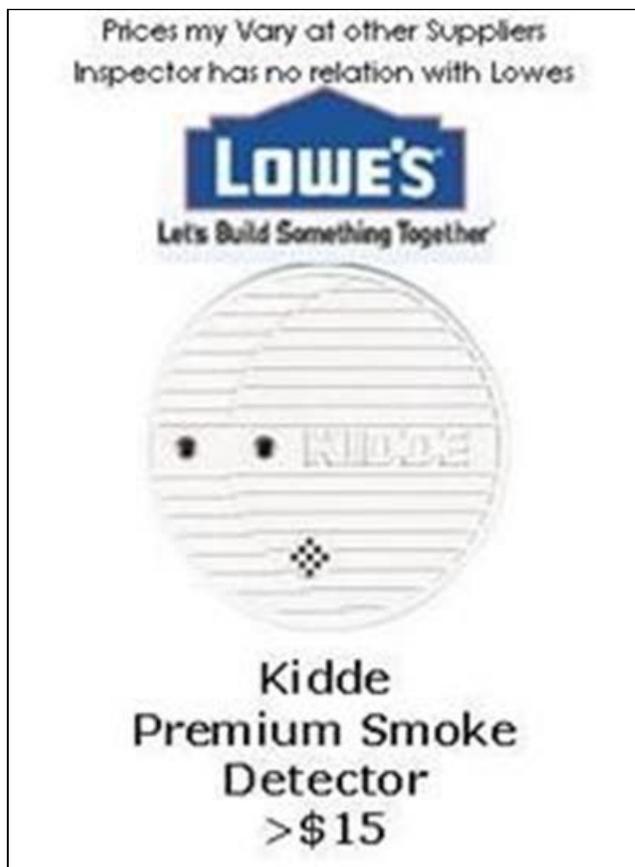
3.12 Item 1(Picture)

**Missing or faulty Smoke Detectors****Issues or Concerns that may require Action**

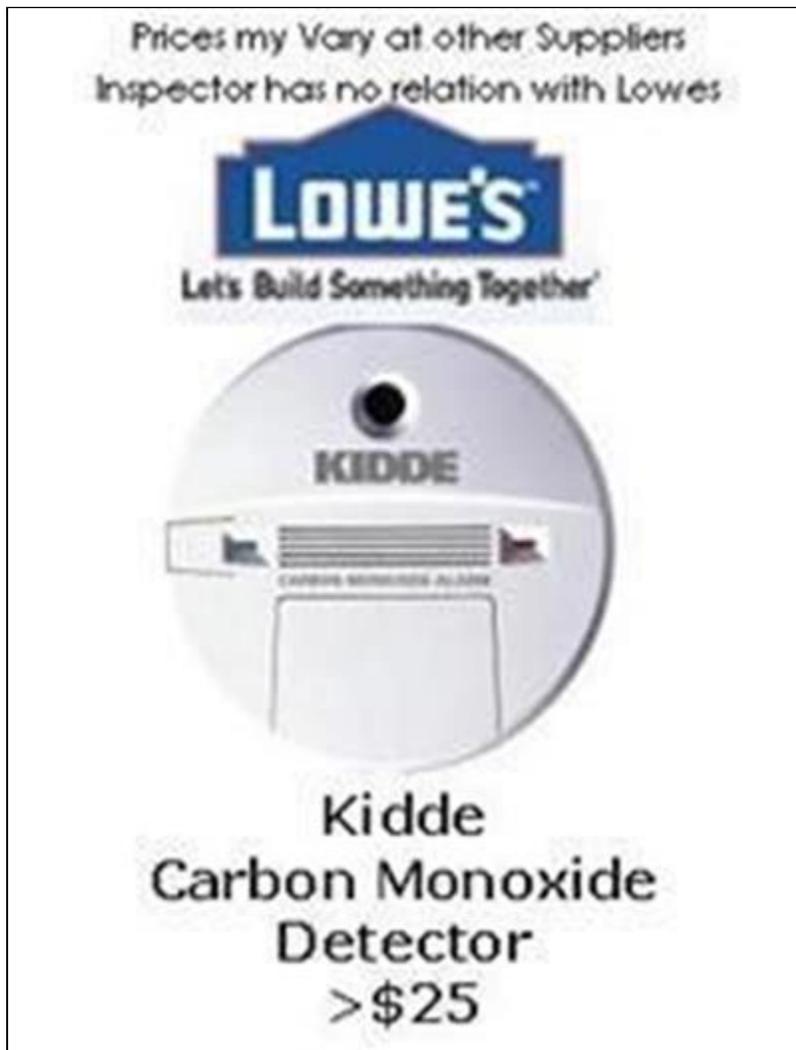
3.13 Item 1(Picture)

**This home is missing the safety equipment, please install**

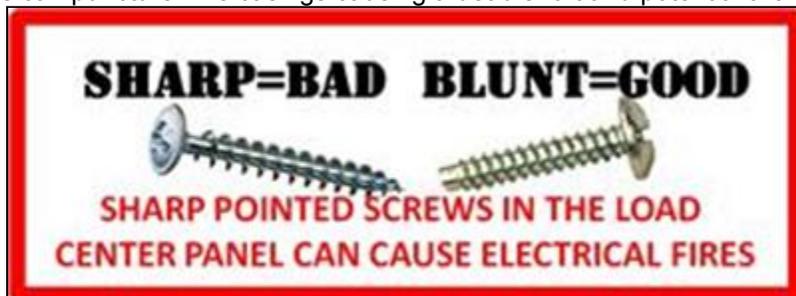
3.14 Item 1(Picture)

One or more screws were found to be missing that hold the cover on the load center. This is a minor issue but one that required the proper screws. Use only blunted panel screws as sharp pointed screws can puncture wire casings causing a dead short and potential arcing or fire.

1. Screws are missing in the load center cover plate and the missing screws should be replaced. Item 22(Picture)
2. Some fixtures in the home have bulbs that appear to be out of service. Item 4(Picture)

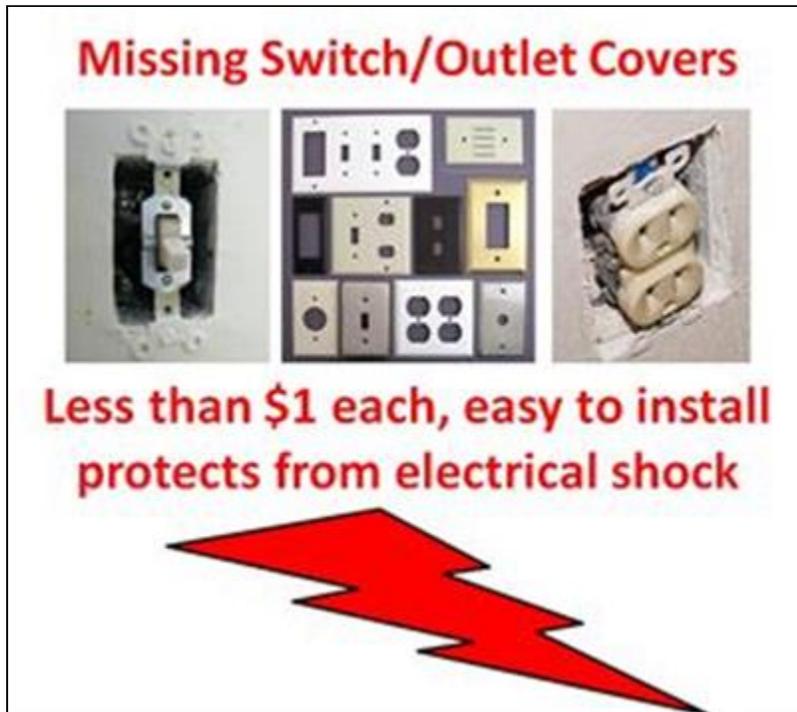
3.16 Item 1(Picture)

Outlet and Switch covers are necessary and will protect you and your family from electrical shocks. Outside outlets and switches require special approved covers to guard against moisture and further issues.

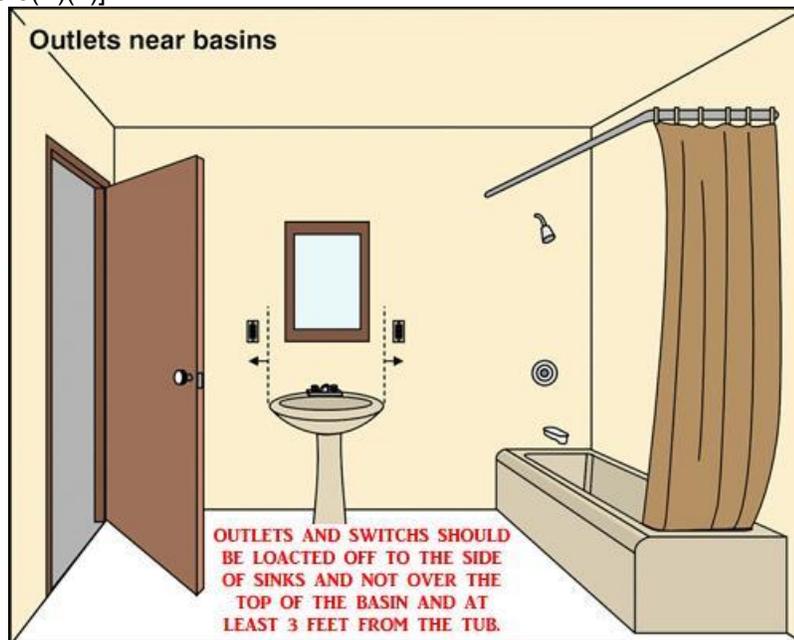
3.18 Item 1(Picture)

10. In the master bath, I found a GFCI outlet positioned directly over the sink and this is a code/safety issue and it should be moved to one side... this is to prevent cords from lying in a sink and this creates a shock hazard.

In dwelling units, not less than one 15A or 20A, 125V receptacle outlet must be installed within 3 ft from the outside edge of each bathroom basin [210.52(D)]. The receptacle outlet must be located on a wall or partition adjacent to the basin counter surface, or on the side or face of the basin cabinet not more than 12 in. below the countertop [210.11(C)(3)]. One receptacle outlet can be located between two basins to meet the requirement, but only if the receptacle outlet is located within 3 ft of the outside edge of each basin. The bathroom receptacles must be GFCI-protected [210.8(A)(1)].

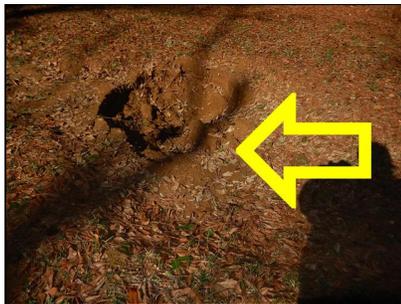
4.0 Item 7(Picture)

1. The exterior is brick and in good order, there is a small number of sheer cracks in the bricks in a couple areas but this is consistent with the foundation repairs that have been made in the home in the past and they are just leftovers. Item 8(Picture)
2. Handrails at the front door are loose and need replacement or repairs. Item 13(Picture)
3. There was once a pool on site, it has been filled in and there is some settlement in that area. Item 7(Picture)

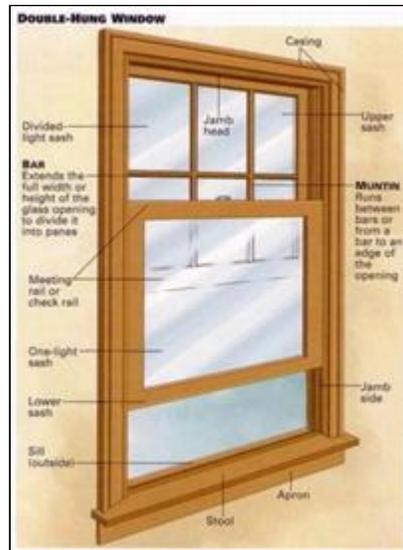
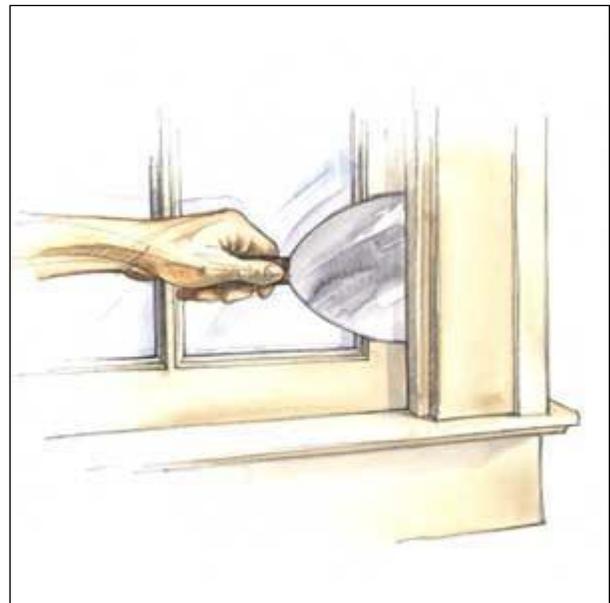
The windows were inspected and appear to be in a general overall good condition.

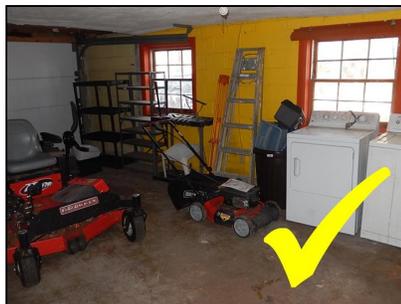
5.0 Item 1(Picture)

1. The garage has a manual door, it was operational.
2. The ceiling in the garage is partly missing and this constitutes a missing required firewall. Today's homes are required to have fire rated ceilings, the home is about 60 years old and this does not apply but having a fire rated ceiling would be a good thing.

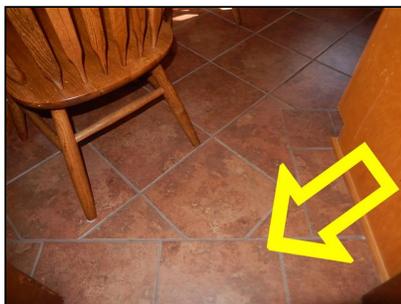
6.0.A Item 1(Picture)

1. Tile in the kitchen is soiled. It can be cleaned. Item 1(Picture)
2. The anti tip bracket is missing at the oven, please add.Item 4(Picture)
3. The microwave oven was showing an error code. It appears to need repairs or replacement. Item 5(Picture)
4. The microwave is not so old but has rusted up and it should be freed up. I feel it can put back into use. Item 8(Picture)

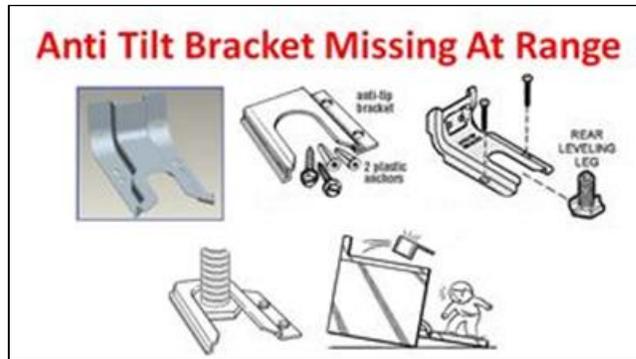
6.3.A Item 1(Picture)

**6.3.A Missing Anti-Tilt Bracket  
Issues or Concerns that may require Action**

Check with your owner's manual for directions on how to properly install the anti-tip bracket for your range. There are several safe ways to check if the anti-tip bracket is installed correctly. If your bracket is missing or not working, it is very important to repair or replace it.

If your range was manufactured after 1991, contact your appliance retailer, property manager, or home builder and specifically request the anti-tip device to be installed. You can also check with the manufacturer for a replacement anti-tipping bracket and instructions for correctly installing the bracket. If your range was manufactured before 1991, check with the manufacturer of the range to see if they offer a retrofit anti-tip device for your range.

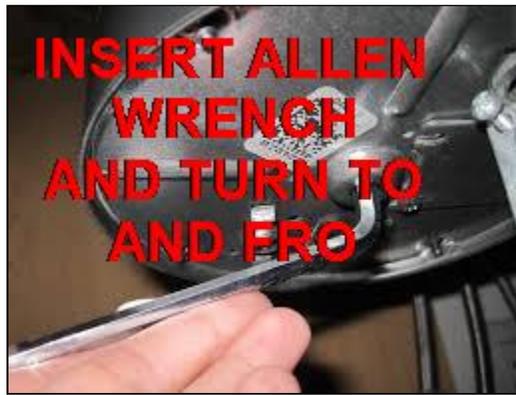
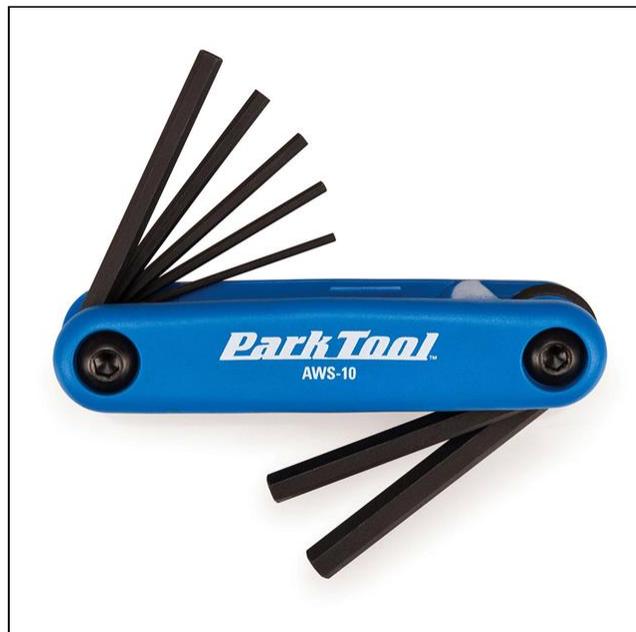
6.7.A Item 1(Picture)

If the flywheel was not stuck and the unit is humming with nothing in the grinding chamber, then the garbage disposal's motor has seized or has one or more frozen bearings. If a bearing is seized, then the garbage disposal needs to be replaced.

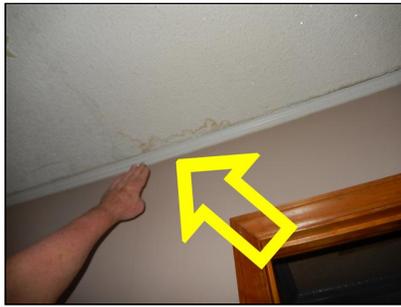
7.0.B Item 1(Picture)

7.3.B Water stains were found on the ceilings. Issues or Concerns that may require Action

Water stains could be from old leaks at the roof or even from a leak in plumbing or a back up cooling system leak. We do every thing we can to find the source of all of them but often they are relics form past issues now repaired.

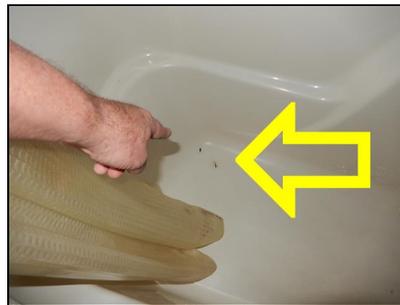
8.0 Item 5(Picture)

- 1. One tub shower has a very small ding in the fiberglass and this is minor. Item 5(Picture)

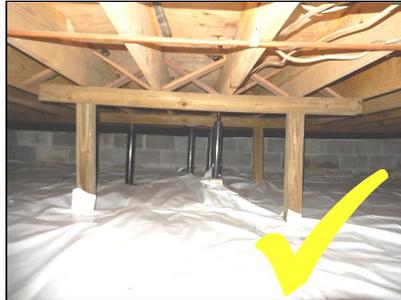
9.0 Item 1(Picture)

1. The crawlspace has been improved with jacks and beams and they appear in good order and a new moisture barrier was in place and in good order. The crawlspace was dry and in good order. Item 1(Picture)

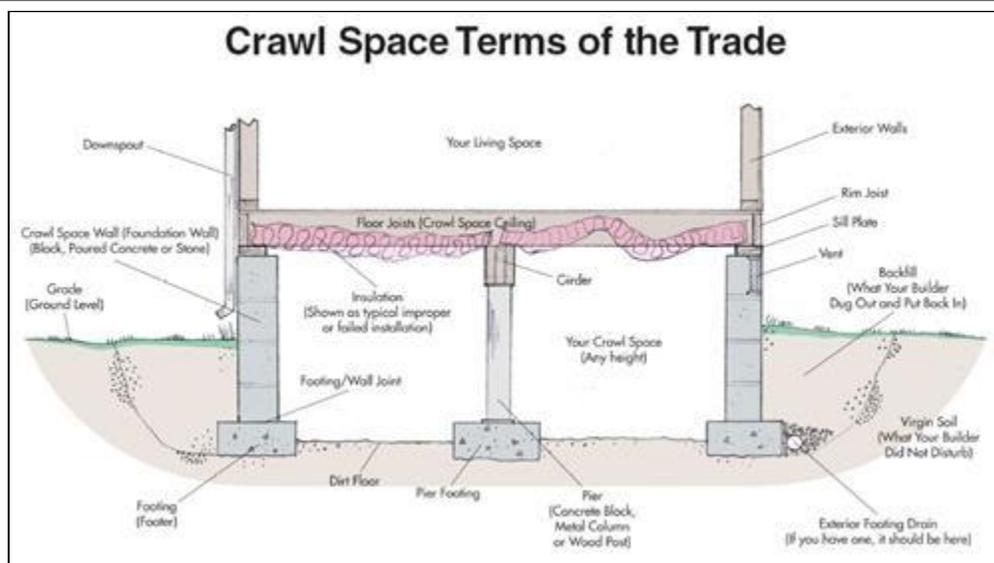
9.6 Item 1(Picture)

The picture below is of a typical crawlspace and we make the following recommends to help keep your home safe and sound for years to come.

1. Install a well maintained moisture barrier or 6 mil plastic.
2. Install automatic venting that opens and closes with the weather
3. Consider installing an exhaust fan that operates base on humidity and it should be pulled into a GFCI protected outlet.

4. Remove or do not add foundation insulation, it holds moisture and with the auto vents, the temperature of the crawlspace will rarely dip below the ambient temperature of the earth (57 degrees in this area).

7. If you crawlspace access door is loose or low below grade, add a well block the water there too.
8. If you dont have gutters, get them and if you do have gutters, make sure the downspouts port water away from the foundation.

9. Keep electrical wires off the floor of the crawlspace
10. Ideally, the earth around the foundation should slope away at least dropping six inches in ten feet, if it does not, and you cant make it so, install one or more sump pumps in the crawlspace.

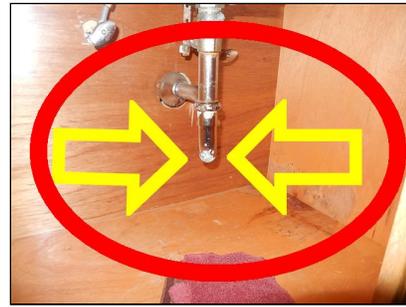
10.0 Item 2(Picture)

1. The plumbing was in good order and the plumbing supply lines are generally copper.
2. Under one vanity, i found a chrome drain corroded and it will soon leak and I recommend it be repaired with PVC now. Item 2(Picture)
3. The 50 gallon water heater is electric and circa 2002 = 14/15 years old. Item 5(Picture)
4. When the water heater is replaced, please add an expansion tank, a new code that is in place because the water meters now have check valves.

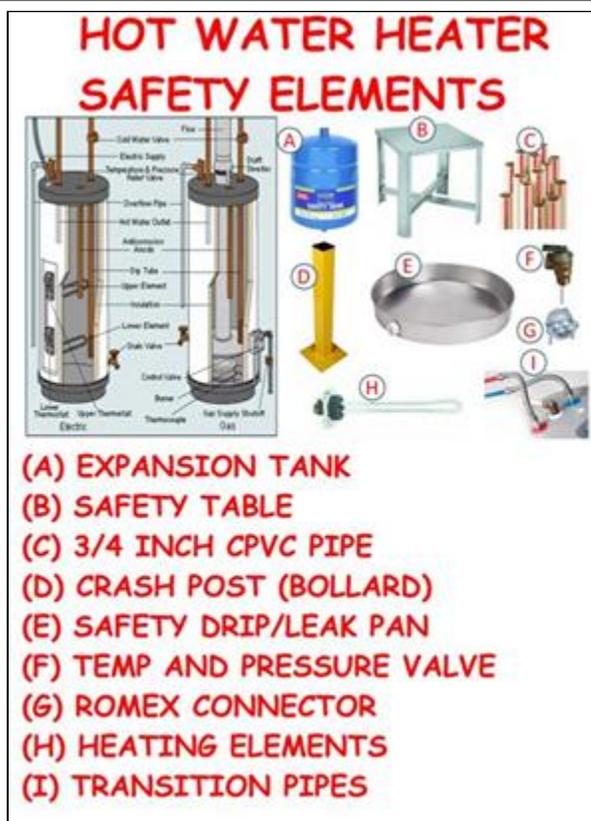
10.6 Item 1(Picture)

(B) **SAFETY TABLE :** Protects against flash fires due to spilled fuels. Required in garage installations. The Uniform Plumbing Code (Section 510.1) states that:- Water heaters generating a glow, spark or flame capable of igniting flammable vapors may be installed in a garage, provided that pilots, burners or heating elements and switches are at least eighteen (18) inches above the floor level. This applies also to **ELECTRIC WATER HEATERS** installed in garages.

(D) **CRASH POST:** Protects tank and fuel supply from runaway vehicle damage

(E) **SAFETY DRIP PAN:** Protects floors from leaks of failing tanks and should be drained to outside the home.

(F) **TEMPERATURE AND PRESSUE VALVE:** First defence against failed thermostat, provides pressure relief and this drain should be drained to the outside of the home with no less than a 3/4 inch line.

(I) **TRANSITION PIPES:** Particularly in CPVC plumbed homes, transition pipes protect CPVC from becoming brittle due to constant heat. Brittle pipes are prone to crack and leak without warning.

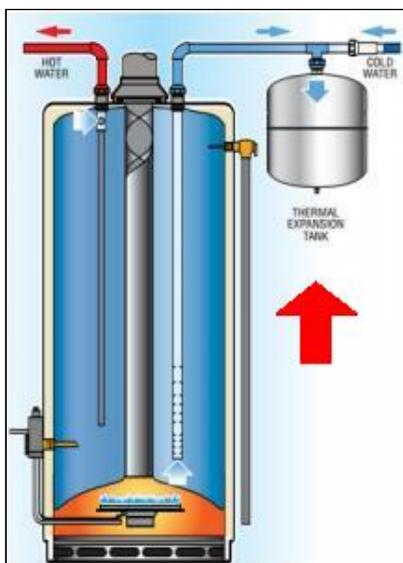
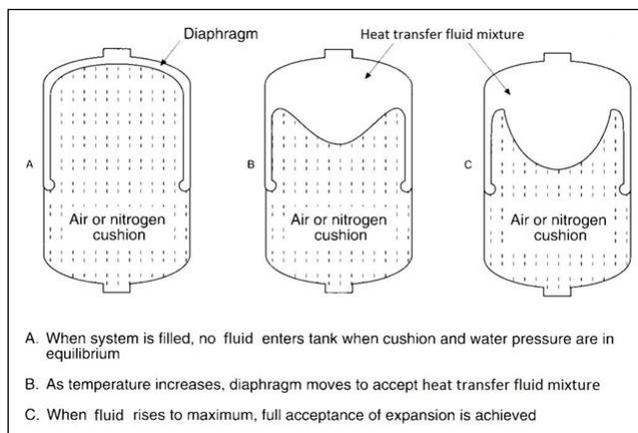
10.7 Item 1(Picture)

The International Residential Code (P2903.4.2) requires the installation of an expansion tank on a hot water tank where thermal expansion may cause an increase in pressure. The tank is only required when the water supply system incorporates a backflow prevention device, check valve or similar device.

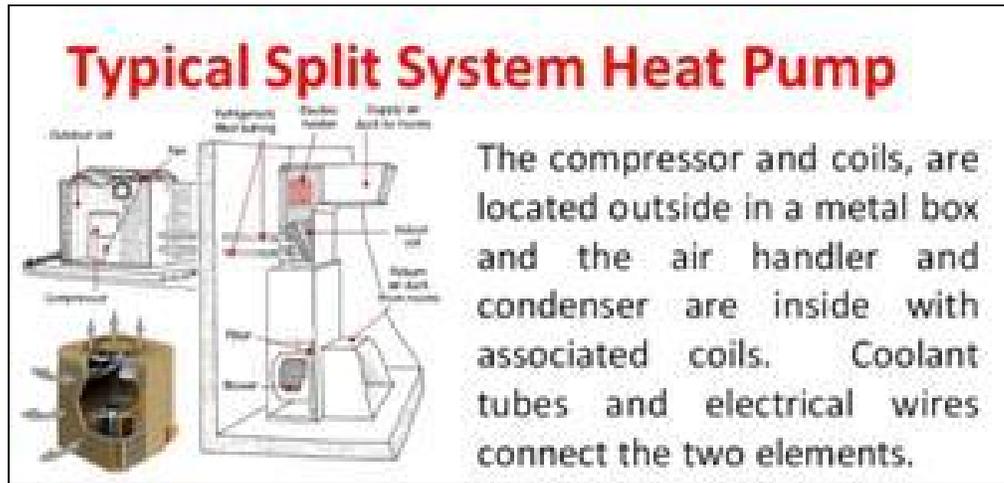
11.8 Item 1(Picture)

This home has a split heat pump. There are inside and outside elements and the system is all electric.
