PROPERTY INSPECTION REPORT

10035 Towne Rd.
Carmel IN

Property inspection performed on 10/20/2016 for property address: 10035 Towne Rd. Carmel, IN. Report prepared by

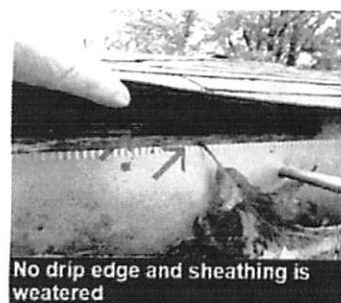
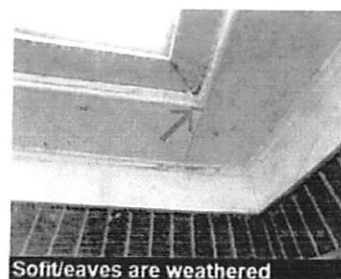
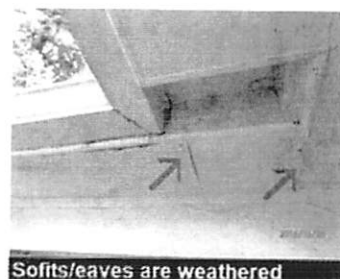
Gutters are full of debris

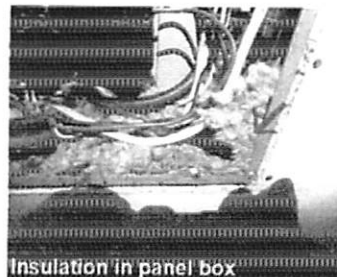
Inside of cabinet has insulation at bottom that could be a fire hazard, and needs to be removed. The sheathing on the wiring is too long inside the panel and should only be an 1" or less. There is a grommet missing for the wires entering top center of panel box, these should be secured. Due to the sensitive nature of electrical components and associated safety hazards working with electricity, and considering the long term integrity of the repairs, a licensed electrician is best suited to perform repairs no matter how trivial the repairs may seem.

Sheathing too long in panel box

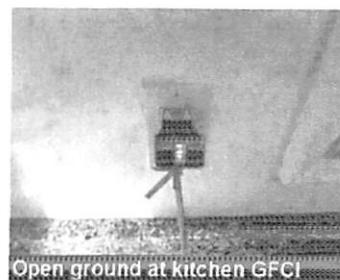
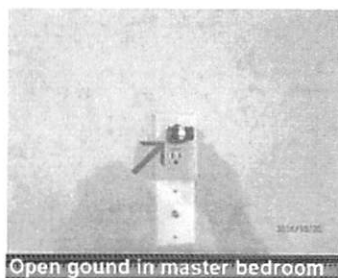
Exterior Receptacles

Observed at the kitchen receptacle: GFCI has an open ground. The GFCI will not operate correctly. Open ground in master bedroom receptacle for a TV up high on wall.

Due to the sensitive nature of electrical components and associated safety hazards working with electricity, and considering the long term integrity of the repairs, a licensed electrician is best suited to perform repairs no matter how trivial the repairs may seem.

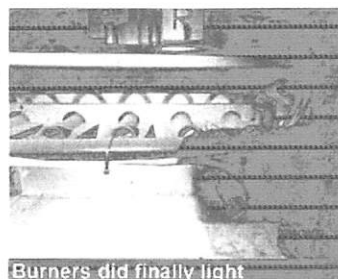
To maintain peak and effective working condition of the heating system especially with older units, annual preventive maintenance should be performed. Unit responded to normal operating controls but took 4 times to ignite the burners as intended. A qualified technician is recommended to service as necessary.
