**Perfection Home Inspections**  
**1042 E. Fairbrook Circle**  
**Mesa, AZ 85203**  
**602-524-2916**  
**perfectionhomeinspections.com**

Client Information: Record Number 7458

**Champ, Joe**  
**373 N. Arizona Ave.**  
**Chandler, AZ 85249**

Inspected 12/13/17 1:30 PM  
Built 1941  
1300 sf

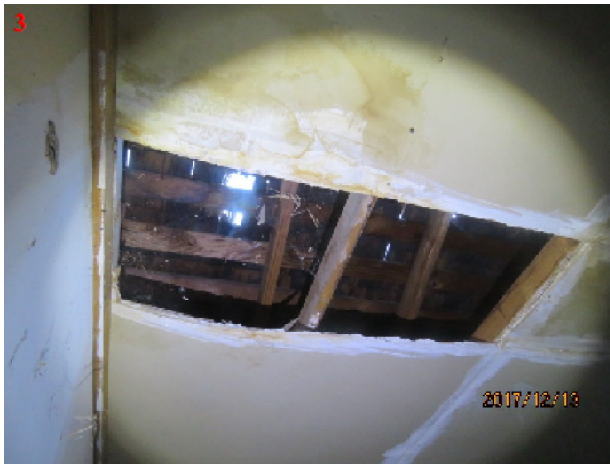
### **Major Defect** Garage / Carport Roof - Shed, Gable

The far back section of garage with the gable roof and wood shake shingles is in poor condition with holes in the roof. This is allowing water to leak into this section of the garage. This section of the garage may need to be demolished. Recommend a qualified roofing contractor evaluate and make all necessary repairs.

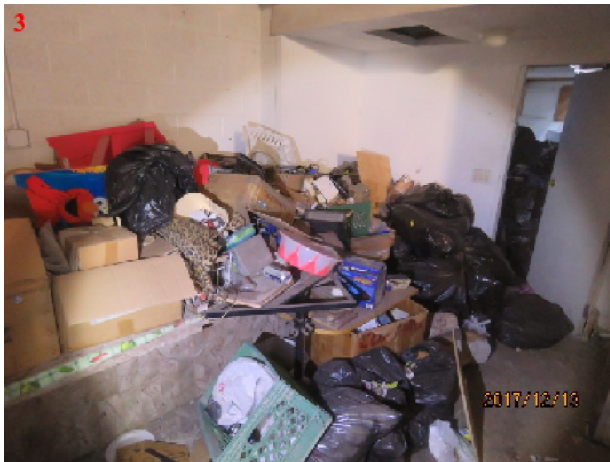
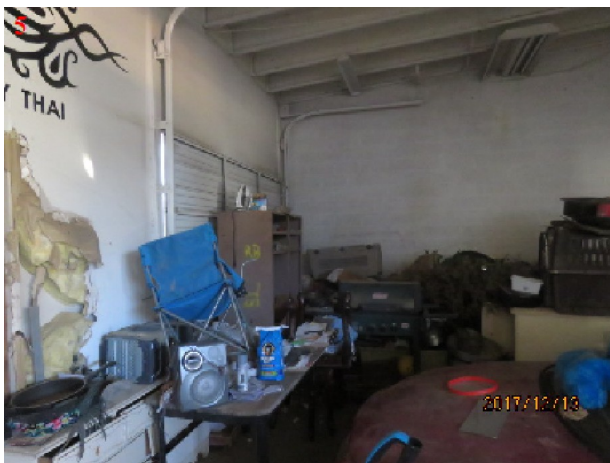
### Service/Repair GARAGE - Garage Stuff

Stuff in the garage blocks view of the interior of the garage.  
Recommend inspecting garage area after the stuff is removed.  
None of the garage overhead door can be tested due to stuff in the garage.

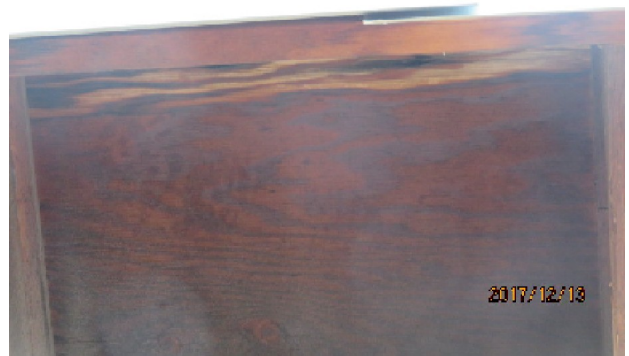
### **Service/Repair** Garage Fascia/Soffit - Wood

Water stains in the garage roof soffit on the roof sheathing.  
Recommend a qualified contractor evaluate and make all necessary repairs.

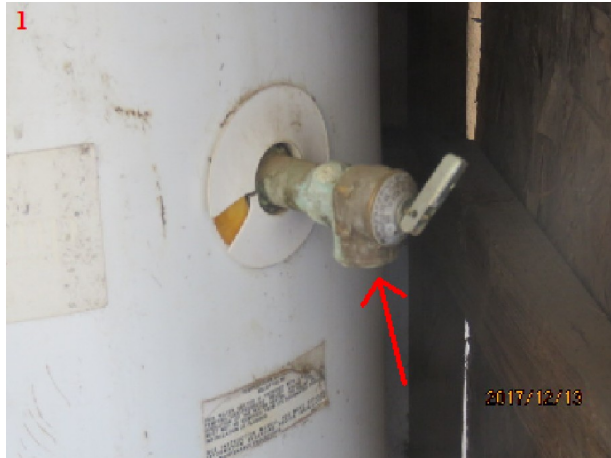
**Safety Concern** Temp. Pres Relief Valve and Pipe - Ext Pipe Missing

Recommend the water heater temperature and pressure relief valve have a pipe extended from the valve to within 12 inches to the ground and point straight down. The current arrangement is a safety issue. Scalding steam can unexpectedly blow out the end of this pipe and the chances of someone getting burned increases the further the pipe gets above the ground. The water heater temperature pressure relief valve was not operated unless other wise noted in this section of the report.

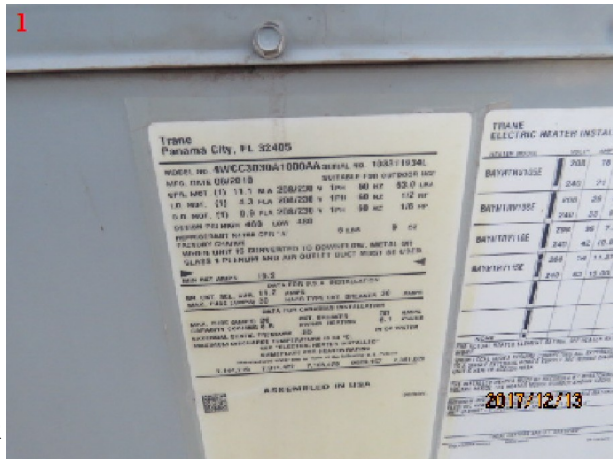
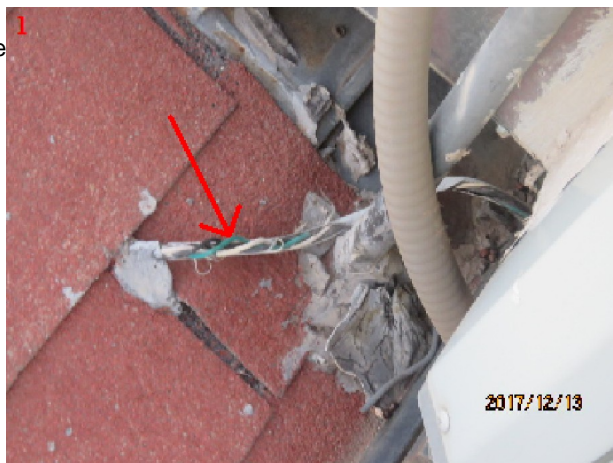
### Service/Repair Low voltage thermostat wires - Cracked insulation

The low voltage wires from the thermostat to the AC coil on the exterior have been damaged. Damage to these wires can cause the AC unit to malfunction. Recommend a qualified contractor evaluate and make all necessary repairs.

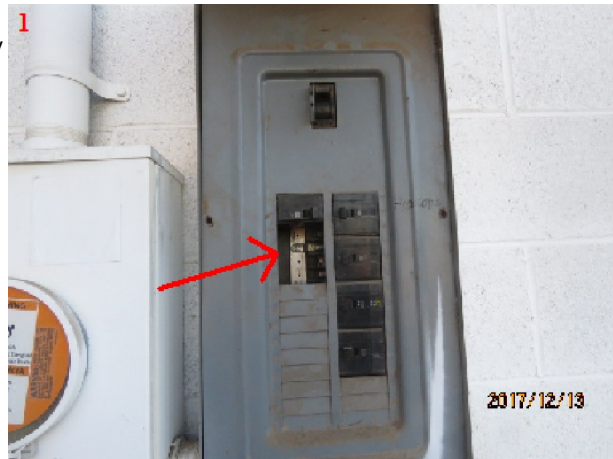
### **Safety Concern** Main Electric Panel - Inspected, Missing Knockouts

Garage panel breaker cover reads "Burnt" Recommend further investigation.

Knockouts are missing on two of the garage main electric panel cover plates. Recommend installing cover plugs to avoid electrical shocks. See picture

No breaker cover plate installed on the main electric panel.  
Recommend a qualified contractor evaluate and make all necessary repairs.  
Garage panel breaker cover reads "Burnt" Recommend further investigation.  
Knockouts are missing on two of the garage main electric panel cover plates. Recommend installing cover plugs to avoid electrical shocks. See picture

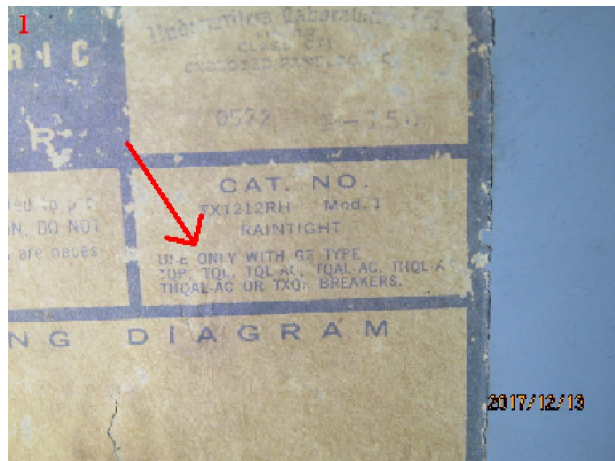
### **Safety Concern** Compatibility Issues - Wrong Breaker(s)

The electric panel calls for breakers made by the manufacturer of the panel and this panel has one or more breakers installed that are not made by the manufacturer. The wrong breakers can be a fire hazard and or a shock hazard. Recommend a qualified contractor evaluate and make all necessary repairs.

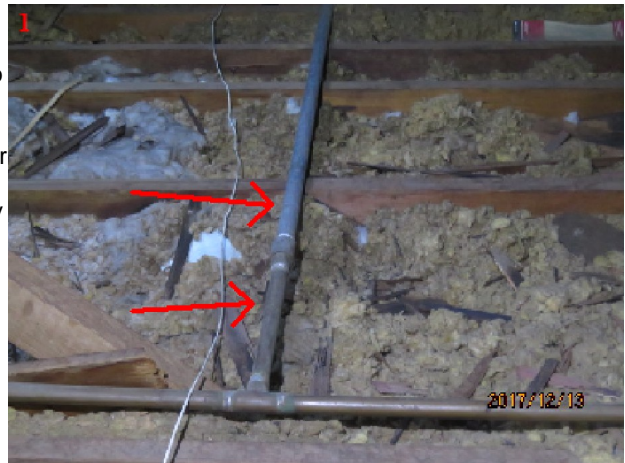
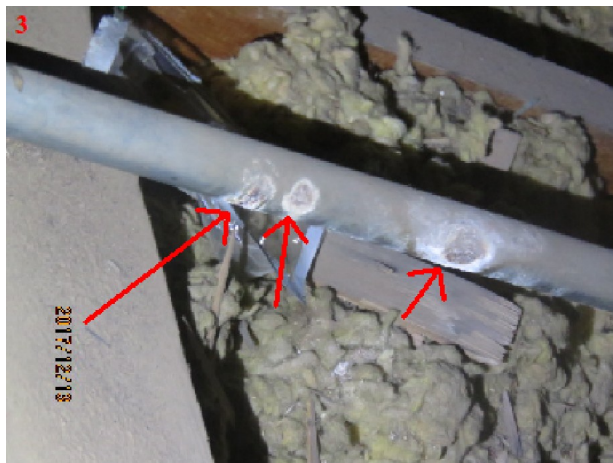
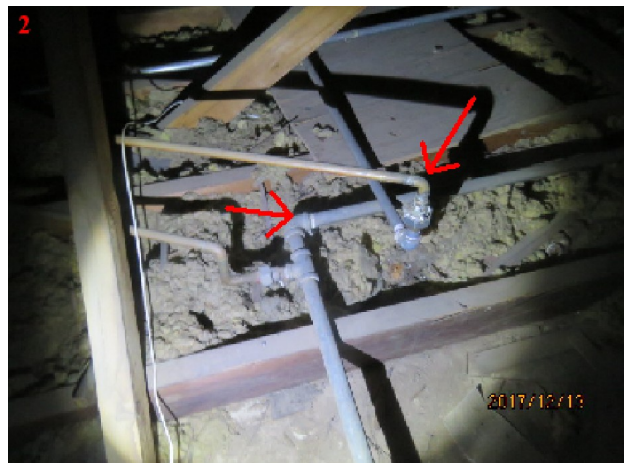
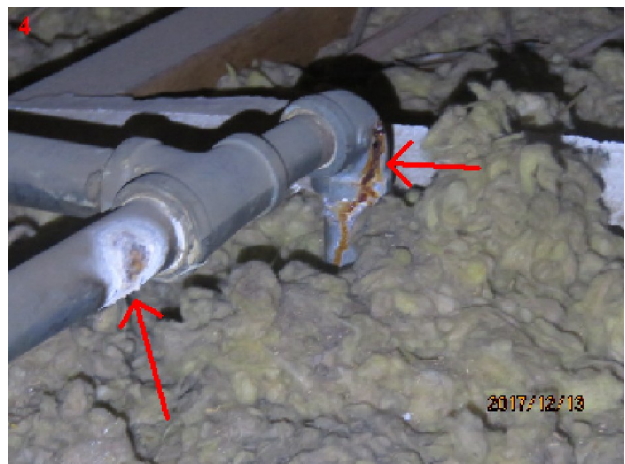
Galvanized pipes should not be installed with copper pipes. The two metals together create electrolysis a condition in which the metals corrode each other over time. This is not normally an emergency situation but should be corrected soon to avoid leaks and poor water flow and to increase the life of the plumbing system.

Recommend a qualified contractor evaluate and make all necessary repairs.

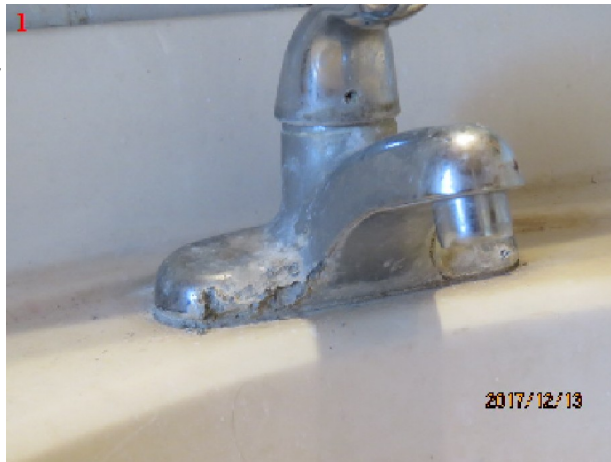
### **Service/Repair** Sink Faucet - Tested

The hot water supply to the sink has extra poor water flow and has been shutoff due to a faucet leak. The sink faucet is corroded. Recommend a qualified contractor evaluate and make all necessary repairs.

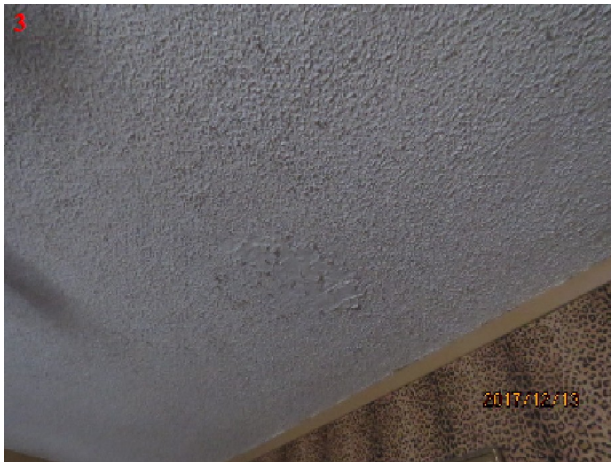
### Service/Repair Walls and Ceiling - Inspected

Holes in the walls and ceiling and missing wall tiles.  
Recommend a qualified contractor evaluate and make all necessary repairs.

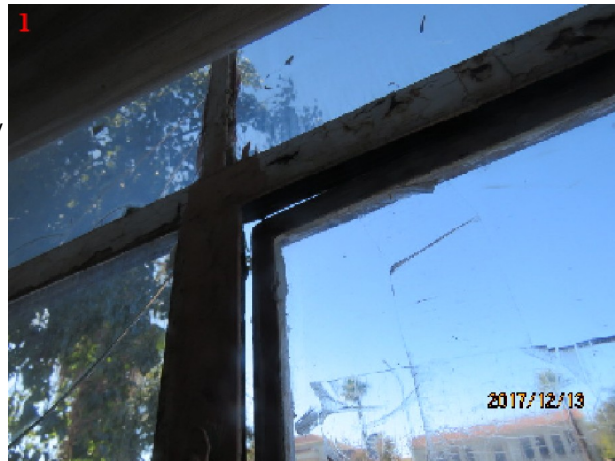
Recommend keeping all bedroom windows in proper working order so they can be used as a fire escape if needed.

Recommend a qualified contractor evaluate and make all necessary repairs.

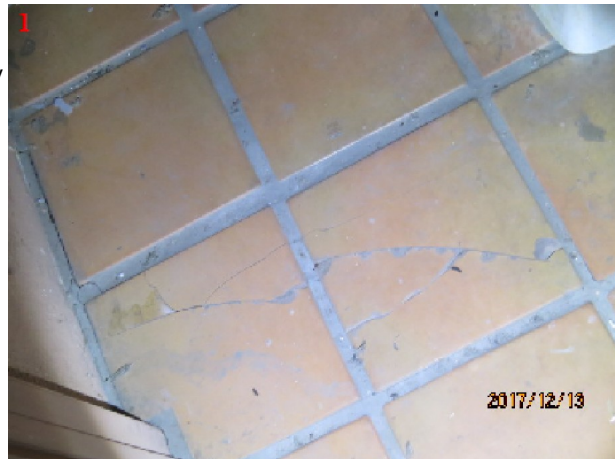
### **Service/Repair** Floor Covering - Tile

Several cracked floor tiles and the floor is sloped towards the exterior.  
Recommend a qualified contractor evaluate and make all necessary repairs.

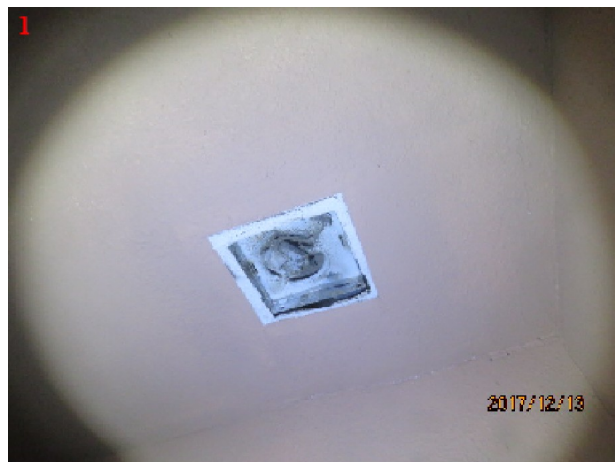
### **Service/Repair** Ventilation - Fan Cover Missing

Exhaust fan cover missing. Recommend installing a cover for the exhaust fan.
