## House Inspection and Repairs

The property was inspected by King Home Inspections on February 15, 2019.

# Property Inspection Report

14016 S. Rockhill Rd., Phoenix, AZ 85048

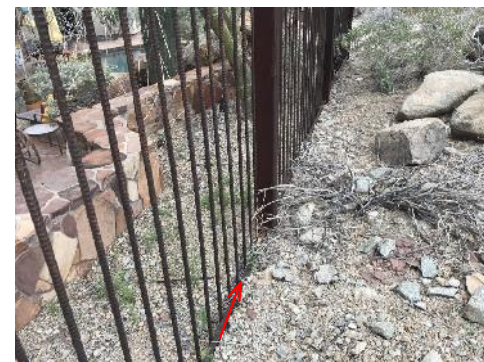
2. Fence Metal The soil covers the bottom rail of the fence in multiple places.

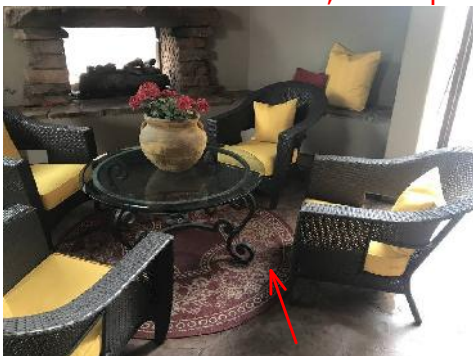
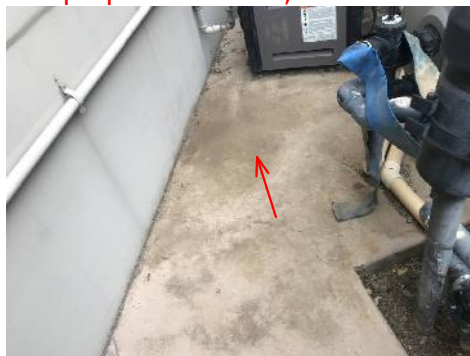
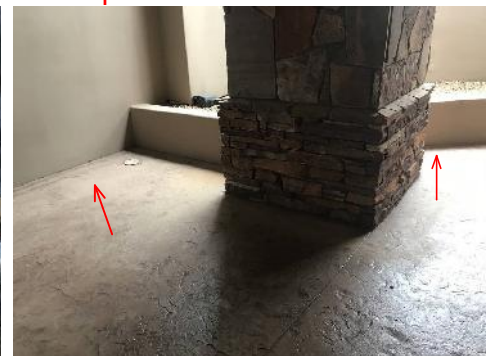
7. Patio/Courtyard Material Concrete There is evidence of water ponding in the outdoor entertainment area, the pool equipment area, the north west patio.

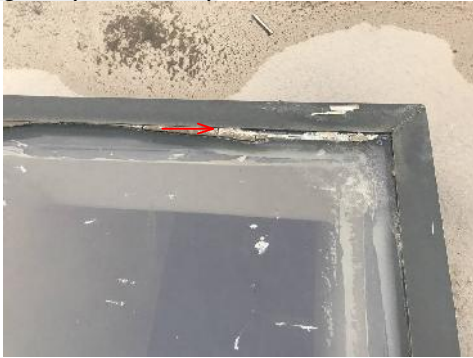
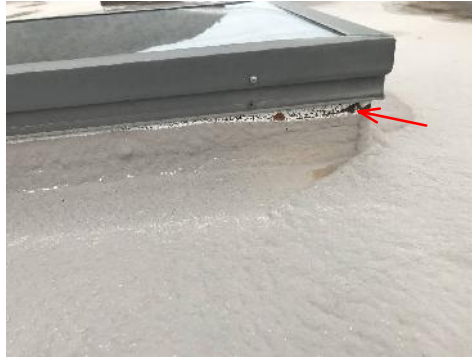
13. Skylights **Issue** The sealant is deteriorated at the edges of the skylights.

5. Skylights resealed with caulk
6. The "reverse direction drain" is not a drain but a passthrough for exterior water to get to a drain in the corner of the house.

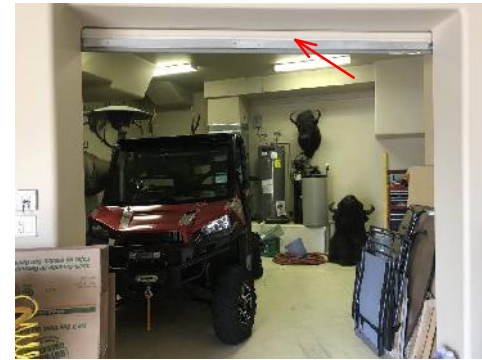
17. Vehicle Door Opener Issue The overhead door to the storage/mechanical room does not function.

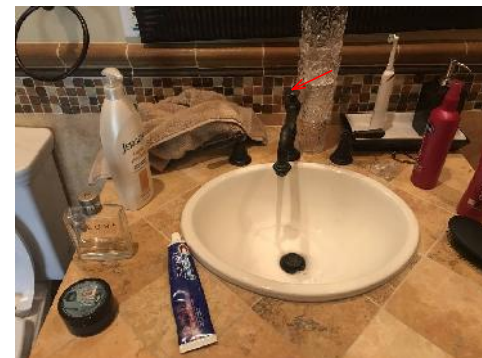
20. Sink Drains Issue The drain stopper is disconnected in the north east secondary bedroom bathroom.

9. Toilet secured in north east bathroom
10. Sink stopper connected in north east bathroom.
11. No evidence of new leakage in pool room....just received 2 inches of rain.

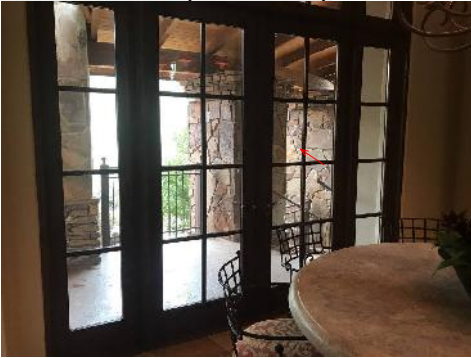
24. Exit Doors/Others Issue The screen door is damaged on the rear of the house. The screws are stripped at the top hinge, the header/threshold pins do not engage on the double door and the door knob does not function for the main electrical service panel closet. The exterior doors difficult to close at the eating nook.

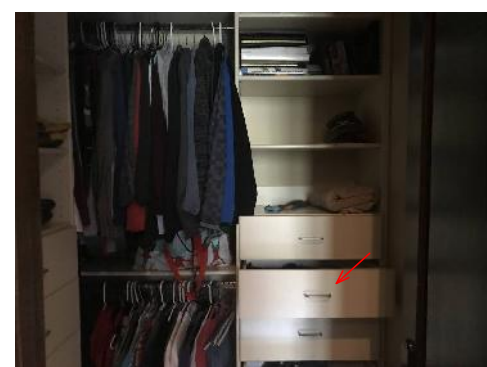
**30. Counter Tops/Cabinets Issue** The drawer guide does not function in the secondary bedroom closet of the north east secondary bedroom.

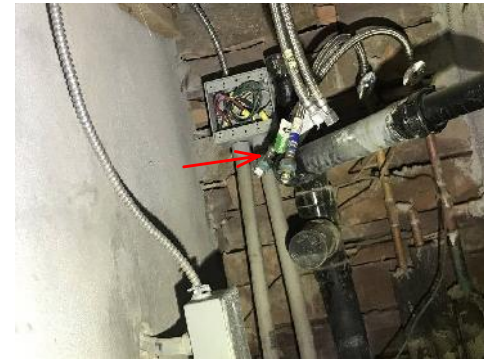
31. Sink Faucet Issue The sink at the outdoor kitchen cannot be tested because the plumbing is disconnected below the sink.

12. New sink fixture installed in outside kitchen
13. Bedroom fuse replaced.
14. Replaced bulbs in house and outdoor fixtures.
15. Blower and "lo" notice on spa to be addressed and fixed on Monday Feb. 25.

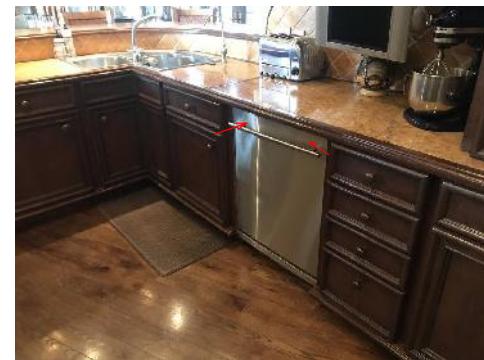
32. Dishwasher Issue The dishwasher is not attached to the cabinetry.

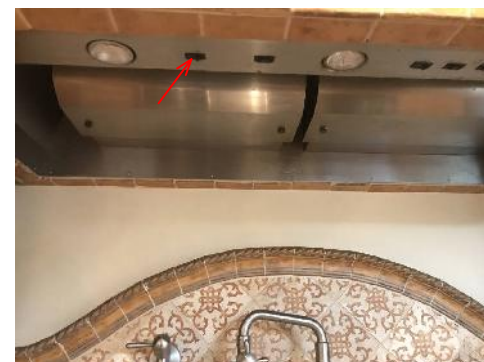
33. Range Exhaust Fan/Duct Operated When Tested The left on/off switch does not appear to function at the range exhaust hood in the kitchen.

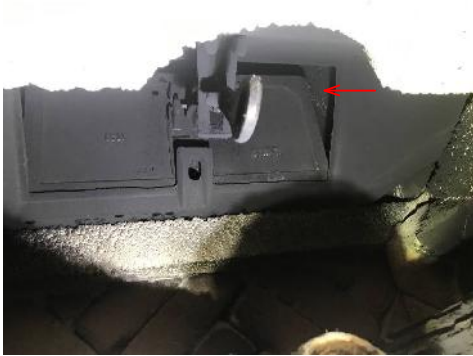
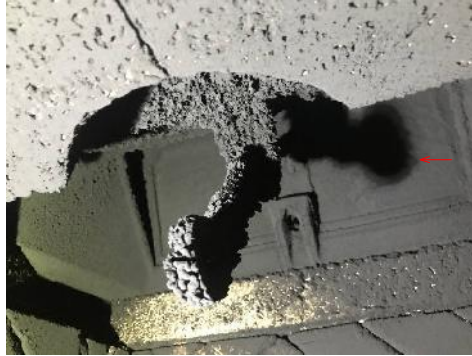
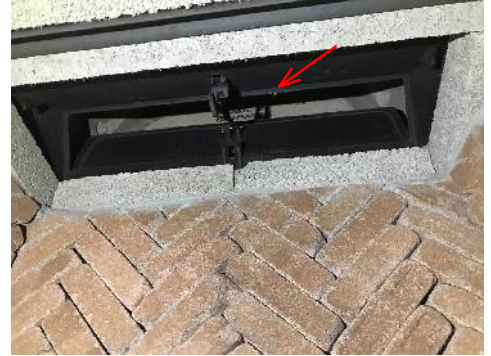
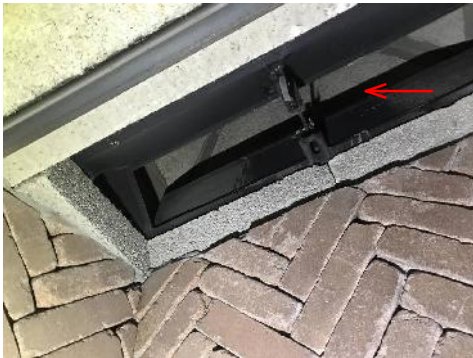
35. Damper Issue The damper is missing the damper clamp in all of the interior fireplaces.

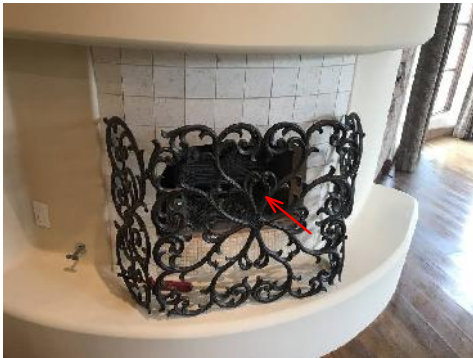
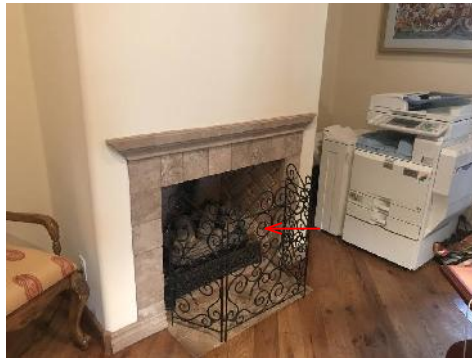
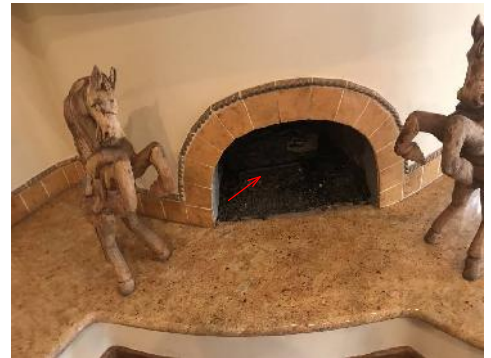
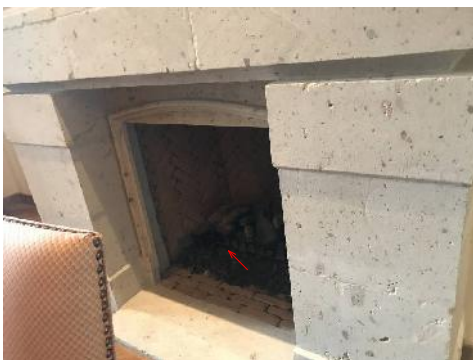
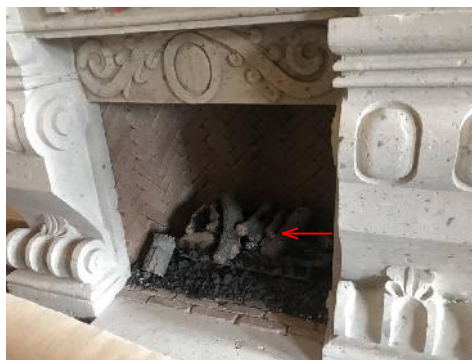
36. Gas Fireplace Function Issue I was on able to light the pilot lights and fireplaces on the interior of the house.

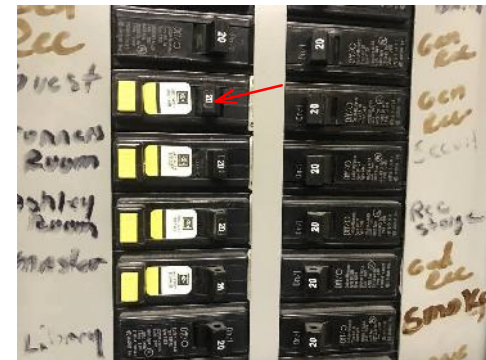
- 37. Breakers/Fuses Issue** The arc fault breaker is in the tripped position and will not reset for the guest room in the upstairs sub-panel.

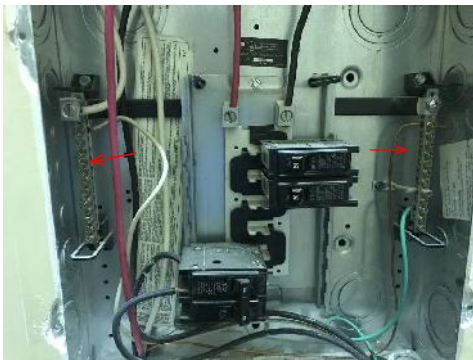
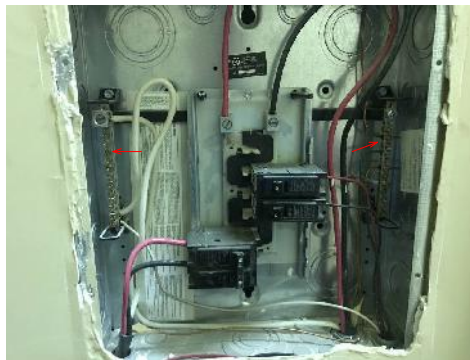
- 38. Buses Issue** The buses are tied together for the sub-panel at pool equipment sub panels one and two.

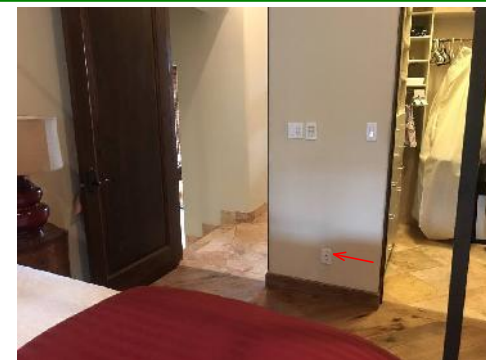
- 39. Outlets Issue** The outlet tested not grounded in the guest bedroom.

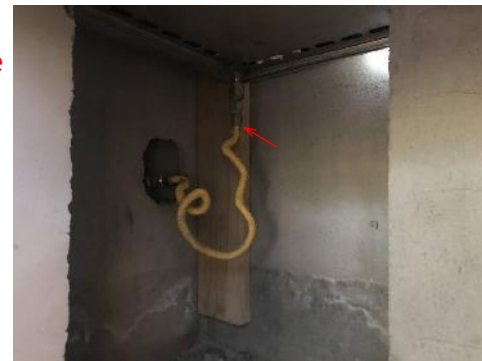
46. Gas Connectors **Issue** There is no pressure regulator installed in the gas supply between the shut off valve and grill at the outdoor kitchen.

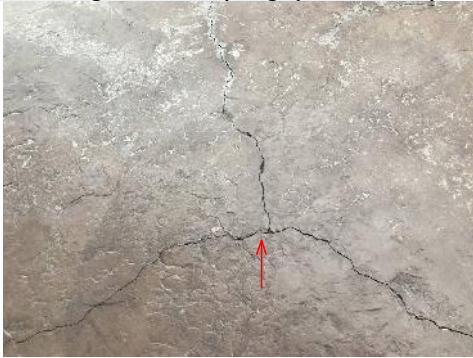
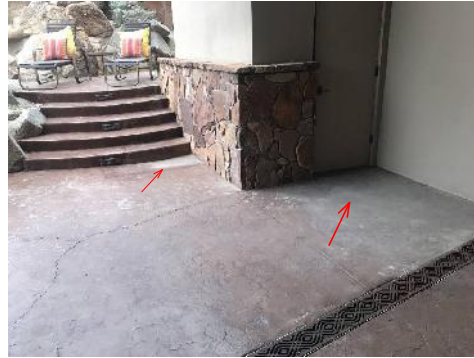
49. Surrounding Deck/Coping **Issue** There are cracks with separation in the pool deck in multiple places. There is evidence of water ponding on the pool deck.

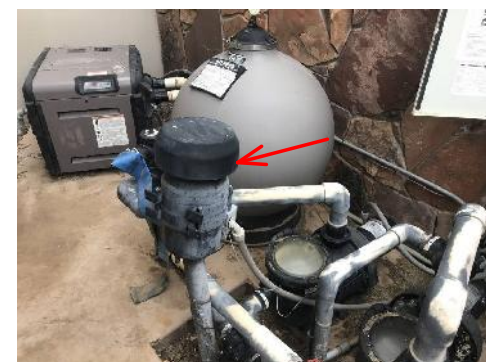
52. Spa Blower Issue The spa blower does not function.

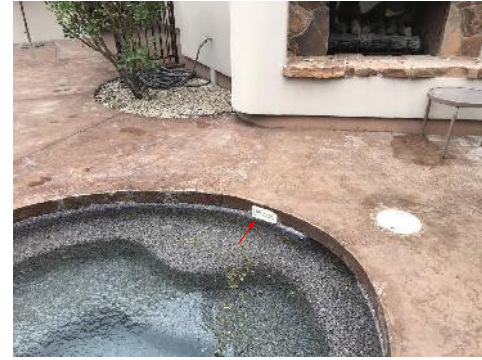
53. Spa air switch .. **Issue** The air switch at the spa for the blower appears to be connected to the waterfall circulating pump.
